Risk assessment methodologies for pedestrian crossings without traffic lights – Warsaw case study – pedestrian safety assessment

Tomasz Mackun^{1,*}, *Artur Ryś*¹, and *Piotr Tomczuk*²

¹Gdansk University of Technology, Faculty of Civil and Environmental Engineering, Gdansk, Poland

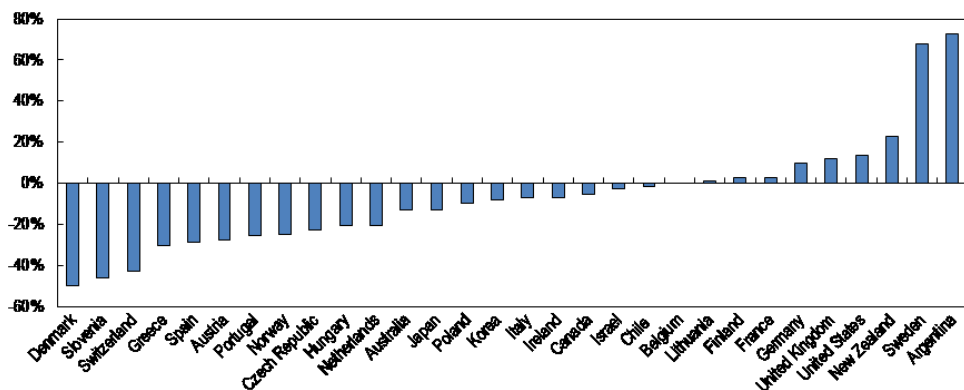
Fig. 1. Percentage change in the number of deaths among pedestrians, 2010-2014 [2].

According to the data [2], the number of pedestrian fatalities dropped by 9.7% (Fig.1) in the years 2010-2014 in Poland. The decrease in fatalities including pedestrians can be caused
