Agnieszka TUBIS¹, Mateusz RYDLEWSKI¹, Marcin BUDZYŃSKI²
¹Wrocław University of Science and Technology (Politechnika Wroclawska)
²Gdańsk University of Technology (Politechnika Gdańska)

SAFETY AND FUNCTIONALITY ASSESSMENT OF TRAM LOOPS IN WROCLAW

Abstract: *The article presents the implementation of the ISFTL method proposed by the authors consisting in an indicator assessment of the safety and functionality of tram loops. Five tram loops located in Wrocław were analyzed. Each of these loops has different characteristics. The components of each assessment are described in detail and further directions for improving the proposed assessment are indicated.*

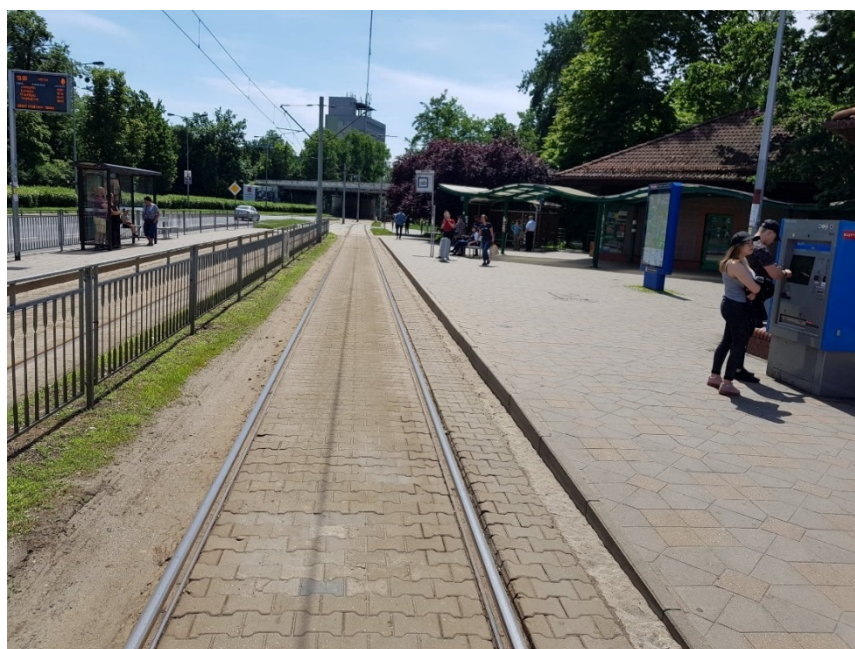
The measurements carried out allowed for the conclusion that the Krzyki loop (fig. 6) has a low level of safety compliance. The first aspect is the condition of the pavement surface, which is not adequate. There are individual defects and unevenness. In the case of the separation of transport traces (ST), no pedestrian crossing through the tram track was identified and there was a clear problem in separating pedestrian and cyclist streams. The entire length of the stop leads as a road to the bicycle parking lot which can lead to dangerous situations in the cyclist-pedestrian relationship. The technical condition of the track is assessed as satisfactory. In terms of the functionality of the loop, the evaluation result is satisfactory.

Fig. 6. Tram platform stops located in Krzyki tram loop in Wrocław (Poland)
