Stability Assessment of Coastal Cliffs Incorporating Laser Scanning Technology and a Numerical Analysis

Rafal Ossowski, Marek Przyborski

Faculty of Civil and Environmental Engineering, Gdansk University of Technology, 80-233 Gdansk, Poland

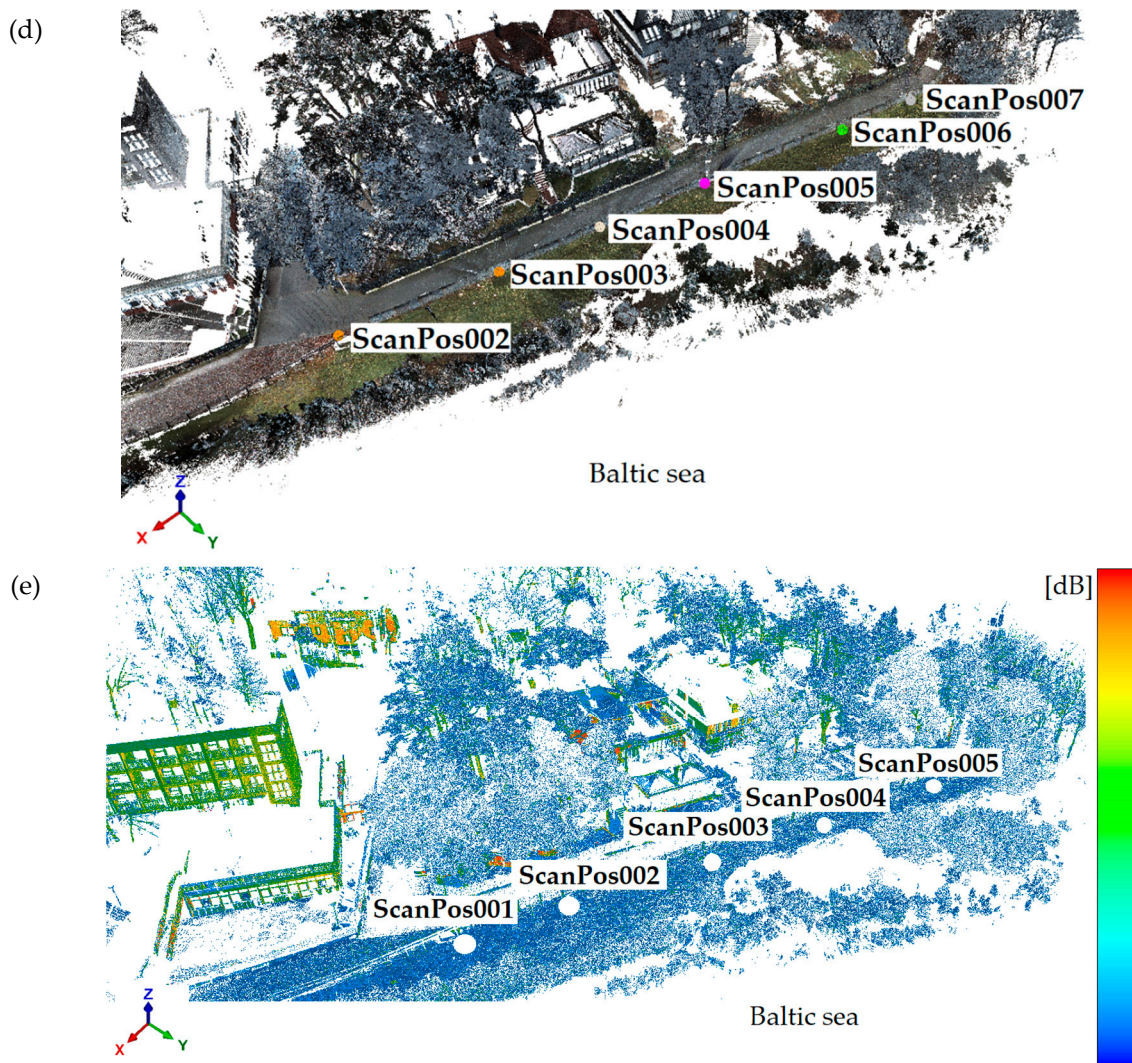
Figure 8. The scanner locations for the (a) February 2015, (b) March 2017, (c) July 2017, (d) November 2018, and (e) March 2018 measurement missions.

Figure 8 presents the location of the scan positions for each of the February 2015, March 2017, and July 2017 measurement missions and the deployment of positions in the local system in November 2017 and March 2018. The point density for each measurement mission was equal 4200 pts/m². In Figure 8a–c,e respectively, colours are presented as a function of light reflection amplitude, while Figure 8d shows the fragment of the upper part of the cliff in RGB (Red-Green-Blue) colours.

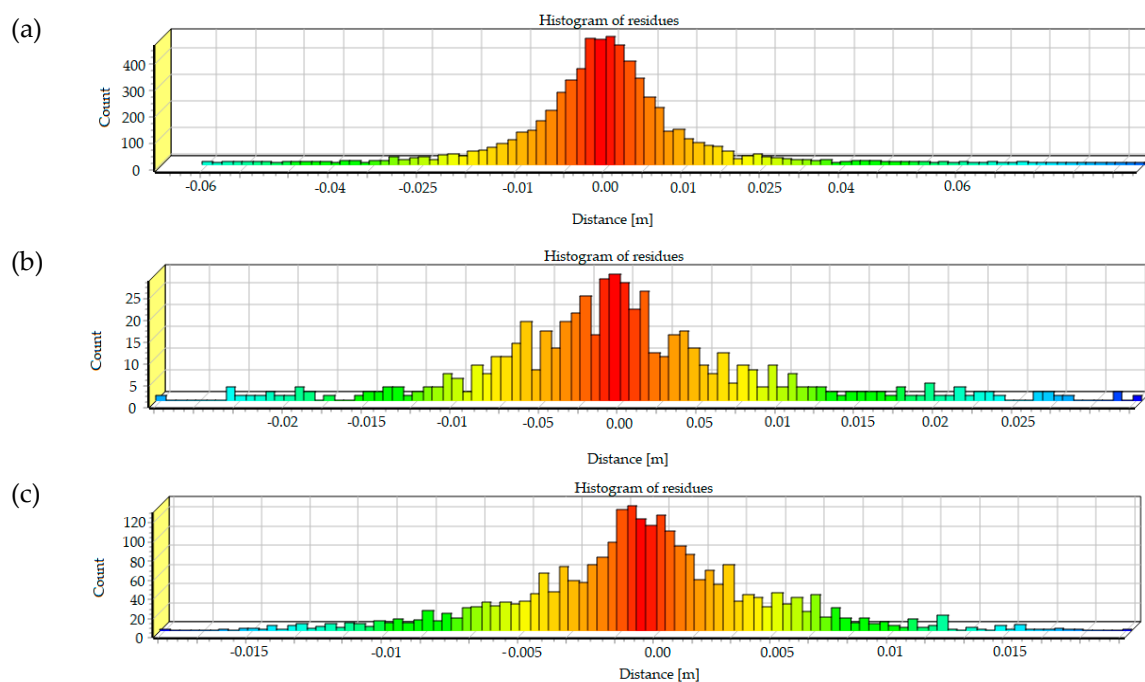
Figure 10. Residuals showing the equalization of point clouds using the Iterative Closest Points (ICP) algorithm in (a) February 2015, (b) March 2017 and (c) July 2017.

The validation of the terrestrial laser scanning data was based on a histogram of the distance between the control points. We applied the ICP algorithm (Figure 10) and the standard deviation and attached a point cloud to the EPSG:2177 coordinate system (Table 2). We needed to provide a fixed GNSS receiver solution where the error in the calculation of the average position would be no more than 1 cm. In the case of an erroneous measurement by satellite technology, the standard deviation of such an aligned point cloud to the EPSG:2177 coordinate system would be a decimetre, or even higher, and thus easy to detect. Based on the obtained results from Figure 10 and Table 2, we assumed that the accuracy of the comparative analyses may fluctuate around 10 cm ($2.5\sigma_1$) when using Terrestrial Laser Scanning. For this reason, the precision of the displacement reading will also be in the range of 10 cm. Table 2 presents the transformation matrix in the first column, number of reference points used in alignment process in the second, and the value of the calculated standard deviation in the third. The presented residues show the differences in distance between the tie points in the case of automatic extraction described in Section 2.4.1.

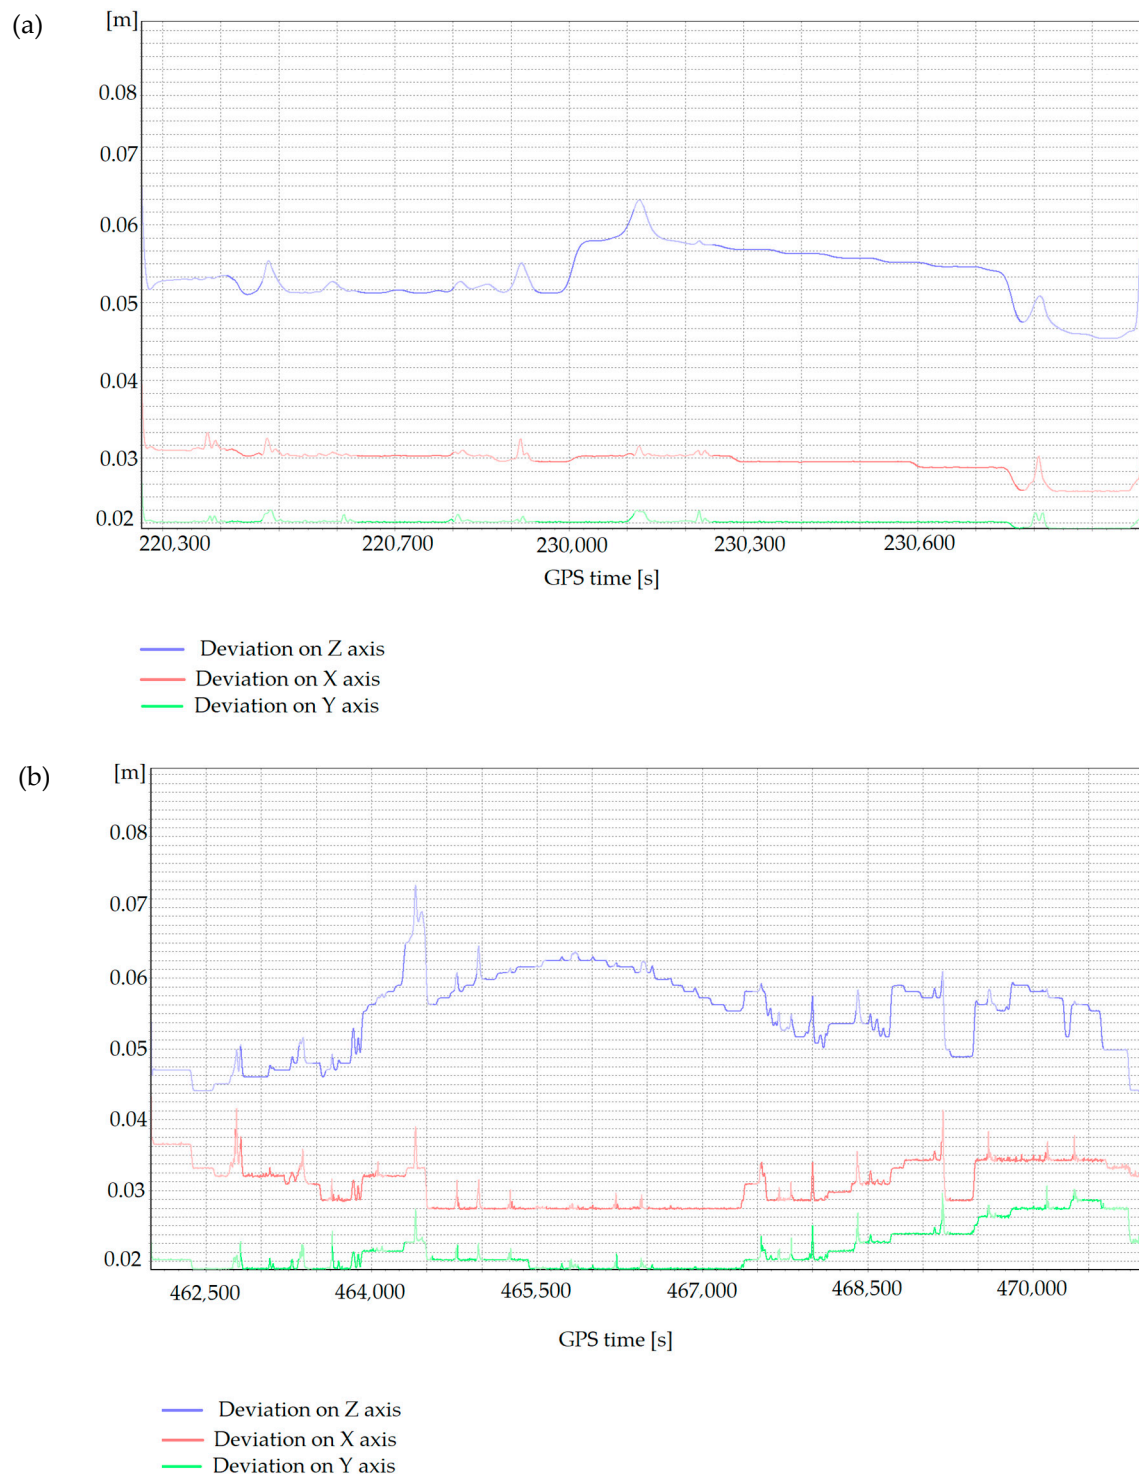
Figure 11. Deviations from the approximated trajectory on each axis for (a) the flight from 2014 and (b) the flight from 2017.

Furthermore, analyses of the airborne system's data were conducted. Figure 11 shows a diagram of the INS position deviation based on trajectory, and Table 3 shows a histogram of differences among control points. As can be noticed in Figure 11a, which shows the deviation from the flight that was performed in 2014, the elevation has the highest value of deviation of 6 cm. Figure 11b, which shows the deviation from the flight that was performed in 2017, has similar values to those in Figure 11a. This means that the trajectory was correctly aligned. An assessment of the accuracy was carried out after establishing individual records of scans between them and the EPSG:2177 coordinate system. The resulting differences between the accuracy of alignment of individual axes result primarily from

the measurement characteristics, where the aircraft fluctuated, but also from the emerging drift of the device. Seen offsets can be removed during strip-adjustment procedures.
