Stress-strain model of lower corroded steel plates of normal strength for fitness-for-purpose analyses

This study investigates the mechanical properties of specimens made of normal strength steel subjected to lower marine immersed corrosion degradation levels (below 25 %). The specimens were corroded in laboratory conditions, and only natural factors were controlled to raise the corrosion rate (reaching the level of 1 mm/year). Three different thicknesses of plates made of normal strength of shipbuilding steel are investigated (between 5 mm and 8 mm). The standard tensile tests are performed for estimating the stress-strain behaviour of corroded specimens. Non-corroded specimens were tested to establish the initial mechanical properties and uncertainty level as a reference. Further, the corroded specimens were tested too. Based on that, the changes in mechanical properties (i.e. yield stress, Young modulus, ultimate tensile stress and total elongation) were analysed. It was found, that for degradation level reaching 25%, approx. 10% reduction of yield stress was observed. A new parameter, defining the area reduction, was established as more closely related to the mechanical proper

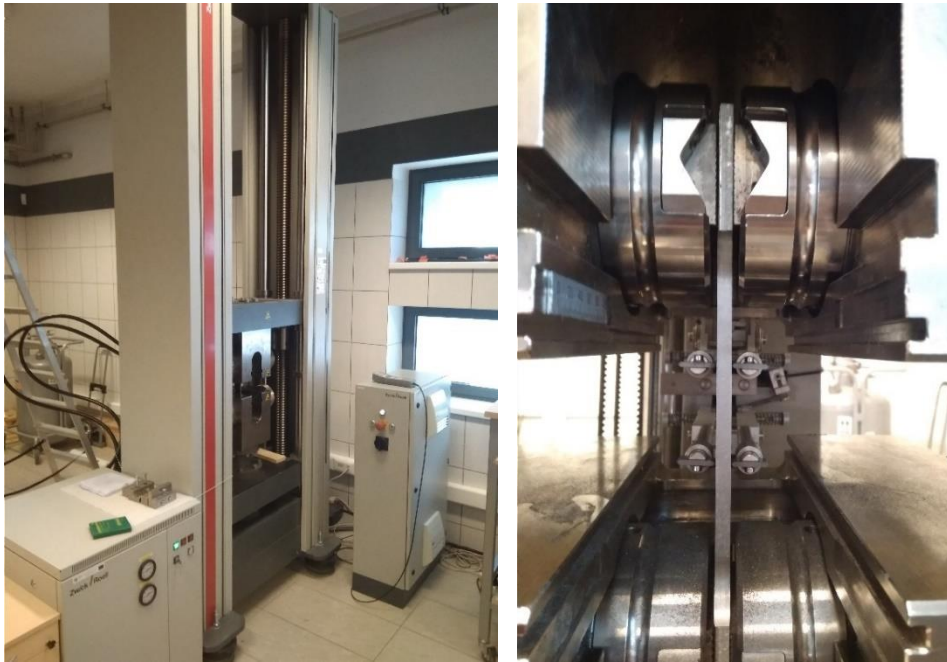
200 Figure 5. Testing machine (left) and mounted specimen with installed extensometer (right).

193 The standard Zwick-Roell Z400 machine with a step electric engine was used to conduct the tensile
 194 test and estimate the elasticity modulus, where a mechanical extensometer was adopted (see Figure
 195 5). The tests were performed following the ISO standard for tensile testing [35] of flat coupons, and
 196 the loading was displacement-driven. The strain rate was 0.00025 mm/mm/s up to the moment, where
 197 the yield point has been reached. Above the yield point, the strain rate was 0.002 mm/mm/s. The
 198 distance between heads was 170 mm.

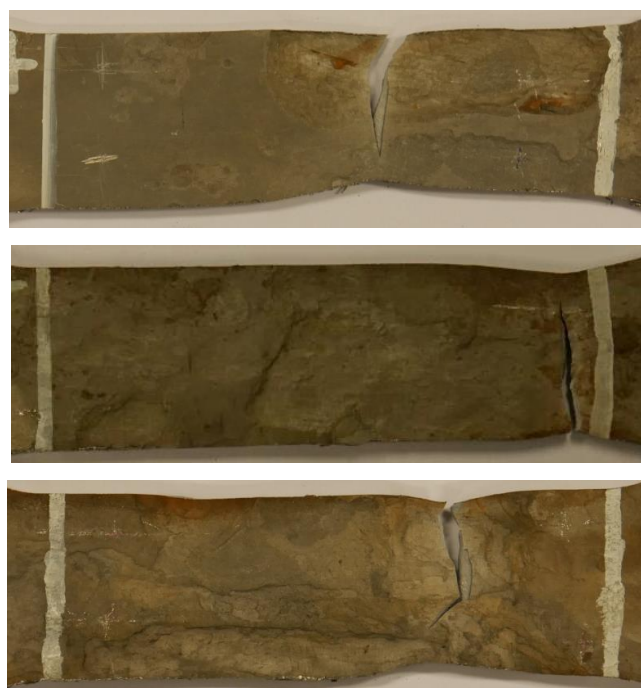
328 Figure 13 shows examples of failure modes of tested specimens. It could be noticed that the failure
329 mode is different in comparison to typically observed for intact specimens. In most cases, the cross-
330 section, where the breaking line is followed, is related to the position, where the minimum cross-
331 sectional area along the gauging part is located [29]. Further, the breaking line is non-straight and
332 inclined in most cases, which is not the case of intact specimens, where a straight line is usually noted
333 perpendicular to the loading direction.
