# TECHNICAL ASSESSMENT OF 120-YEAR-OLD RAILWAY RIVETED TRUSS BRIDGE

**Abstract.** A 120-year-old railway truss bridge over the Bóbr River, Poland, is investigated in this paper from the mechanical and chemical properties of the materials by testing of old steel samples in a lab – through geodetic measurements, bathymetric measurements of the riverbed and dynamic measurements of bridge spans under service load – to the analysis of structural behaviour by finite-element modelling. The mechanical and chemical properties of the structural old steel are investigated by testing steel elements extracted from the old bridge. Structural analysis shows that the bridge is eligible for renovation or replacement for a new one due to unfulfilled today's load requirements in terms of bearing capacity. The paper begins with a survey of chosen literature carried out on the investigation of the old steel railway bridge's subject matter. This paper can provide scientists, engineers, and designers with an experimental and structural basis in the field of old steel riveted railway truss bridges.

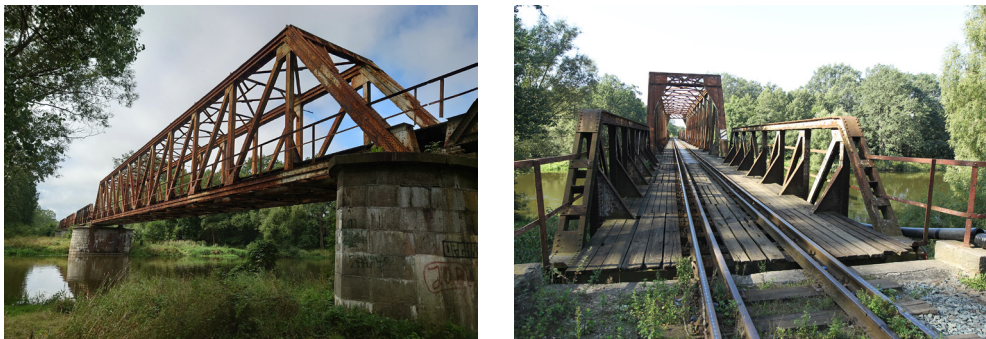
Figure 1. View on railway truss bridge

The railway riveted truss bridge (see Figure 1), which is the subject of this study, is located over the Bóbr River, Poland. The year of construction of the bridge was 1904 (see Figure 2), while in 1957 the bridge was completely renovated. The renovation covered cleaning of corrosion and applying protective paint coatings, as well as replacing the deck sheathing. After nearly 50 years of service, it is necessary to verify that the bridge meets today's load requirements in terms of bearing capacity, and serviceability state and make decisions on a range of reconstruction and repairs.

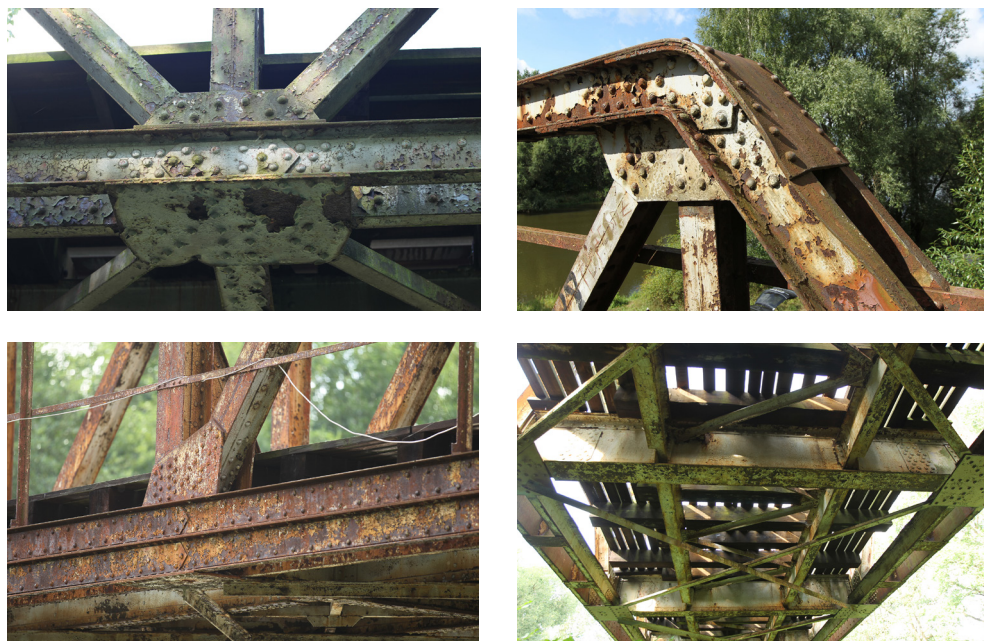
**Figure 5.** Bridge technical inspection – view on chosen defected elements of the railway truss bridge

The technical condition of the bearing-capacity structure of the bridge (see Figure 5), after the bridge technical inspection, is assessed as inadequate. The condition of the span structure bridge deck, supports, slopes and embankments are considered sufficient. The railway superstructure condition on the facility is insufficient due to a lack of anti-derailment plates, fire protection plates, and compensating devices, and the profile of the rolling rails was inconsistent with ID-2 (PKP, 2005). Expansion joints are faulty operation because expansion joints jammed – blocking the span structure for the horizontal shift on supports No. 3 and 6. The condition of the railway superstructure on the access roads, the load-bearing structure of the spans – lattice girders (degree of corrosion, local deformations, cracks, losses), bearings (degree of corrosion, contamination, excessive displacement of movable bearings on pillars No. 3, 4, 6), service sidewalks (surface defects) is considered insufficient. The bridge site inspections indicated that the bridge was eligible for repair due to high corrosion, local deformations and cracks of structural elements, which was an issue for the bridge superstructure.

- To increase the temporary load capacity of the span bridge structure, it is technically possible to strengthen the platform elements: stringers and crossbars.

- Due to the blocking of expansion joints on supports no. 3 and 6, it is recommended to immediately unblock the expansion joints by undercutting the steel elements of the platform structure, so that the span structures can move freely on movable bearings.

- Necessary renovation works can be divided into variants depending on the necessary date of their implementation and the goal that will be achieved after their completion: works necessary to be performed immediately to ensure the safety of use; works to ensure the safety of use and protection of the facility against further degradation; works to ensure the safety of use and restore the functionality and proper load capacity of the facility.

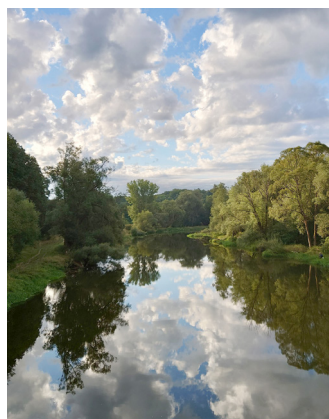
**Figure 6.** The banks of the Bóbr River near the bridge site

Bathymetric measurements of the riverbed within and in the vicinity of the bridge are performed (see Figure 6). The measurement of the bottom elevation was made with a single-beam HydroBox echo sounder with a 200 kHz transducer. The echo sounder was positioned using the RTK GPS - Leica System1200 satellite positioning system, which used the correction of the position transmitted from the LEICA SMARTNET system. The digital model of the riverbed is created by the grasshopper method, which involves targeted measurements at specific points. Based on measurement points, isobaths and cross-sections are generated. The riverbed digital model is made in a hydrographic program.

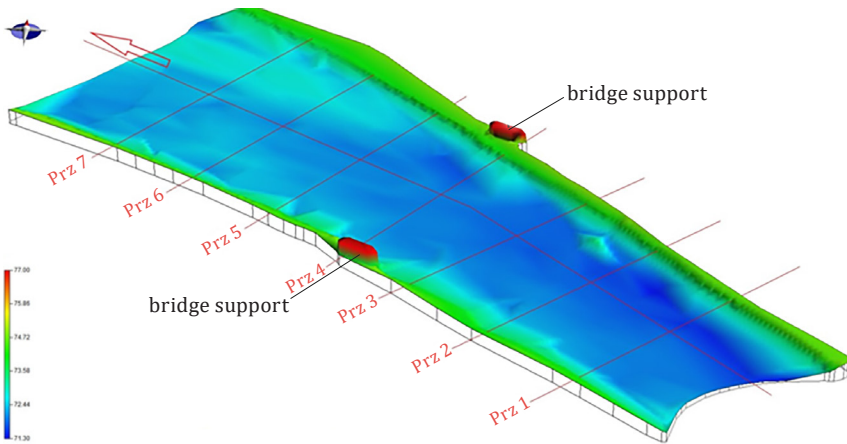
**Figure 7.** River bottom with local river axis and cross-sectional diagram

The results of the bathymetric measurements are shown in Figures 7 and 8. A map of ordinates (Figure 7) and cross-sections of the river bottom with ordinates (Figure 8) give the accurate river bottom shape. The water level during measurements was about 73.83 m over sea level. The bottom of the river bed under the spans of the structure – even and hard, about 2 m deep. On the right bank – in the vicinity of pillar no. 2 – the bottom is inclined at an angle of about 15°, there is a riprap at the bottom, no washout and no losses of the riprap. At the left bank – in the vicinity of pillar no. 3 – at a distance of about 1 m from the support face – the bottom gradually rises, and the depth of the bottom is about 1.5 m. In the vicinity of the body and foundation of pillar no. 3, deposits of silt with a thickness of about 1 m and the lack (washing out) of the riprap were found. Based on the tactile condition assessment (complete lack of visibility due to silting of the bottom), no mechanical damage and no losses of the pillar body were below the water table.

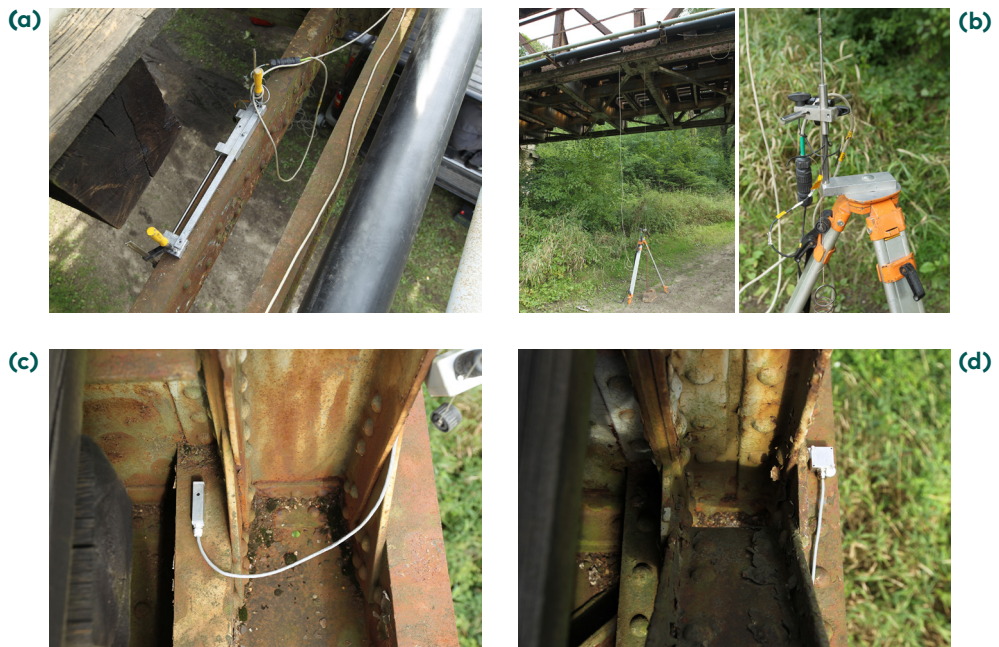
**Figure 9.** View on chosen measurement points: (a) – Strain measurement point; (b) – Vertical displacement measurement point; (c), (d) – Acceleration measurement points

Dynamic measurements of bridge spans under actual service load (passage of trains) were performed. The dynamic analysis of bridges under moving loads requires the determination of the dynamic parameters of bridge spans and moving vehicles (Kilikevičius et al., 2018; Paeglitis & Paeglitis, 2014; Siwowski et al., 2021; Szafranski, 2021; Zoltowski et al., 2022; Zwolski & Bien, 2011). The dynamic tests cover the following: measurements of the vertical and horizontal components of transverse accelerations of span structures; measurements of vertical displacements – deflections of span structures; and measurements of strains and normal stresses in the bottom chords of truss girders (see Figures 9 and 10).

Dynamic tests under service load aimed to determine the actual response of the structure to present railway loads and to identify the modal parameters of the bridge structure, as follows: forms and values of natural vibration frequencies, damping coefficient values, and dynamic coefficient values. The obtained results allowed for the validation of the numerical FE computational model of the bridge developed and used to determine the current load-bearing capacity and fatigue life of the bridge structure.
