B. Świczko-Żurek¹, M. Krzemiński²

THE DEGRADATION OF METAL IMPLANTS

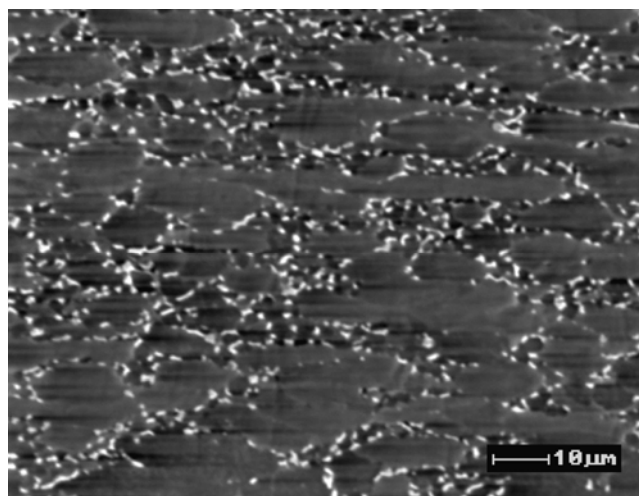
The research was carried out by using the scanning electron microscopy (SEM) (pic.2), it showed that the microstructure of Ti-6Al-4V consists of phasal combination ($\alpha+\beta$).

Pic.2. The view of Ti-6Al-4V structure

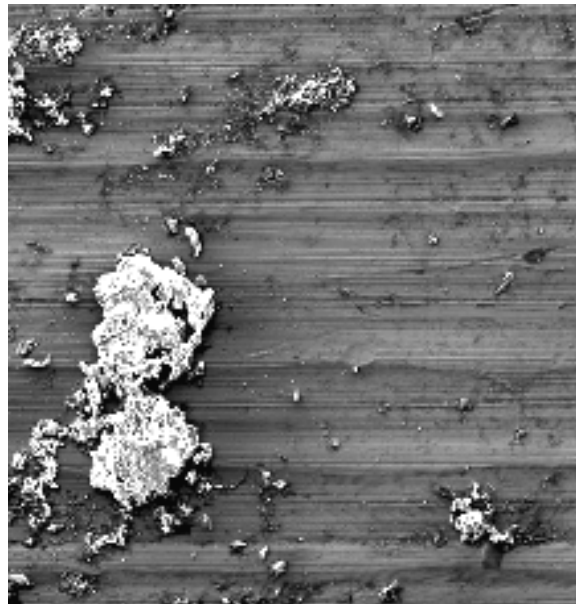
The microscopic analyses of surface layer showed the presence of *Staphylococcus Epidermidis* (pic.3). It is considered to be skin bacteria flora. It can enter the body, when balance between immunity and bacterial systems is broken, causing inflammation of soft tissue and organs. *Staphylococcus Epidermidis* is capable of producing phlegm, which makes sticking different objects like prosthesis possible. The produced phlegm deteriorates immunological functioning as well as proper absorption of antibiotics in the infected area.

Pic.3. The view of *Staphylococcus Epidermidis*

1. The reason for removing implants was their degradation caused by improper conditions provided by the body – both patients suffered from *Poliarthritits Rheumatoidea*.
2. The bacteria *Staphylococcus Epidermidis* as well as the environment of the body

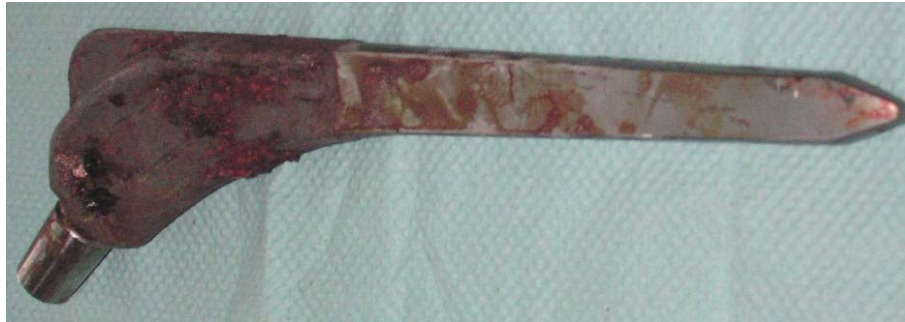
Those were endoprothesis of two men. First one aged 59 (had his endoprothesis planted in 1991 and removed in 2003). The other patient aged 65 (had his endoprothesis planted in 1997 and removed in 2005). In both cases aseptic loosening was the reason for removal.

Picture 4 and 5 show degraded implants, after removed of human body.

Pic.5. The degraded implants from the second patient
