The influence of welding heat input on the quality and properties of high strength low-alloy dissimilar steel butt joints

Jacek Tomków^{1*}, Jacek Haras¹

¹ Gdańsk University of Technology, Poland

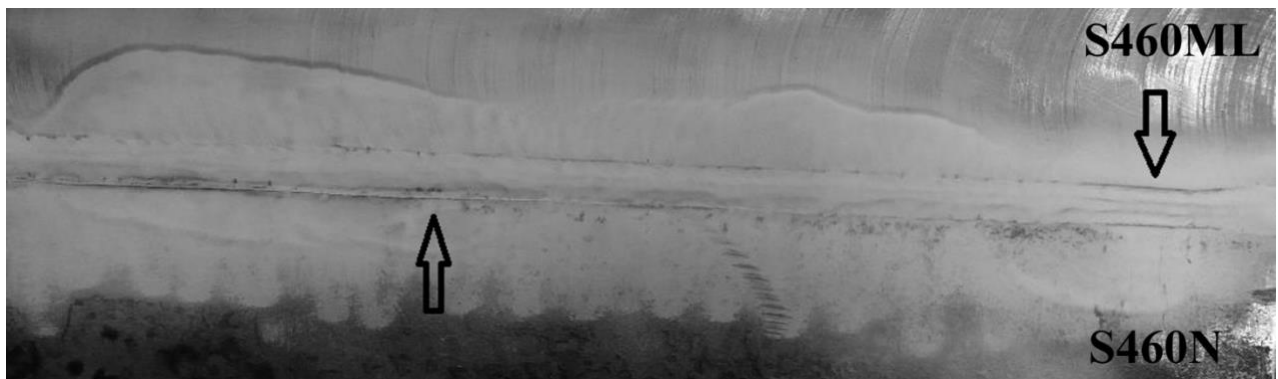
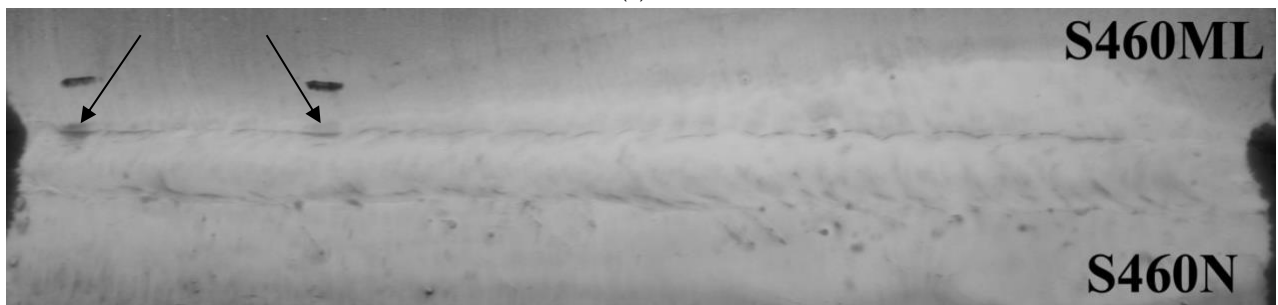
Fig. 4. Results of PT: a) Specimen 1, porosity in the middle, indication at right; b) Specimen 2, lack of fusion marked by lines

Before applying the penetrant, the surfaces were cleaned and the spatters were removed from them. A penetrant was then applied, the excess of which was removed with a cleaner after ten minutes, to then apply a developer layer. During the examination of the first sample, two indications appeared on both sides of the weld at the fusion line and a cluster of blisters at the place indicated during VT tests from the S460N steel side. Examination of a sample welded with lower heat input showed no other indications than in VT tests. The results of PT testing are presented in figure 4.
