The role of isolated farmsteads in the open landscape protection on the example of Kashubia

Introduction

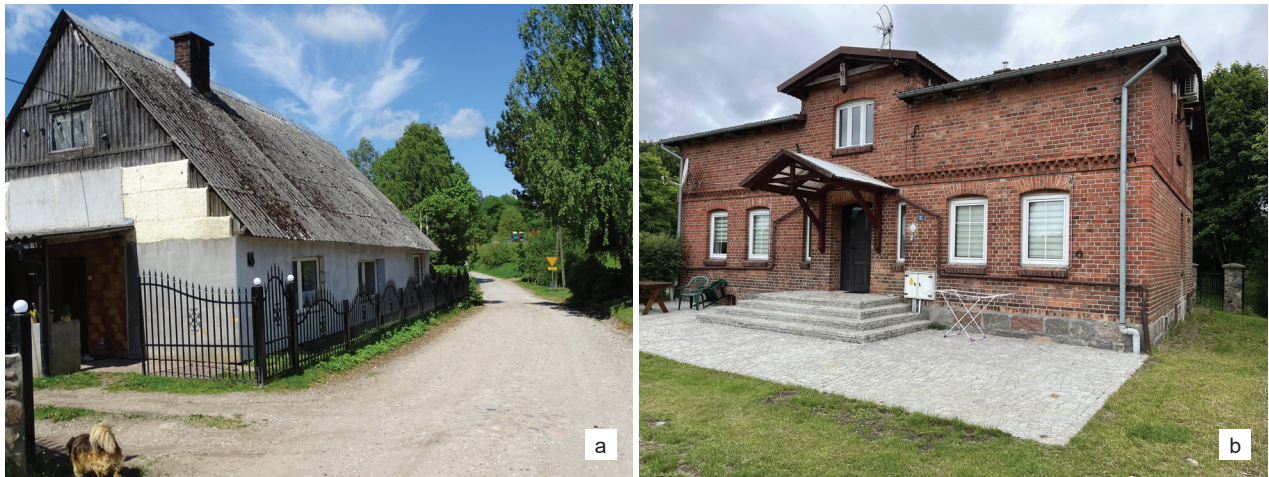
Fig. 2. Two types of farmstead houses in Kashubia:
a) a building with a high roof, b) a building with a semi-flat roof (photo by A. Górka)

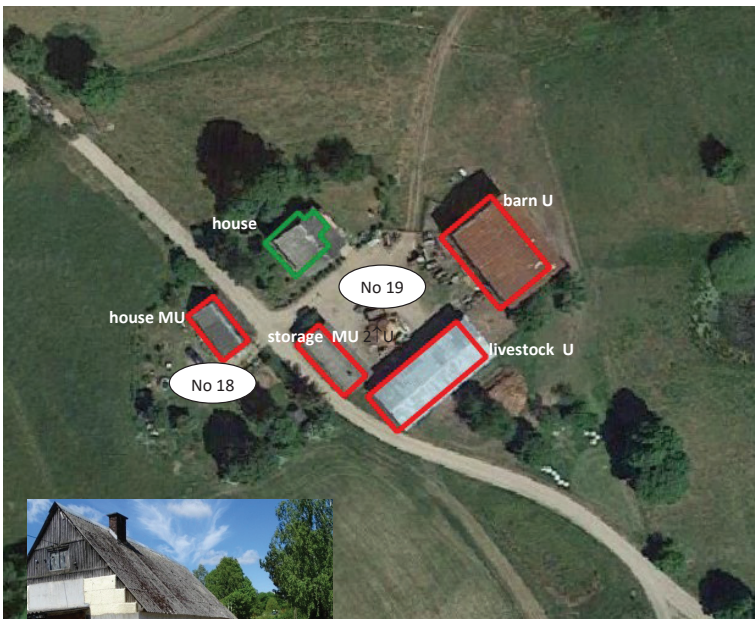
M – a modified building body or facade; U-used; D - degrading; R- in ruins

map from 1937 with building data from 2020

orthophotomap and building data from 2020

Fig. 4. An example of a farmstead inventory card (elaborated by A. Górka)

Along the scenic routes, 26 historic farmsteads were identified (Fig. 3). Each of them was described on an inventory card, in accordance with the model shown in Figure 4. Based on cartographic research and expert analysis of architectural features, buildings dating back to before 1937 and ones that were erected later were identified. They were documented in photos, their condition was described while modifications to traditional features were noted.
