## *The room above the porte cochère of the Kwidzyn castle in the times of the Pomesanian chapter*

#### *The room above the porte cochère of the Kwidzyn castle in the times of the Pomesanian chapter*

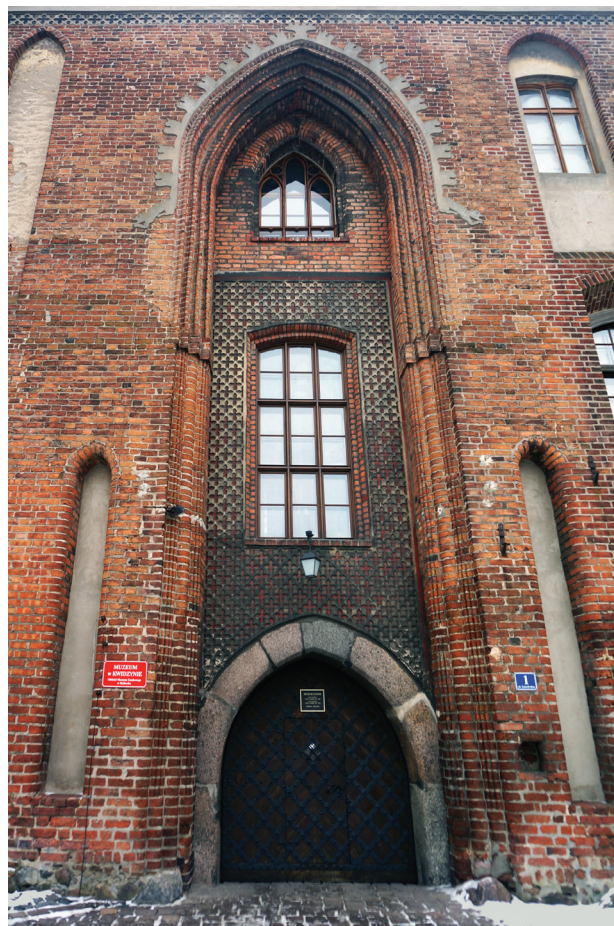
Fig. 2. View of the entrance and the rooms located above from the north (photo by A. Piwek)

one). A low porte cochère located in the northern wing led to the interior of the complex (Figs. 1, 2). Above it, there was a room whose history was connected not only with the porte cochère but also with the fate of the castle inhabitants. Their aspirations and needs significantly influenced its interior.

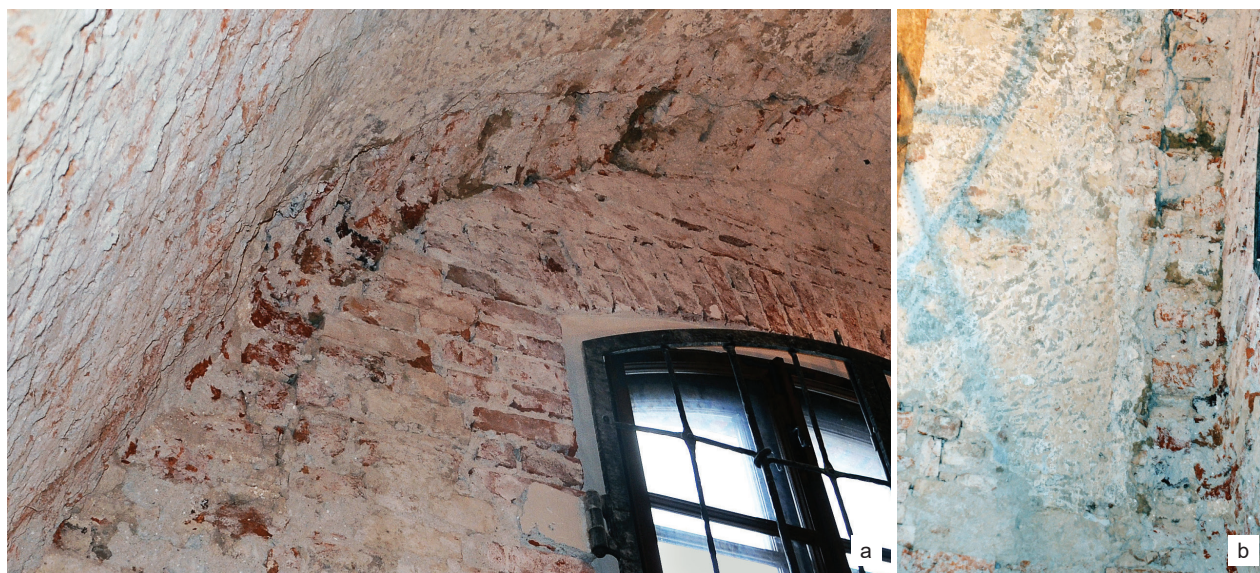
Fig. 4. Remains of the original recess in the northern wall (with a window):

- a) fragment of the arch (disappearing in the middle of the vault) at the junction with the cover of the widened recess,
  - b) part of the medieval widened recess arch with traces of the narrowing of the northern wall (strip of bricks by the window wall)
- (photo by A. Piwek)

etrating (in the middle of the recess) its lintel (Fig. 4a). The ogival arch of the recess has a strip of chipped bricks, approx. 15 cm wide, separated by a joint at the window wall (Fig. 4b).

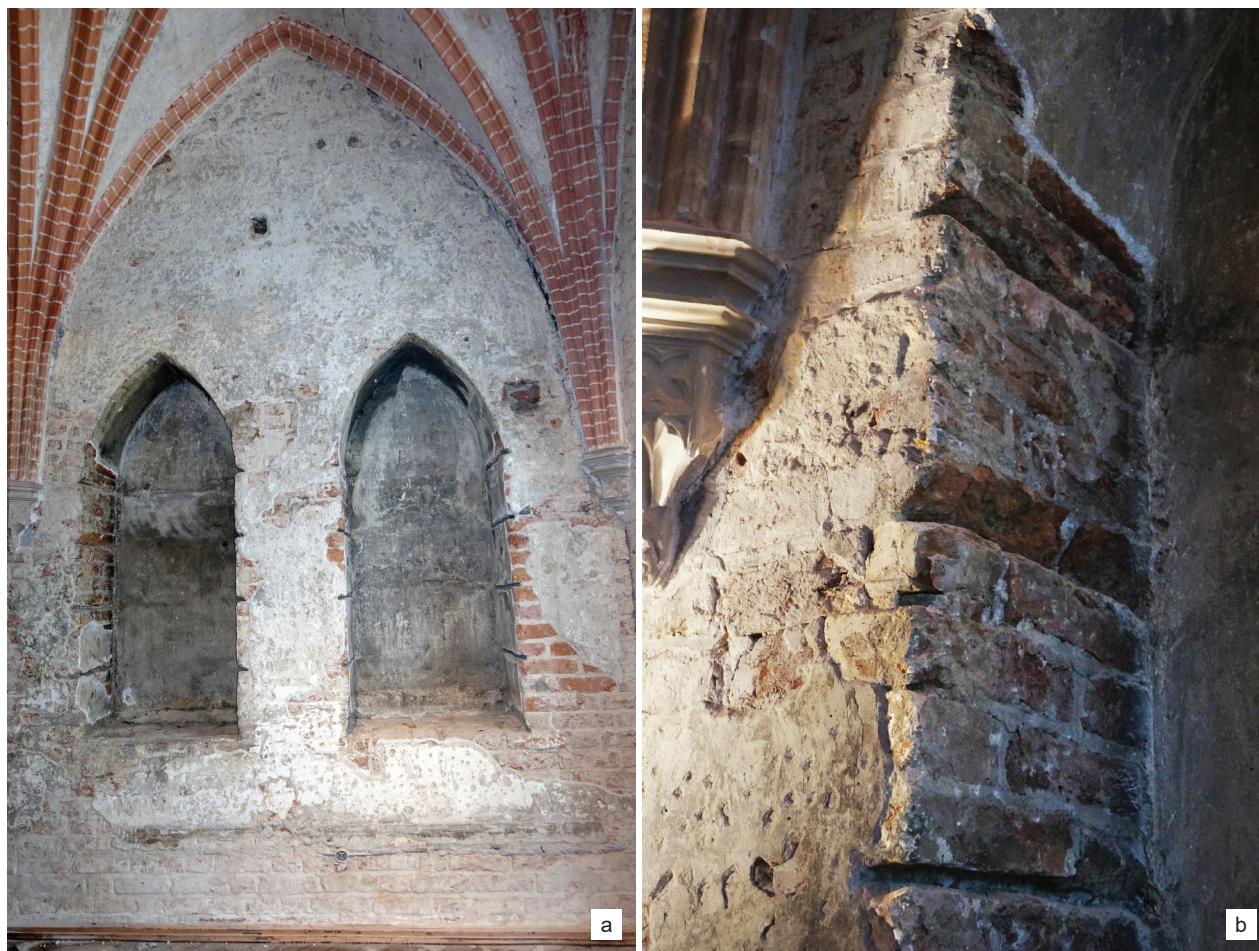
Fig. 5. The northern bay of the western wall with a pair of ogival recesses. Their side walls contain horizontally bevelled and right-angled cuts so that shelves could be fitted: a) general view, b) detail with cuts in the southern wall of the second recess from the north (photo by A. Piwek)

The western wall contains mainly  $30.5\text{--}31.0 \times 14\text{--}14.5 \times 7\text{--}7.5$  cm bricks classified as medieval. In the north bay, two ogival recesses were found 95 cm wide, 235 cm high (up to the keystone), bricked up with  $30.5 \times 14.0 \times 8.5$  cm bricks, as well as  $25 \times 15.0 \times 9.0$  cm bricks and medieval shaped stones (Fig. 5a) [9, p. 9]. After their removal, it was possible to determine the depth of these recesses – 45 cm on average. The side walls of the recesses contained intentionally made small indentations (Fig. 5b), four on each side. In the second recess to the north, there was a marked variation in their execution. The two uppermost rows and the third row on the north wall were bevelled at the top, while the rest were right-angled. Bevelled cuts were also found in both recesses where the vertical walls meet the base of the recesses. A similar recess to the two described above was found in the south bay, between the passage to the hall adjacent to the western and the southern wall of the room under study, except that its southern wall was

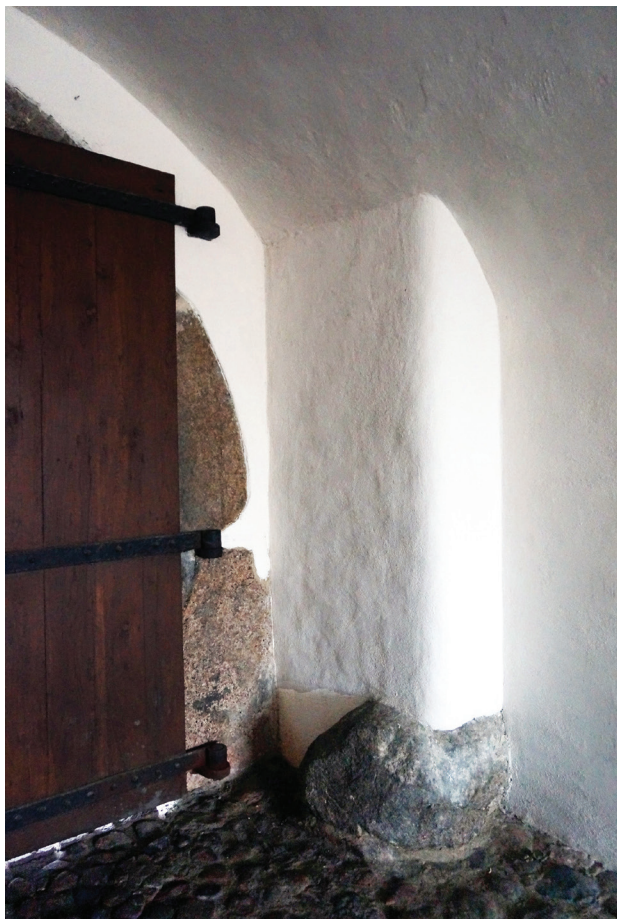
Fig. 7. The eastern fragment of the medieval entrance to the Kwidzyn castle with a late-Gothic extension (pilaster) and a modern segmental vault (photo by A. Piwek)

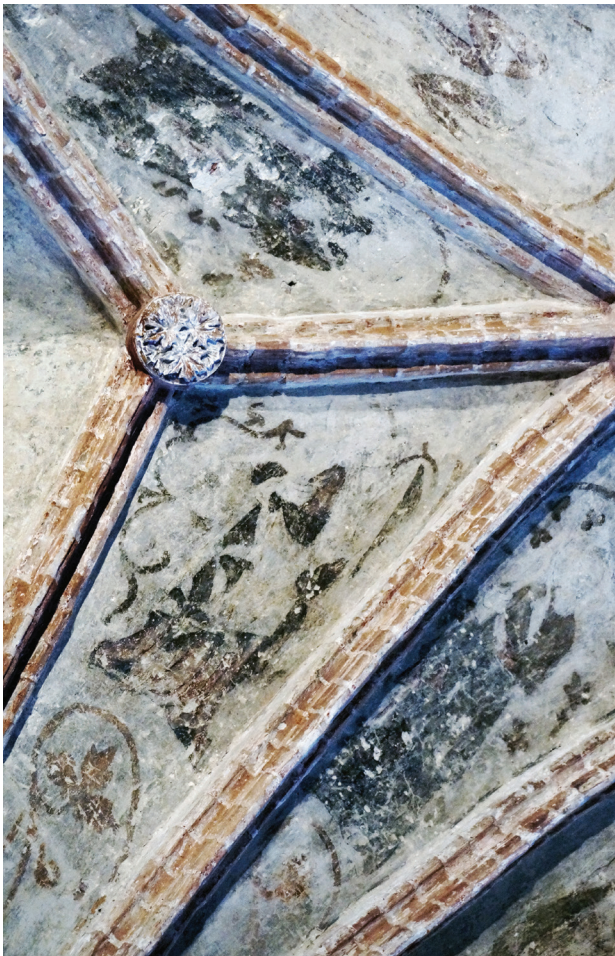
Fig. 9. Part of the northern bay vault with traces of exposed polychrome (2<sup>nd</sup> quarter of the 15<sup>th</sup> century?) (photo by A. Piwek)

The completely uncovered polychromes (Fig. 9) indicate the sacral function of the room and the time of its creation. It is assumed that they were made between 1400 and 1450 [10, pp. 8, 9], although this is not the only possibility<sup>13</sup>. Their sacral content (figures of saints) corresponds with the new use of the hall. Their appearance only on the vaulting of the northern bay has not been explained yet. The suggested reason is the start of the war in 1409 [9, p. 8] and its consequences. There is also another explanation. When a wooden partition is placed in the middle of the interior, it separates parts intended for users of different status – the clergy and the castle servants.

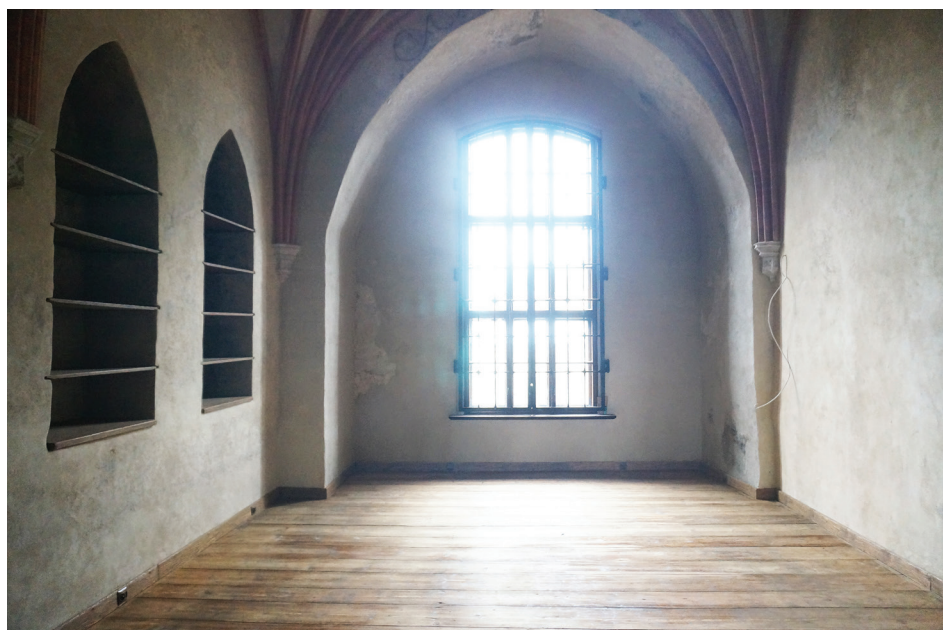
Fig. 10. Northward view of the interior of the room above the porte cochère at the end of conservation work (September 2017) (photo by A. Piwek)
