# Water-lubricated bearings of ship propeller shafts - problems, experimental tests and theoretical investigations

Wojciech Litwin, Ph. D.  
Gdansk University of Technology

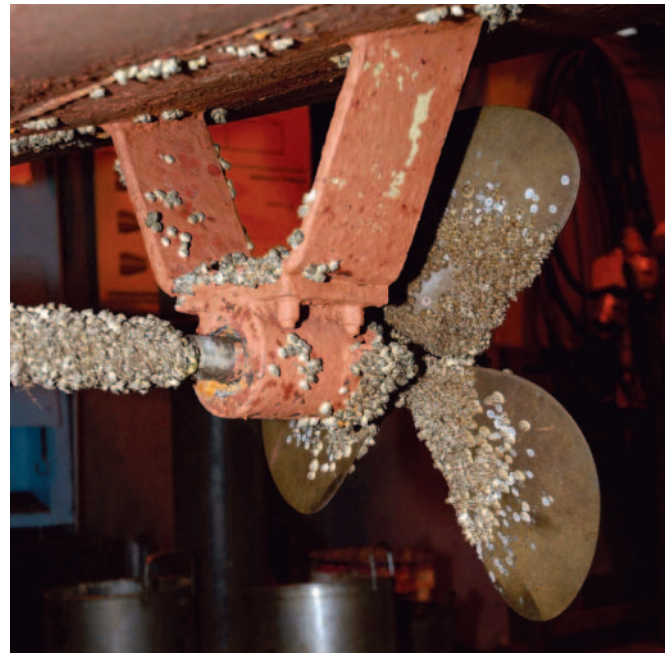
*Fig. 2. Cantilever open bearing of yacht's propeller shaft*

Each of them is characteristic of different properties and, resulting from them, advantages and disadvantages. Rubber effectively damps vibrations and is not sensitive to contamination, which is the reason for using it in e.g. cantilever open bearing systems (Fig. 2). It is important that contaminations which fell into rubber bearing accelerate its wear process only moderately. This concerns also hard contaminations, e.g. high-silica sand grains.

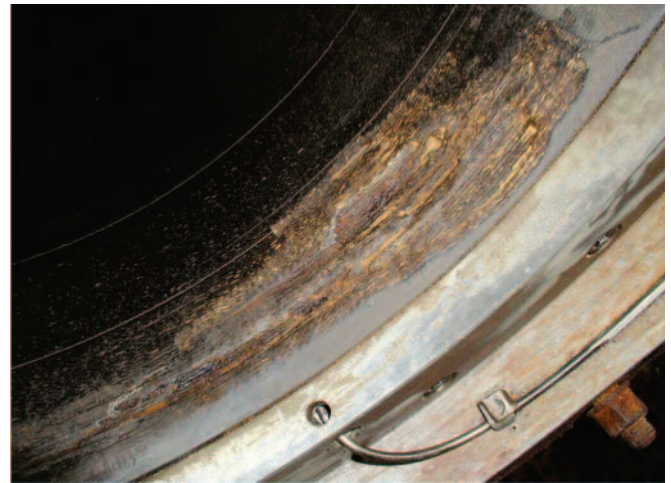
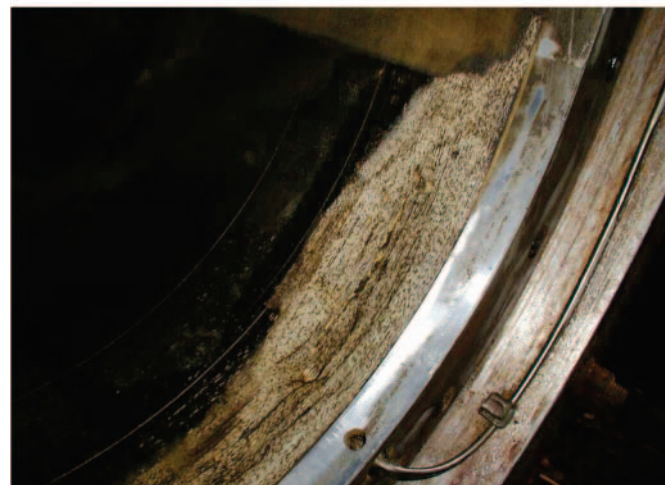
*Fig. 3. Damage of a composite bush, resulting from edge thrust resulting from skew position of shaft axis (up); during repair the damaged edge was grinded to avoid cracks and delamination of the composite (down)*

Composites, out of all the above mentioned materials, are characteristic of the largest value of rigidity modulus amounting to about 4500 MPa. Therefore they are sensitive to edge thrust in the case of shaft skewing. (Fig. 3), but they also have important merits. They are durable and highly resistant to form distortion which is a disadvantage of some homogenous polymer materials.

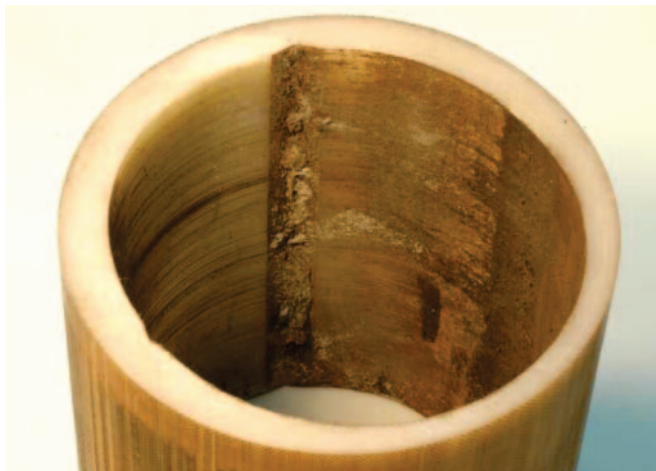
*Fig. 6. An unsealed sea-water-lubricated bearing which was exposed to pollution and fouling*

Ship water-lubricated bearings can have different forms recommended by their manufacturers. Such differences concern both values of recommended clearance in bearings and magnitude and number of longitudinal lubricating grooves and their suggested location as well. For fear of clamping the bush material exposed to water some producers recommend to increase clearance values. Most of recognized producers of ship slide bearings recommends to make certain number of lubricating grooves led along the bush. They play a significant role. Due to them, cooling water flow rate increasing is possible. It has a great importance as polymer bush practically makes heat transfer from friction zone to housing impossible. Additionally, the grooves, especially in the systems of open cantilever sea-water-cooled bearings, make it possible to more effectively remove wear products and contaminations from the bearings (Fig. 6).

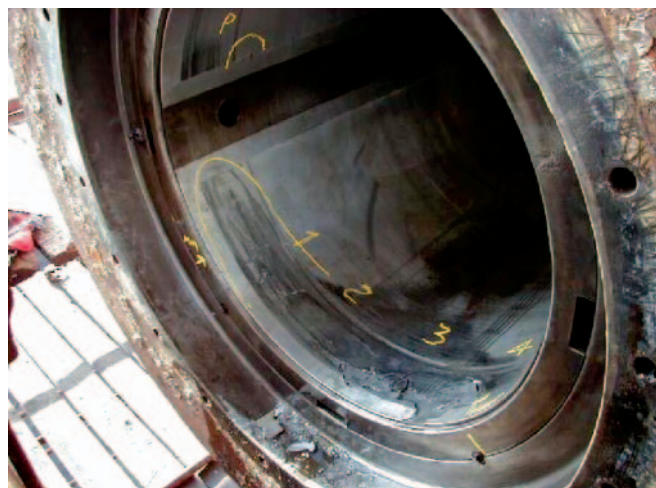
*Fig. 7. A white metal bush of oil-lubricated bearing, damaged due to edging*

Appropriate alignment of shaftline and bushes is the next important factor which directly influences lifetime of bearings; therefore mounting accuracy is of a special importance. In the case when mounting errors happen the skewing of shaft axis versus bush axis may occur. As a result load-carrying capacity of the bearing will be limited. In the extreme case the so-called edging phenomenon and associated fast progressing wear can appear because values of allowable contact pressure are locally exceeded. Bearings fitted with rigid ceramic, metallic or composite bushes are especially sensitive to the phenomenon (Fig.7).

The shaft axis skewing leads to decreasing load-carrying capacity of bearing, and in extreme cases, when rigid bush materials are used, the so-called edging occurs as a rule (Fig.7). It results in an intensive local wear of bush material and sometimes also in shaft failure.

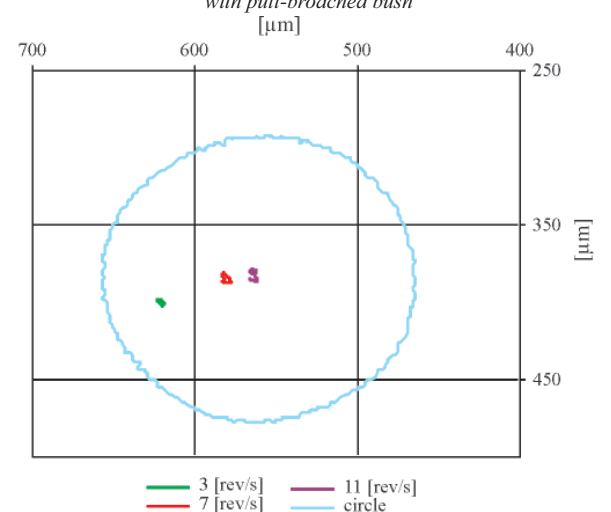
Fig. 18. Bearing fitted with composite bush of 0.0017 relative clearance value; up – the bearing with turned bush; down – the bearing with pull-broached bush

The performed tests showed that roughness topography, i. e. its arrangement has not any significant impact on bearing qualities [7]. Below, an example comparison of the experimentally recorded shaft axis trajectories, is shown. The observed very small differences in the journal's position demonstrate that the state of surface has negligible effect on hydrodynamic bearing qualities. Worth adding that the tests were performed just after mounting the bearing and before bush material running-in.
