### Wet H<sub>2</sub>S corrosion and degradation of pipeline in amine regeneration system

The paper presents the results of NDT examinations, metallographic tests and risk assessment of degradation related to corrosion of amine regeneration unit in a desulphurisation system. Intensive corrosion resulting from acid gases environment upon water condensation causes perforation of the pipeline. Detailed analysis reveals cracking related to the mechanism of wet H<sub>2</sub>S. Hydrogen penetration, resulting from the wet H<sub>2</sub>S process, causes a decrease in mechanical properties of steel and an increase in hydrogen content inside steel. Corrosion results mostly from high stream velocity, the presence of acid gases (with high ammonia content), the presence of amine and low stream temperature.

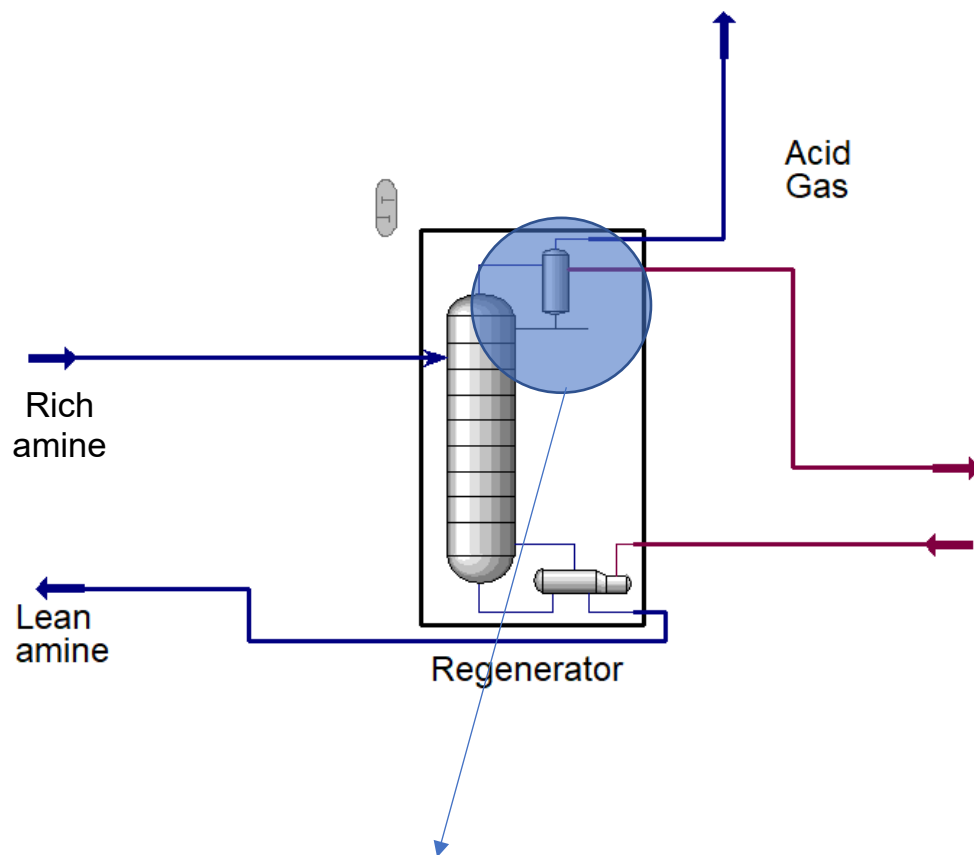
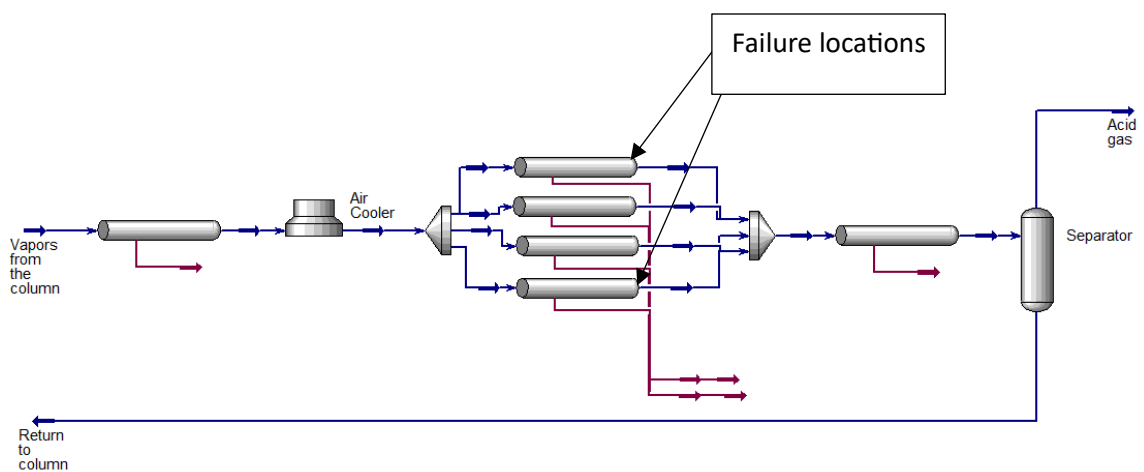
**Figure 1.** Simplified scheme of amine regeneration unit (a) with the areas, where the failure occurred (b – zoomed in piece of scheme 1a).

The simplified scheme of the unit, where the pipeline failure occurred is demonstrated in Figure 1. The purpose of the unit is regeneration of amine (diethanolamine – DEA), the function of which is to remove hydrogen sulphide and ammonia from the stream of acid gases in the hydrodesulphurisation plant. Rich amine (DEA), which contains high amount of dissolved hydrogen sulphide and carbon dioxide, is heated up and directed to the regenerator (stripping column). Regenerated, freed from hydrogen sulphide and carbon dioxide, lean amine gathers in lower, heated by the reboiler, part of the column (Figure 1a). In the upper section of the regenerator, there is evolution of acid gas, which flows to the upper part of the column. Acid gas, together with steam, with the temperature of approx. 121 °C is directed to the air cooler (Figure 1b), where it cools down to 31.5 °C. As a result of cooling, the aqueous phase separates from the stream. The separation of gas phase takes place in the separator. Acid

gas is directed to the Claus unit, while the condensate comes back to the regeneration column as a phlegm.

There are four pipelines with the diameter of 6 inches that leave the air cooler and then unite in one pipeline with the diameter of 8 inches. Directly after the air cooler in the region before non-return T-pipes (Figure 1b) two outer pipelines were unsealed. Perforations occurred in the region of the welded joint. Figure 2 demonstrates the internal and external side of corrosion damage of the pipelines.

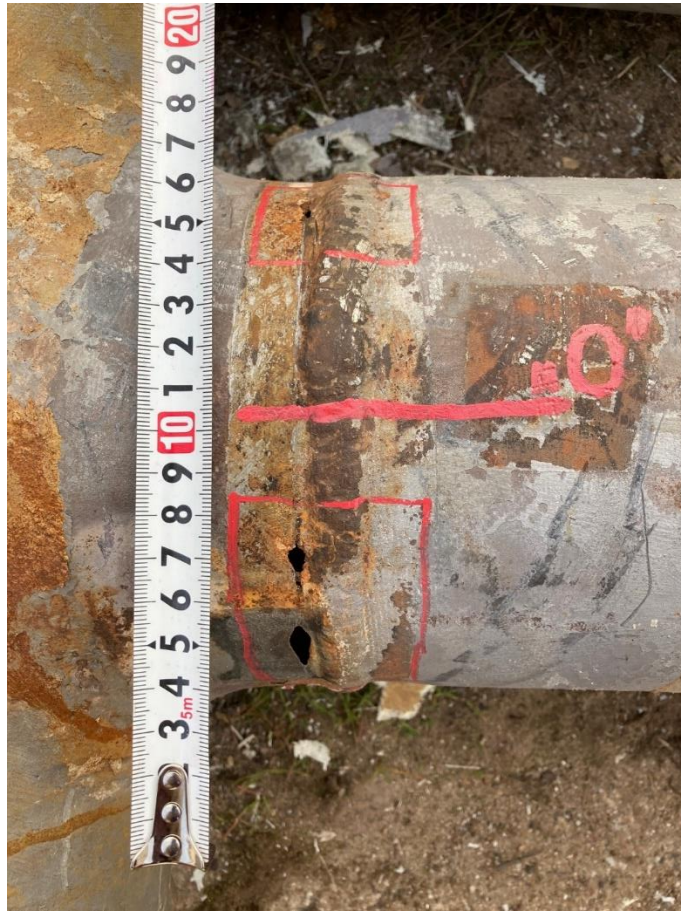
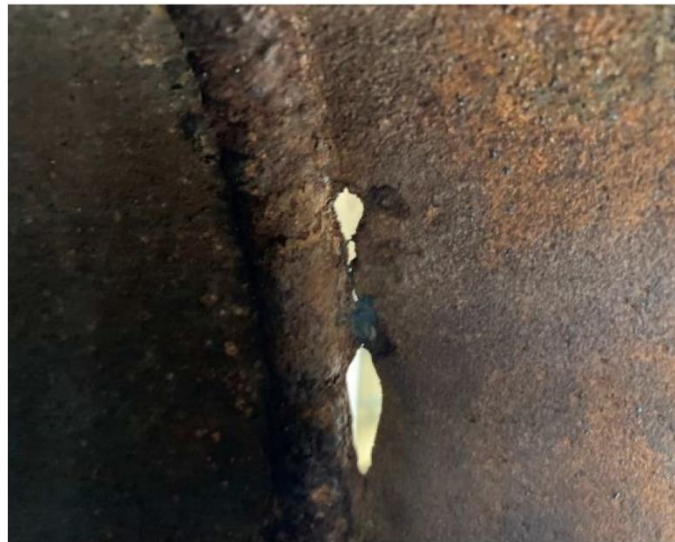
**Figure 2.** Photographs of external (a) and internal (b) side of the perforation in one of failed pipelines.

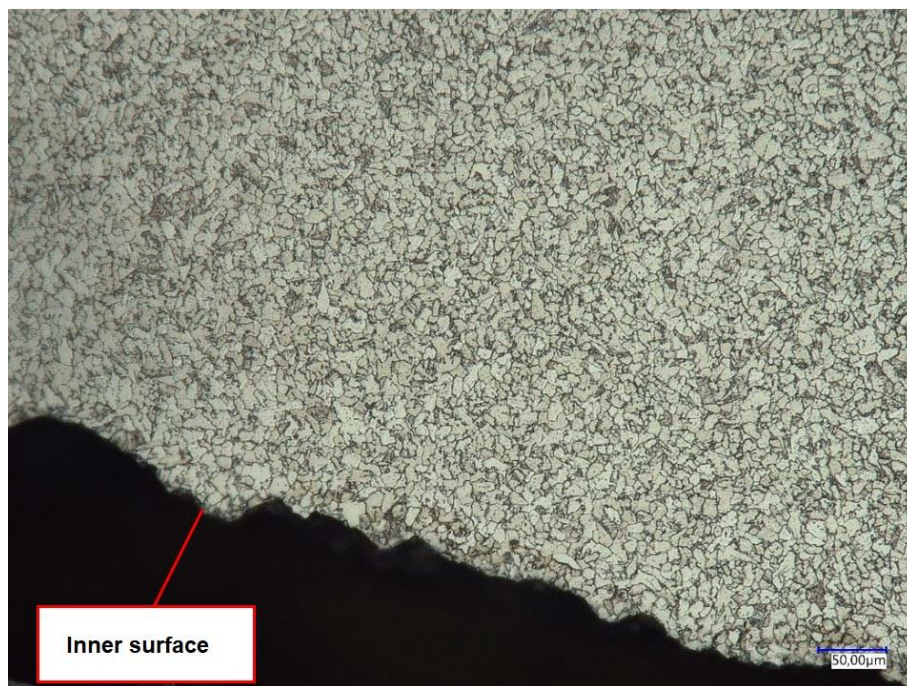
**Figure 4.** Metallographic microsection of the native material in the area with the highest corrosion rate (internal surface).

The microsection in Figure 4 shows the corrosion loss, which is present on the internal surface of the pipeline. The corrosion damage takes an irregular form. Due to aqueous environment and significant amount of hydrogen sulphide, the occurrence of wet H<sub>2</sub>S degradation is possible. In order to assess the risk of wet H<sub>2</sub>S degradation, the hardness of the pipeline's material was examined using a hardness meter. The average hardness value obtained was 150 HB.

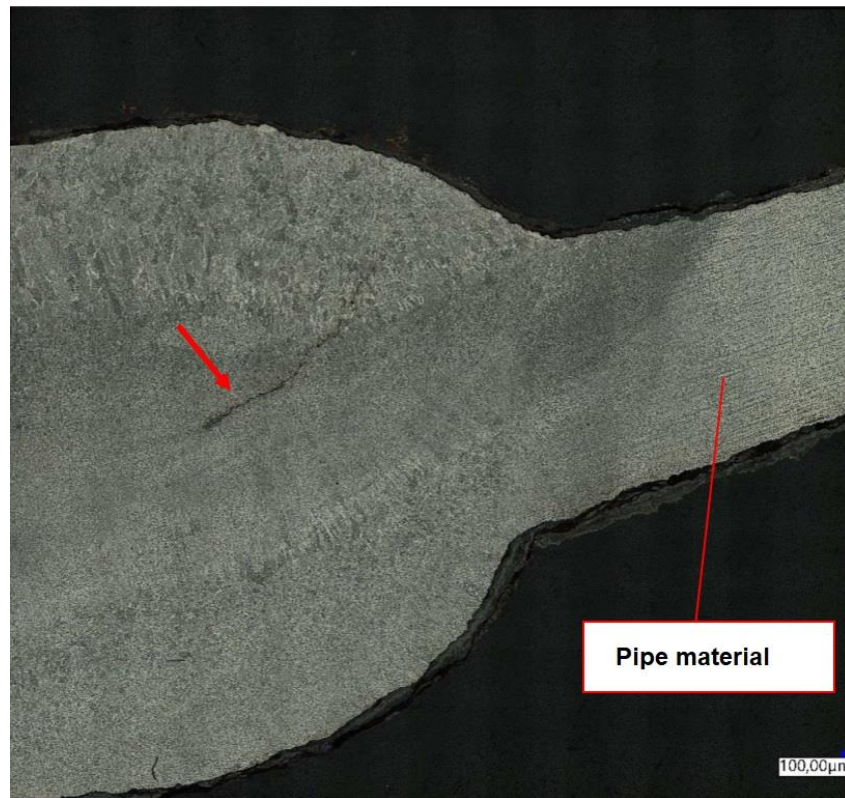
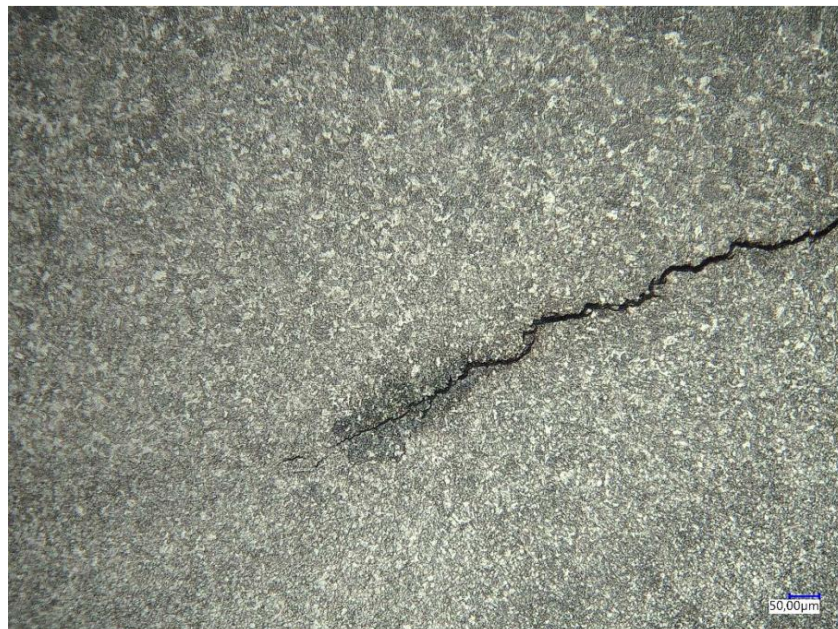
**Figure 5.** Metallographic microsections of welded joint area (T-tube/straight) engulfing joint material, heat affected zone, native material of the pipeline (a) and magnified region of the identified crack (b).

Due to a potential risk of HIC/SOHIC-H<sub>2</sub>S process occurrence, the metallographic tests were carried out on the samples collected from welded joint material. Metallographic microsections were examined with the metallographic microscope. The photographs of microsections are shown in Figure 5.

Metallographic microsections indicate the degradation mechanism called Hydrogen Induced Cracking (HIC). The presence of atomic hydrogen inside the welded joint material leads to an increase in internal stress, which results in a crack formation. The crack has a distinct, graduated, step-like appearance, which is common for this type of degradation mechanism. Despite the crack was found on the surface of the microsections, the cracking process was not a direct cause of the failure. Probably the cracking process was significantly impeded in the heat affected zone due to the PWHT treatment, which has considerably reduced hydrogen absorption inside the metal (Table 4).

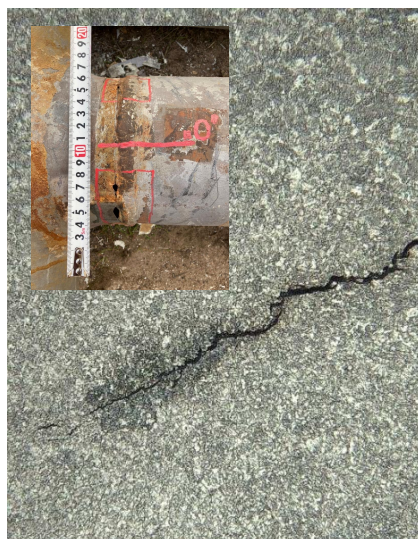
## GRAPHICAL ABSTRACT

Any material failure in refinery and petrochemical plants is associated with health and environmental hazard as well as considerable financial losses due to periodic shut down for repair. Identification of the failure causes is crucial from the damage prevention standpoint. In the paper, the authors investigate the case of wet  $H_2S$  corrosion of a pipeline in amine regeneration system, correlating the material degradation with process parameters of the installation.
