Article

# A Critical Reanalysis of Uncontrollable Washboarding Phenomenon in Metal Band Sawing

**Abstract:** The article analyzes the cutting process of hard bars. Investigations conducted in industrial conditions demonstrated the presence of surface errors in the machined workpieces in the form of washboard patterns. The purpose of this study was to analyze the results of cutting on band sawing machines with different band saw blades. The cutting processes were conducted on three different horizontal band sawing machine types. Analyzed material was an alloy steel Ø40 mm rod with a hardened surface covered with a thin layer of chromium. The hardness of the outer layer was 547 HV with a core hardness of 180 HV. The surface topography measurements of the processed workpieces were carried out with the 3D Optical Profiler, which supplied information on the irregularities of the processed material texture. In each of the analyzed cases, a corrugated surface was obtained after sawing, which is the effect of the occurrence of the washboarding phenomenon, despite the fact that the teeth of each band saw had variable pitches. The washboarding phenomenon when cutting rods with hard surface

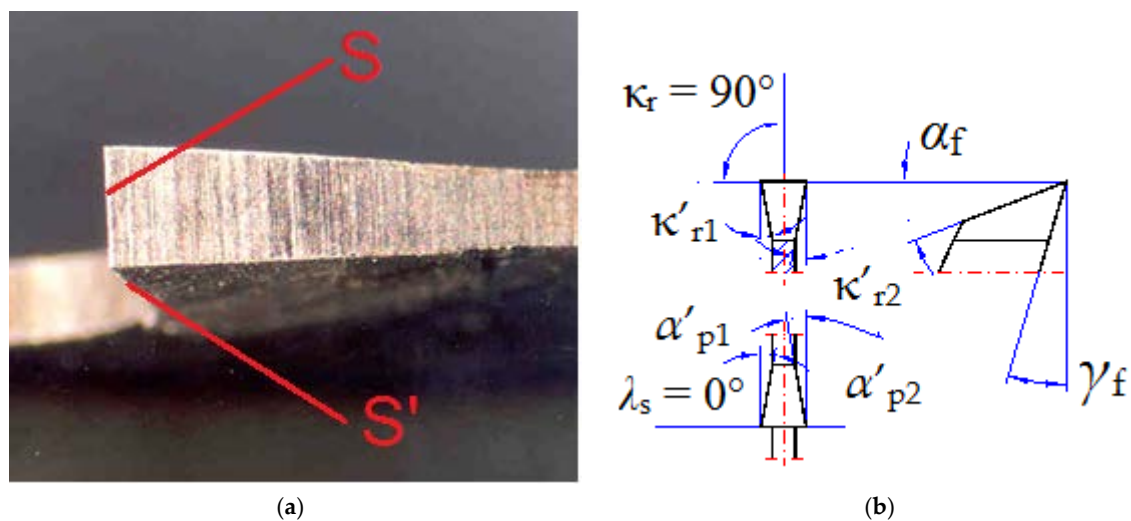
**Figure 1.** Band saw tooth general view from the top (a) and its geometry in the tool-in-hand system (b), where S—main cutting edge,  $S'$ —minor cutting edge,  $\alpha_f$  the tool side flank,  $\alpha'_p$  the tool back flank,  $\kappa_r$  tool cutting edge angle,  $\kappa'_r$  minor tool cutting edge angle,  $\gamma_f$  the tool side rake, and  $\lambda_s$  the cutting edge inclination angle.

It should be emphasized that chatter vibrations are the result of a number of phenomena during the cutting process occurring in the cutting zone on the main cutting edge [10,11]. On the other hand, when cutting with saws, three cutting edges are involved in cutting, for the simplest geometry, the main edge, and two minor cutting edges (Figure 1). The position of the minor cutting edges  $S'$  is defined by the minor tool cutting edge angles  $\kappa'_r$  (Figure 1b).

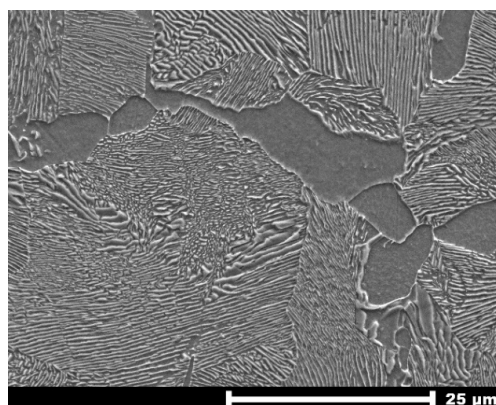
**Figure 2.** Rod metallographic structures: martensitic-ferritic outer layer (a) and pearlitic-ferritic core (b), obtained by SEM electron microscope (magnification 2000 $\times$ ).

In the analyzed cases, the cut material was a rod with a diameter of  $\varnothing 40$  mm from alloy steel (grade of steel 66Mn4 (1.1260)) with a hardened surface. Moreover, its surface was covered with a thin layer of chromium. The hardness of the outer layer was 547 HV (about 52 HRC), while core hardness was 180 HV. HV hardness was determined on the Vickers-Brinell hardness tester HPO 250 (Hegewald & Peschke Meß- und Prüftechnik GmbH, Nossen Germany). The structure of the hardened layer (547 HV) of the workpiece (with a thickness of about 2 mm) was mainly made by martensite with a small amount of ferrite, as shown in Figure 2a. On the other hand, Figure 2b shows the structure of the rod core (180 HV), in which pearlite and ferrite are observed.

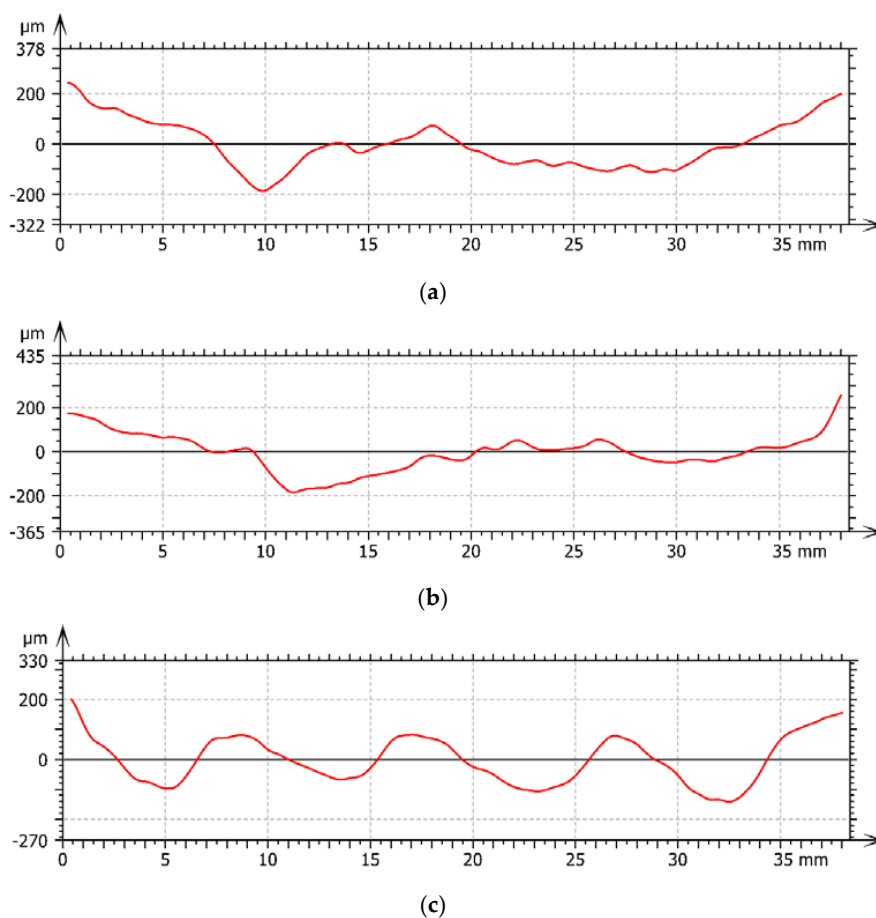
**Figure 7.** Exemplary W—profile at 50% position of the samples #1 (a), #2 (b), and #3 (c).

An exemplary W-profile at 50% position of the sample #3 is presented in Figure 7. According to the values of waviness parameters and profile information given in Table 3, the middle of the machined samples #1 and #2 was distinctly above the edge, 2–3  $\mu\text{m}$  wide, and with deep furrows. In sample #3, all of the furrows after machining process were well visible and their height was similar level to regular spacing of hills and valleys.
