A NEW APPROACH OF COASTAL CLIFF MONITORING USING MOBILE LASER SCANNING

Gdańsk University of Technology, Poland

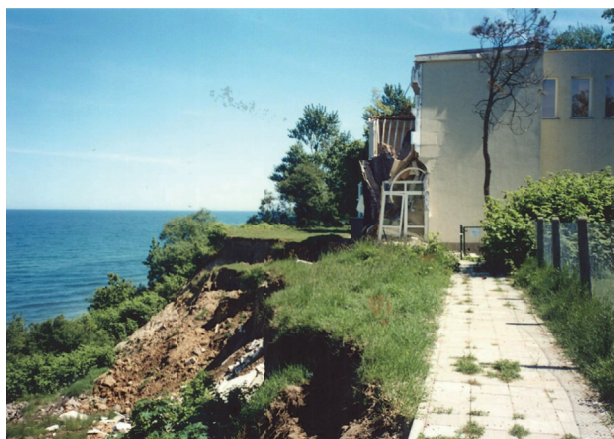
Fig. 2. The leisure centre "Horyzont" situated on the edge of an active cliff and damaged in 2002.
(photo courtesy of W. Subotowicz)

The landslide hazard of the Jastrzebia Gora cliff has been known for several decades. The interest of the society and local self-government in this part of the coast increased in 1988 when the created landslide endangered the leisure centre "Horyzont" (Fig. 2). The average multiannual cliff abrasion rate in this region is approximately equal to 1m/year [1].

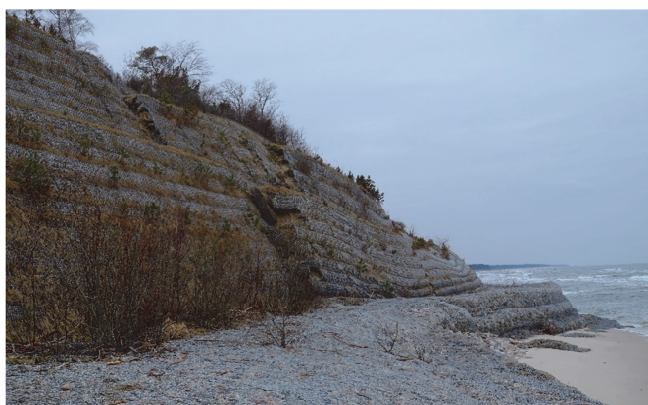
Fig.4. Degradation of reinforced cliff part at Jastrzebia Gora – situation of January 2017.

A general conclusion from the above situation is that all past protection measures revealed low durability (see Fig. 4). Consequently, permanent monitoring of the cliff is indispensable for the safety of tourists and residents.

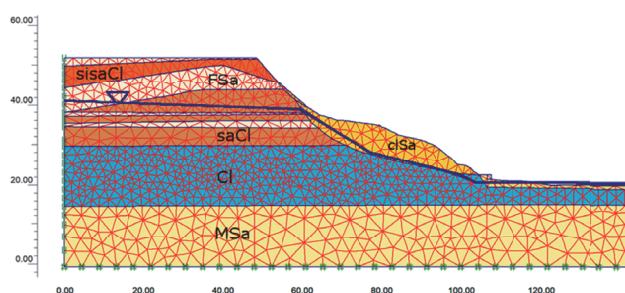
Fig. 9. Geotechnical cross section of km 134.1 and its discretisation

The stability analyses were performed for 2 characteristic cross sections of the cliff massif, which has a relatively complicated geological structure and is characterised by high spatial variability (Fig. 7). The first cross section is situated at km 133,8, near the descent from the cliff top to the beach. Heavy pedestrian traffic of tourists is observed in this area, therefore of high importance is to determine whether this descent is or is not threatened by the occurrence of landslide. The other cross section, at km 134.1, has been selected in direct vicinity of the leisure centre “Horyzont”, which is situated close to the edge of the cliff.

The geotechnical sections created for the analysing purposes were based on archive results, which allowed to reconstruct, in a simplified way, their geotechnical structure and soil-water conditions [2,13], see Tab.1 (overconsolidation effects were neglected in a simulation due to lack of data). The soil material was modelled as the elasto-plastic material with Coulomb-Mohr criterion, while the gabions were simplified to elastic elements, due to small space occupied by them in the model. When the presence of reinforced soil or soil composites had to be considered (which had place in another cliff segment) [14], the model shall be properly modified and appropriate constitutive laws shall be considered. The current geometry of the selected cross sections was determined based

on the results of laser scanning from the sea, complemented with terrestrial scans. The geometry of these sections is shown in Figs. 8-9.

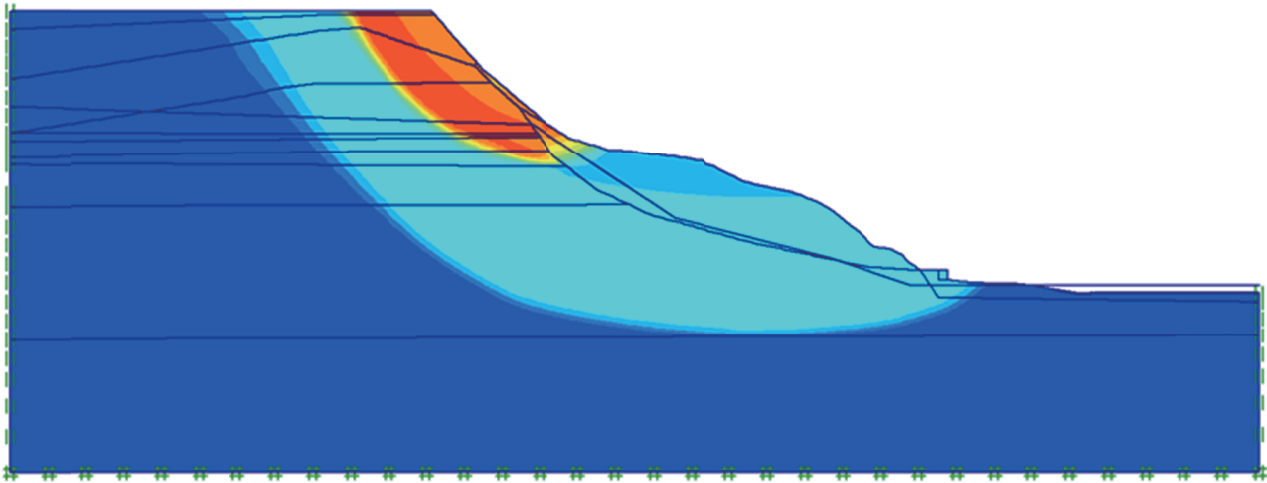
Fig.12. Local destruction with elevated water table (orange indicates failure) in cross section 134.1, $SF=1.09$

It is interesting to compare destruction mechanisms in cross section 134.1 for the current situation (Fig.11) and for the prognosed soil water table elevation by 2m (Fig.12). We can observe that the stability factor after water table rise decreased slightly, but in the former scenario we observe the global destruction mechanism, while in the latter case the local destruction mechanism is initiated.
