B. Świczko-Żurek¹, A. Szumlański², J. Zorn¹

ALLERGY TO IMPLANT COMPONENTS: CHROMIUM, NICKEL, COBALT AND TITANIUM

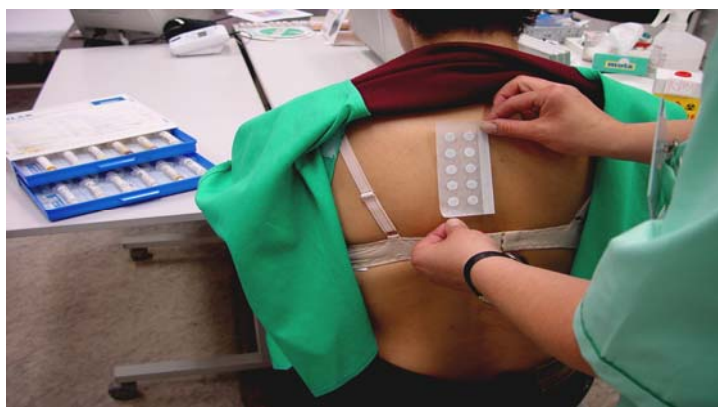
The way of making the tests is shown in the Fig.2

Fig.2. The way of attaching patch tests with the chosen allergic compounds to the body (Ni,Cr,Co,V,Ti)

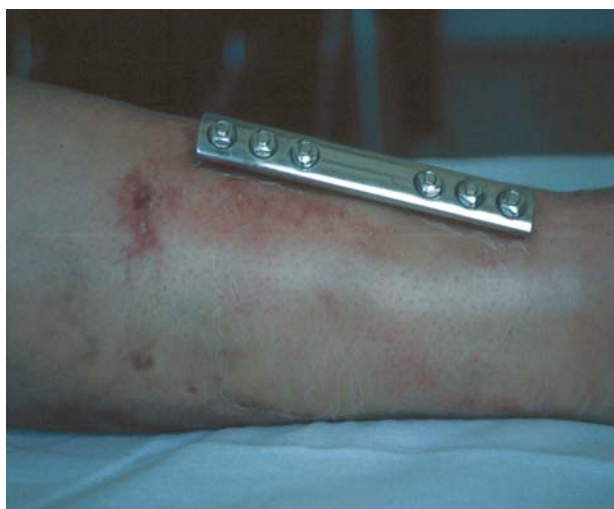
The patients (5,6) whose bones were joint with ZESPOL method, positive reaction to Cr and Ni was found. It appeared as contact dermatitis covering a large area of the skin, not only in the implant-tissue area (Fig.7). Some disturbances in the bone growth was observed. Treatment with antyallegic drugs was ineffective. After 4 weeks the implants were removed and the patients were treated in cast.

Fig.7. The contact dermatitis on the skin surface
