## Analysis of the Load-Bearing Capacity of Historical Foundations in the Context of the Quality of Mortar Used

**Keywords:** historical foundations, mortar modeling, stone foundation, FEM, material models

**Cytowanie / Citation:** Przewłócki J., Grębowski K., Zielińska M. Analysis of the Load-Bearing Capacity of Historical Foundations in the Context of the Quality of Mortar Used. *Wiadomości Konserwatorskie – Journal of Heritage Conservation* 2021, 66:92–105

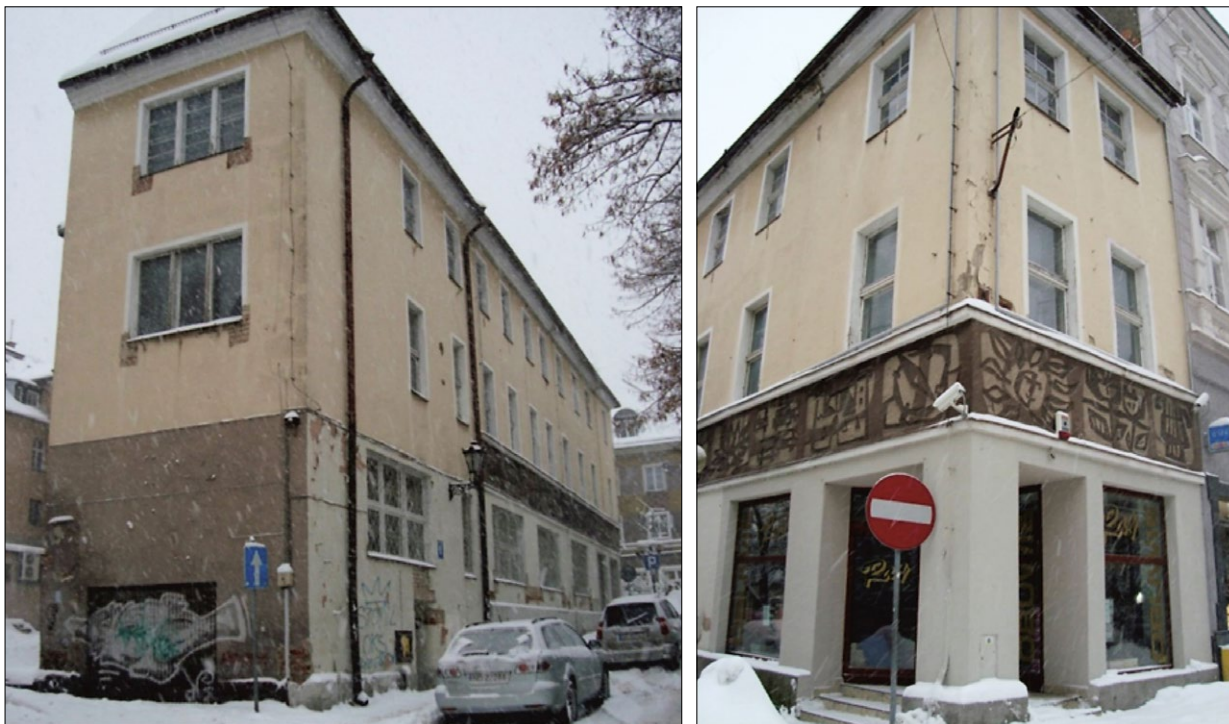
Ryc. 1. Widok budynku położonego w Olsztynie przy ul. Staromiejskiej: a) elewacja tylna, b) elewacja frontowa; fot. M. Zielińska 2012.  
 Fig. 1. View of the building located in Olsztyn at Staromiejska Street: a) rear elevation, b) front elevation; photo by M. Zielińska 2012.

Works related to strengthening the structure of a tenement building located in Olsztyn gave rise to the present study on the modeling of mortars in historical building foundations. It is a building with a basement, three stories above-grade, and an attic covered with a pent roof (Fig. 1). The building is listed in the historical monuments register under number A-3218 in accordance with the decision of the Voivodeship Historical Monuments Conservator (hereinafter referred to as MC) of November 15, 1991. Additionally, the building is located within the historical urban layout of the old town, which is protected by a historical preservation ordinance in accordance with the Olsztyn MC's decision of September 17, 1957. It lists the old town urban layout in the historical monuments register of the Warmian-Masurian Voivodeship under number A-435. The historical monuments register also includes cultural stratifications of this area as specified in the decision of July 2, 1992. Listing a building in the historical monuments entails not only

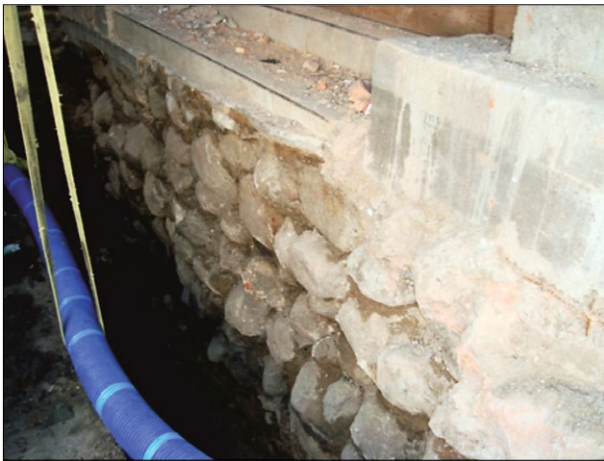
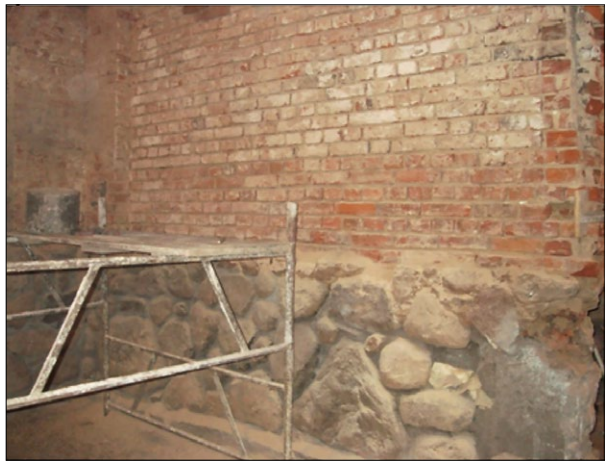
**Ryc. 2.** Widok fundamentu badawczego budynku zlokalizowanego w Olsztynie przy ul. Staromiejskiej: a) na zewnątrz budynku, b) wewnątrz budynku; fot. M. Zielińska 2012.

*Fig. 2.* View of the position of research foundation of the building located in Olsztyn at Staromiejska Street: a) outside the building, b) inside the building; photo by M. Zielińska 2012.

The stone foundations (Fig. 2) had a width of about 60 cm and a varied height due to differences in the ground level. The foundation was damp from

the outside and showed significant mortar losses, which had not been refilled so far. Considerations on strengthening the foundations were focused on mortar, as it was usually the weakest part of the stone foundations. Figure 2 shows a fragment of the foundations analyzed here. The foundations were analyzed numerically, to determine whether the mortar was capable of carrying additional loads. The previously minor loads transferred to the foundation, estimated at about 200 kN/m, increased to 280 kN/m because of the new steel and reinforced concrete structure and the new function of the building.
