Application of RMS for damage detection by guided elastic waves

M Radziński^{1,2}, Ł Doliński¹, M Krawczuk^{1,2}, A Żak² and W Ostachowicz^{2,3}

Abstract. This paper presents certain results of an experimental study related with a damage detection in structural elements based on deviations in guided elastic wave propagation patterns. In order to excite guided elastic waves within specimens tested piezoelectric transducers have been applied. As excitation signals 5 sine cycles modulated by Hanning window have been used. Propagation of guided elastic waves has been monitored by a scanning Doppler laser vibrometer. The time signals recorded during measurement have been utilised to calculate the values of RMS. It has turned out that the values of RMS differed significantly in damaged areas from the values calculated for the healthy ones. In this way it has become possible to pinpoint precisely the locations of damage over the entire measured surface. All experimental investigations have been carried out for thin aluminium or composite plates. Damage has been simulated by a small additional mass attached on the plate surface or by a narrow notch cut. It has been shown that proposed me

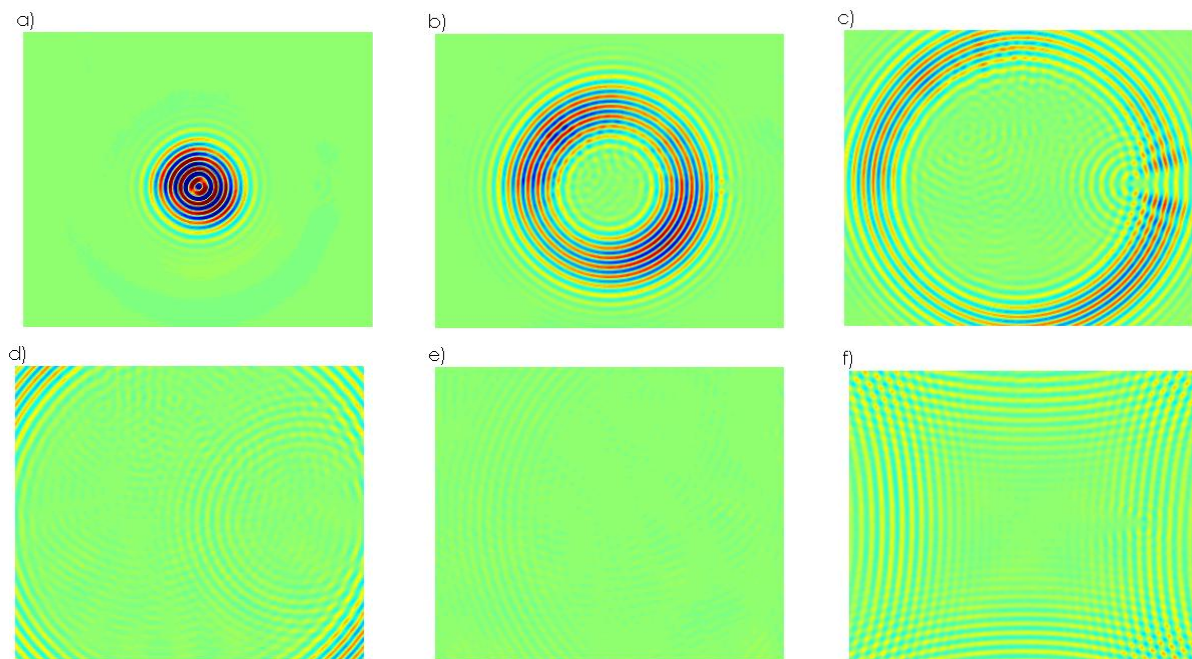
Figure 3. Propagation of elastic wave in the aluminium plate with one damage at time a) 97.66 μ s b) 195.31 μ s c) 292.97 μ s d) 390.62 μ s e) 585.93 μ s f) 781.25 μ s

It is typical for scanning laser measurements that a small amount of points have lower signal-to-noise ratio caused by the fact that not enough reflected light returned to the scanning head. Those points have much bigger Root Mean Squared (RMS) values. To reduce this effect a median filtering in space domain with 3x3 points window was applied. Examples of registered guided elastic wave propagation in the aluminium plate were presented in form of 6 arbitrary chosen time snapshots. Figure 3 shows guided elastic waves propagation in the aluminium plate with attached an additional mass.

Due to the fact that the additional mass introduce discontinuity, propagating waves are reflected and the damage became a source of new waves. This effect is clearly visible in figure 3c. This phenomenon may be used for damage detection. However, it could be hard to recognize all defects when there are more of them like in figure 4. For more accurate damages pattern recognition the RMS-based damage detection method is proposed.
