As- built inventory of the office building with the use of terrestrial laser scanning

Marek Przyborski¹, Paweł Tysiąc^{1,*}

¹Gdansk University of Technology, Faculty of Civil and Environmental Engineering, Department of Geodesy, Narutowicza St. 11/12, 80-233 Gdansk, Poland

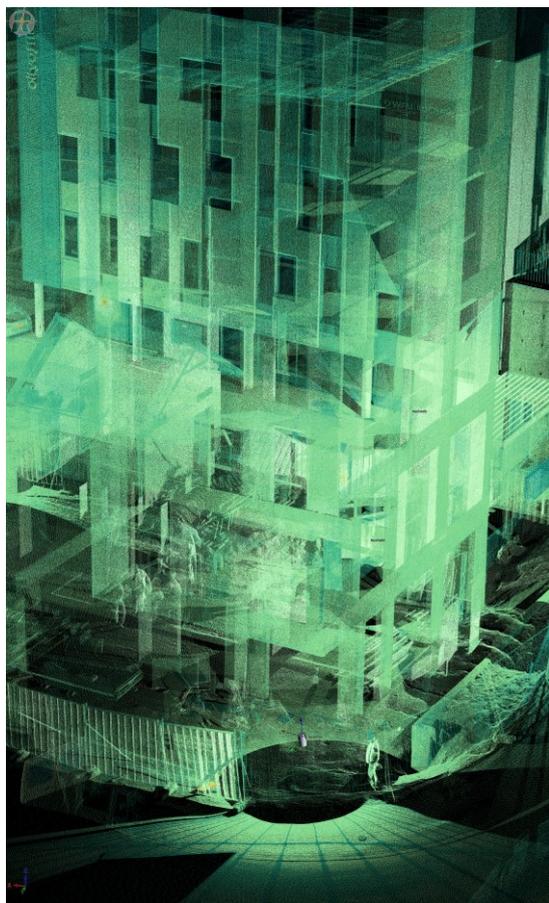
Fig. 2. The view of a scanned object.

Unfortunately, the situation was different from presumed. The whole object was enclosed by metal plates, preventing from enter into the construction site. Also, a close neighbourhood of road and other buildings was a problem for data acquisition. It was not possible to cover assumptions. It was a need to create a lot more scan stations. Authors placed 15 scan positions. The alignment of that positions and estimate the perfect, according to the project place of walls for deviations calculations was crucial. The Fig. 2 is presenting the scanned object.

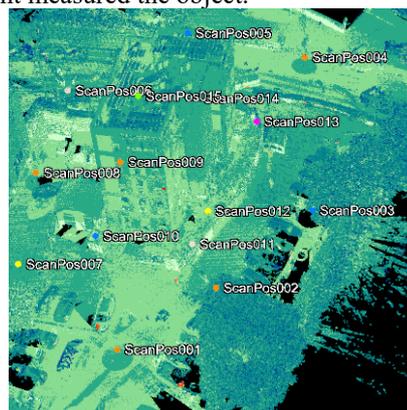
Fig. 3. Positions of the instrument.

The Fig. 3 is presenting the places where the instrument measured the object.

First, scan positions number 1, 2 and 7 was assigned to the North wall. Scan positions number 2, 3, 11, 12 and 13 was assigned to the West wall. Scan positions number 4, 5, 14, 15 was assigned to the South wall and 5, 8, 9, 10 to the East wall. The alignment results were presenting below in Fig. 4 for the North wall, Fig. 5 for the West wall, Fig. 6 for the South wall and Fig. 7 for the East wall. Every of standard deviations results for each wall are presenting in meters.

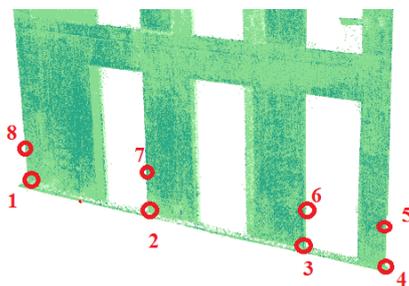
Fig. 8. Chosen points for plane matching which indicate the wall according to its perfect position.

The plane was estimated with the use of the least square- method by indicate 8 points, belonging to the walls at the bottom of walls. The representation of chosen points is presenting in Fig. 8. The same workflow was performed for each wall. The reason for placing points was that from the level 0 to the height of 1 meter it could be observed the hypothetical, non – angular deviated walls of the building. From that wall (It could be named- reference), the angular, real deviation was estimated.

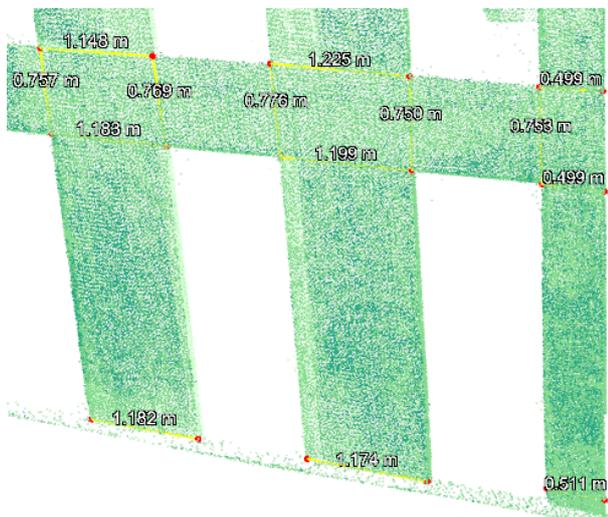
Fig. 9. Examples of windows gaps dimensions.

First, dimensions of windows, doors gaps were measured and comparison between measured ones and from an architectural plan sizes was performed. The results on the example of North wall (down part of the wall, the same as its seen in Fig. 8) was presented in Fig. 9. It could be noticed that the differences between sizes are significant and up to 3.5 cm with the accuracy of 1 cm.

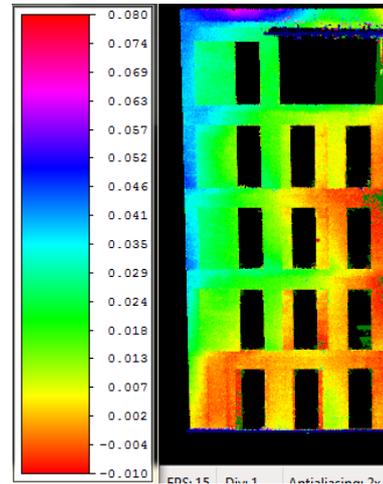
Fig. 10. Angular deviations for North wall in meters.

measurement accuracy was up to 1 cm, the plane matching error has to be estimated. It was computed as standard deviation values for points distances which was taken into consideration and belonging to that plane. With that process, the standard deviation value equals approximately 5 mm. Angular deviations for each wall are presented in Fig. 10 for North, Fig. 11 for South, Fig. 12 for West and Fig. 13 for East. Values are presented in meters.

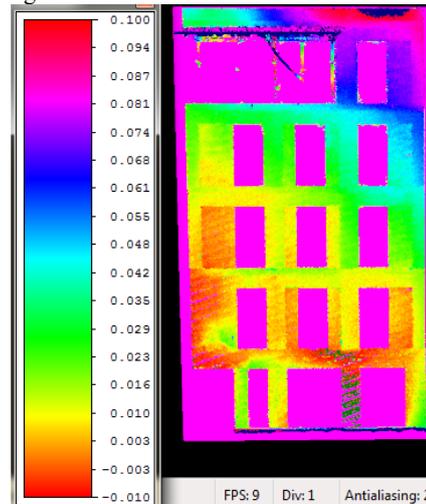
Fig. 11. Angular deviations for South wall in meters.

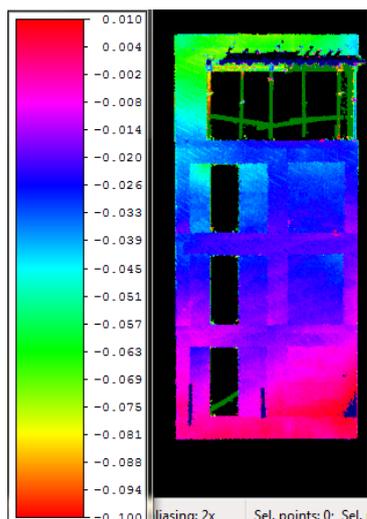
Fig. 12. Angular deviations for West wall in meters.

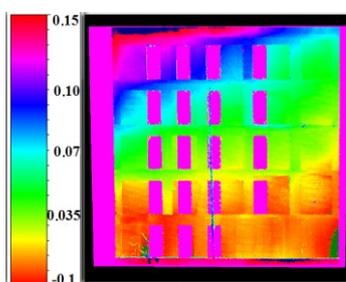
Fig. 13. Angular deviations for East wall in meters.
