## CAUSES OF DEFECTS AND DAMAGE TO BRICK MASONRY ELEMENTS IN HISTORIC BUILDINGS

Maciej NIEDOSTATKIEWICZ<sup>1</sup>, Tomasz MAJEWSKI<sup>2</sup>

<sup>1</sup> Gdansk University of Technology, Faculty of Civil and Environmental Engineering,  
Department of Engineering Structures

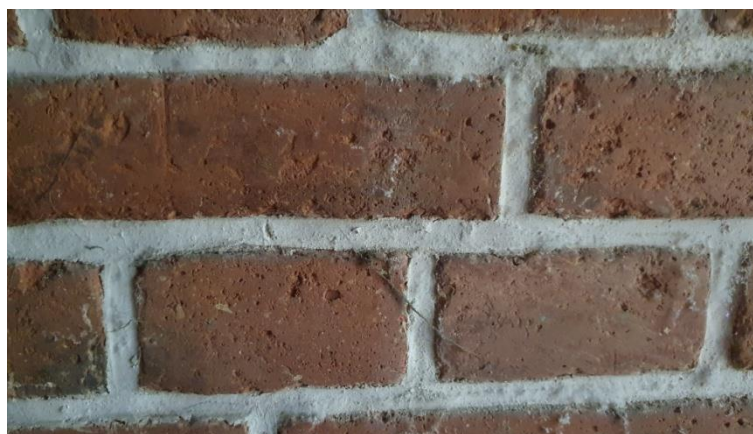
Fig. 1. Open pores and capillaries of the exterior masonry of solid ceramic brick, visible cement mortar tight joint improperly executed in the past period during renovation work (photo: Maciej Niedostatkiwicz)

The destruction and deformation proceeds the faster the brick masonry elements' greater structural irregularities are (Fig. 1), the weaker the adhesion of mortar and the more voids, caverns, fissures and cracks there are in the masonry section.

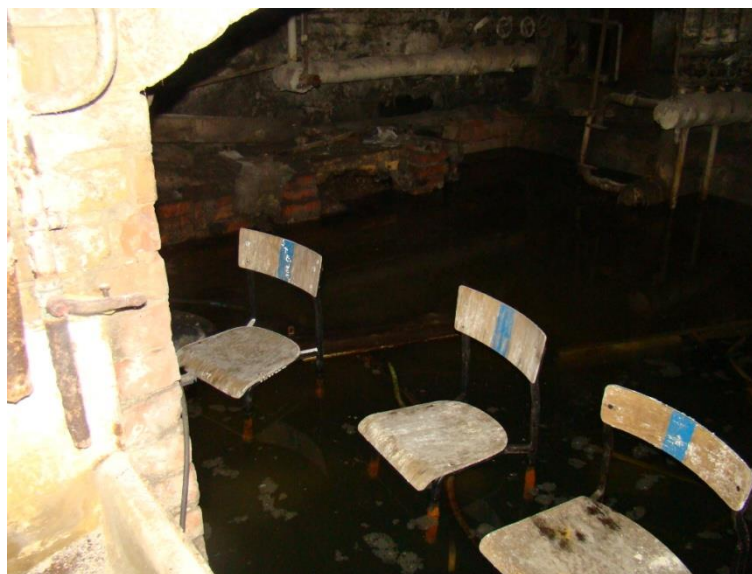
Fig. 2. Flooded basement of the building to a height of 0.45 cm above the level of the basement floor:  
the original groundwater level ~120 cm below the foundation level of brick footings  
(difference between the original state and the state shown in the illustration: ~265 cm)  
(photo: Maciej Niedostatkiwicz)

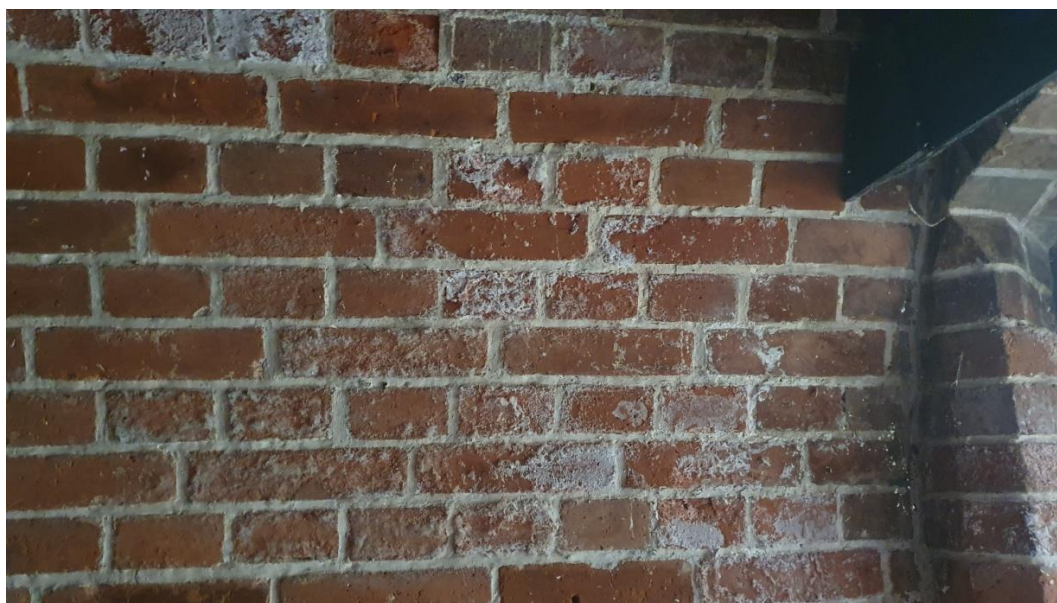
Fig. 4. Development of biological corrosion on the interior surface of the exterior solid ceramic brick masonry, visible cement mortar tight joint improperly executed in the past period during renovation work (photo: Maciej Niedostatkiwicz)

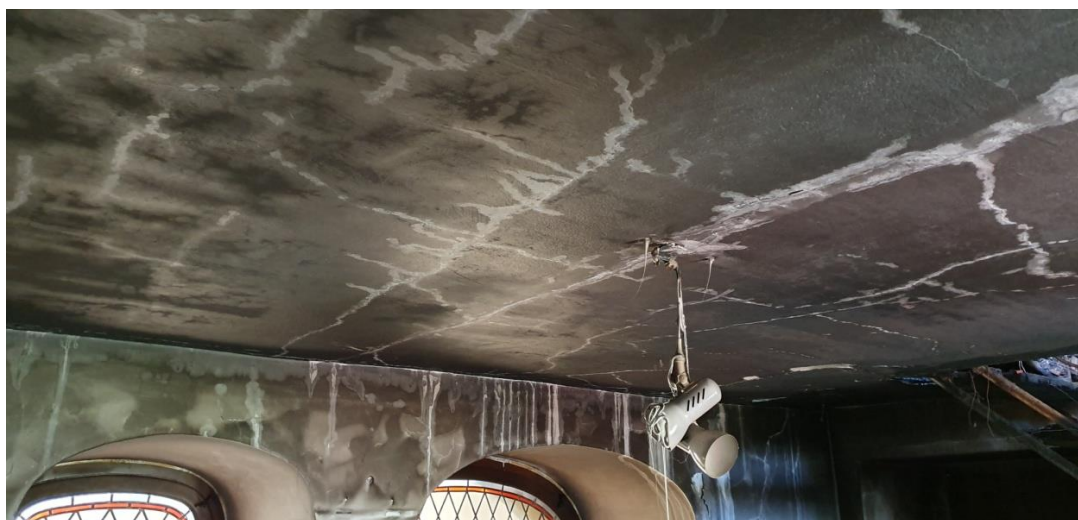
Fig. 5. Fire damage to solid ceramic brick wall and ceiling on wooden beams, visible cracks in plaster on wall and ceiling  
(photo: Maciej Niedostatkiwicz)

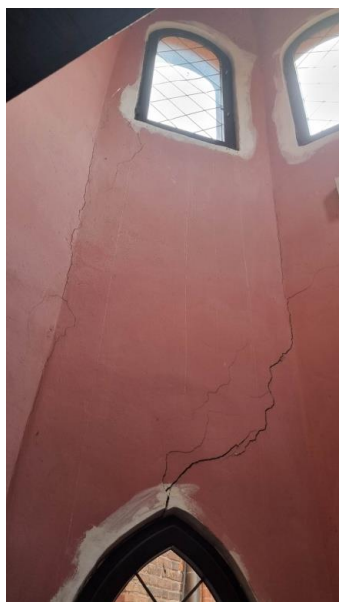
Fig. 6. Cracking of the exterior masonry of solid ceramic bricks caused by above-normal settlement of a section of the building (photo: Maciej Niedostatkiwicz)

- underestimation of bearing capacity of brick footings (Fig. 6),
- the use of so-called poor masonry as a structural solution, i.e. masonry with an outer and inner layer made of fine ceramic elements and an inner filling of brick rubble,
- underestimating the load-bearing capacity of slender brick window pillars,
- underestimation of the load-bearing capacity of brick vaults, especially cross vaults.

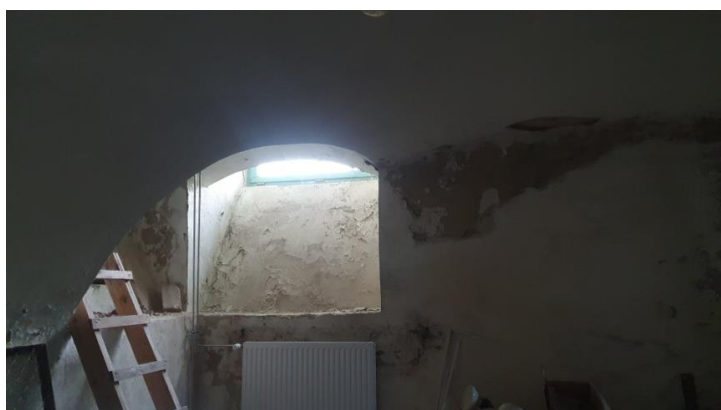
Fig. 7. Dampness of the external wall made of solid ceramic brick caused by the lack of vertical damp proofing in the part sunk in the ground (photo: Maciej Niedostatkiwicz)

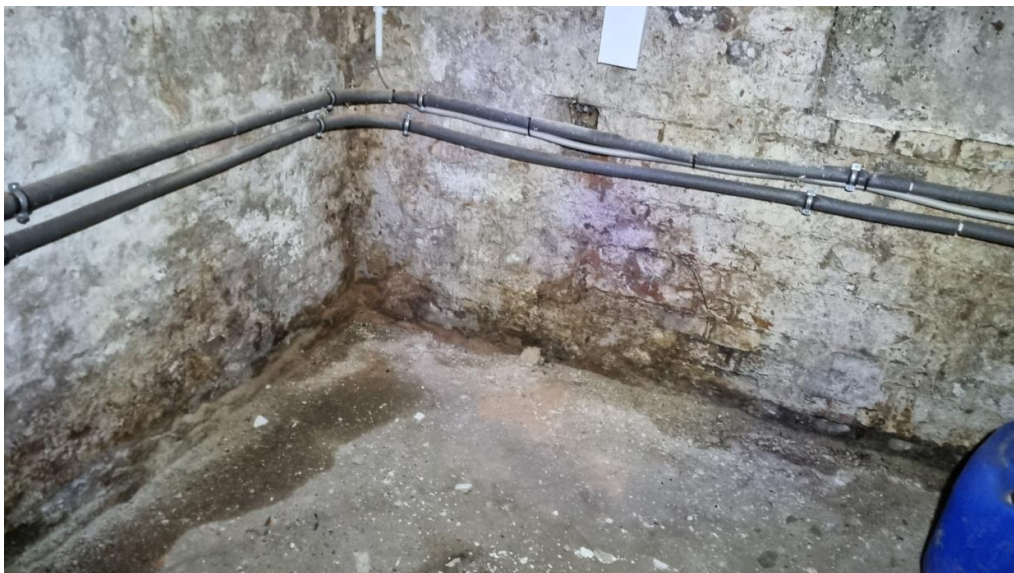
Fig. 8. Dampness of the external masonry of solid ceramic brick caused by the lack of horizontal damp proofing in the part sunk in the ground and the lack of technical efficiency (leakage) of the vertical damp proofing membrane (photo: Maciej Niedostatkiwicz)

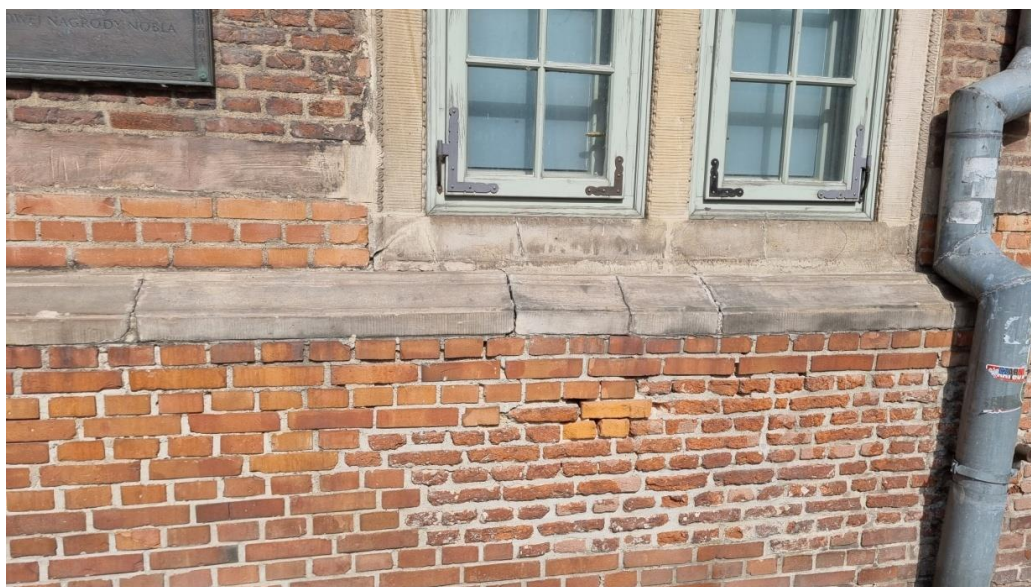
Fig. 9. "Hollow joints" of the exterior masonry of solid ceramic brick, additionally visible frost damage and weathering of the wall (photo: Maciej Niedostatkiwicz)

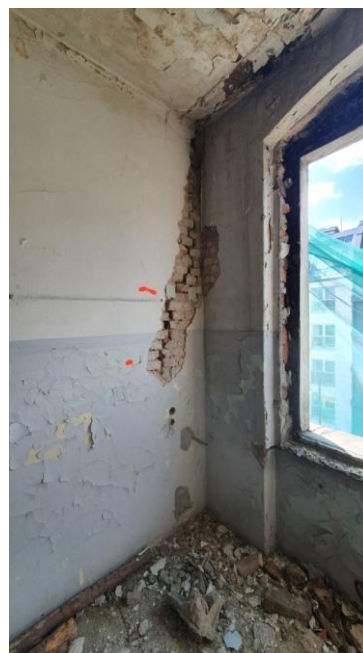
Fig. 11. Cracking of the internal transverse wall made of solid ceramic bricks at the point of connection with the exterior longitudinal wall in a building with ceilings on wooden beams that do not have frontal and lateral anchoring (photo: Maciej Niedostatkiwicz)

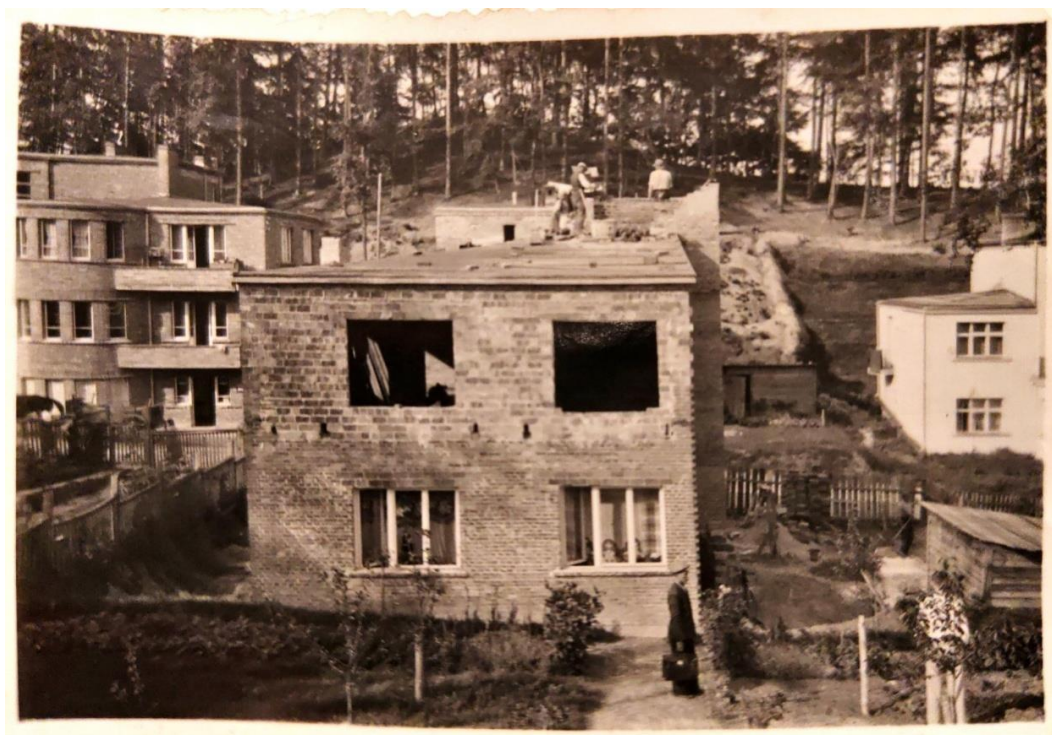
Fig. 12. Building with layered exterior walls (with air cavity), made of ceramic bricks: a) solid, at the level of the ground floor, b) trusses, at the level of the first floor (photo: Jan Niedostatkiwicz)

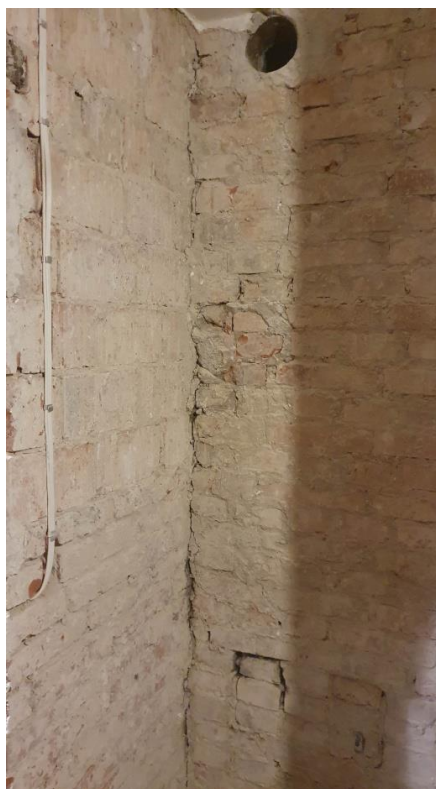
Fig. 13. No masonry bond between transverse and longitudinal interior walls  
made of ceramic solid brick  
(photo: Maciej Niedostatkiwicz)

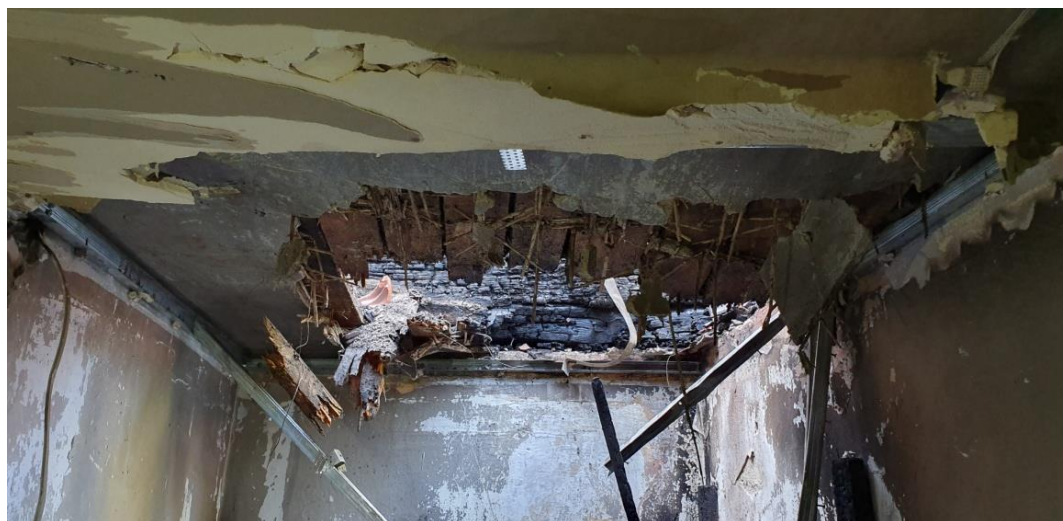
Fig. 14. Moisture damage to exterior and interior ceramic walls as a result of water flooding at the site of a broken roof (photo: Maciej Niedostatkiwicz)

A fairly common phenomenon that causes premature loss of technical value of a historic building is failure to maintain it properly or even lack of concern for the object's durability (Fig. 14 and Fig. 15).

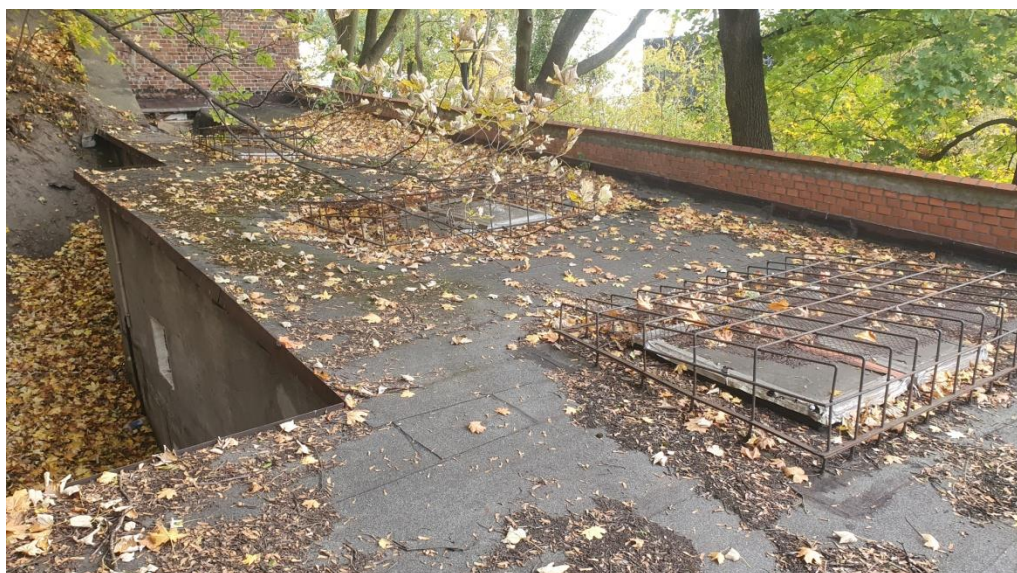
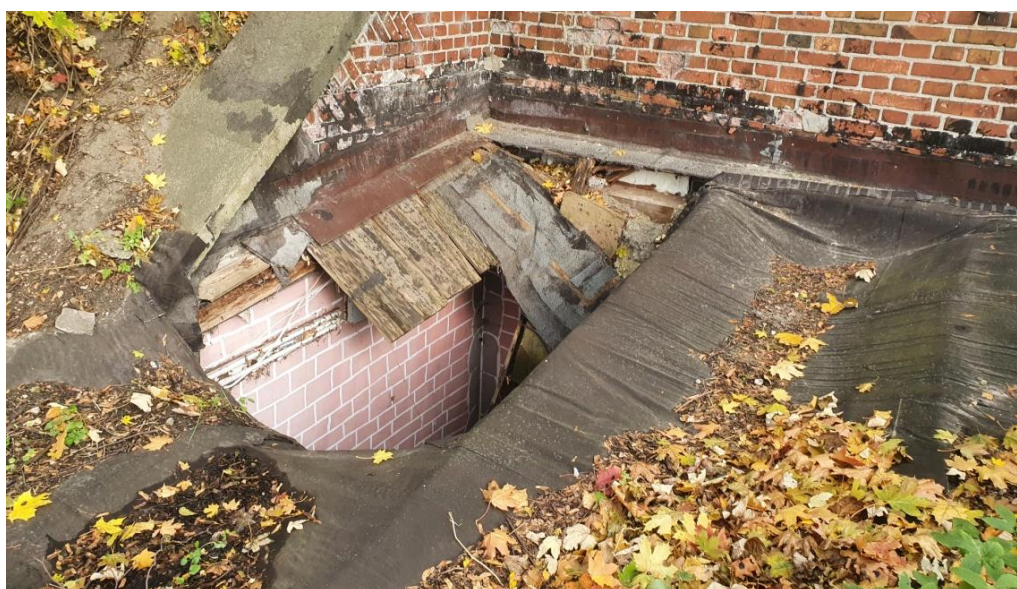
Fig. 15. Moisture damage to ceramic masonry as a result of water flooding caused by the collapse of a moisture-damaged and biologically corroded wood-framed roof: a) view, b) close-up (photo: Maciej Niedostatkiwicz)

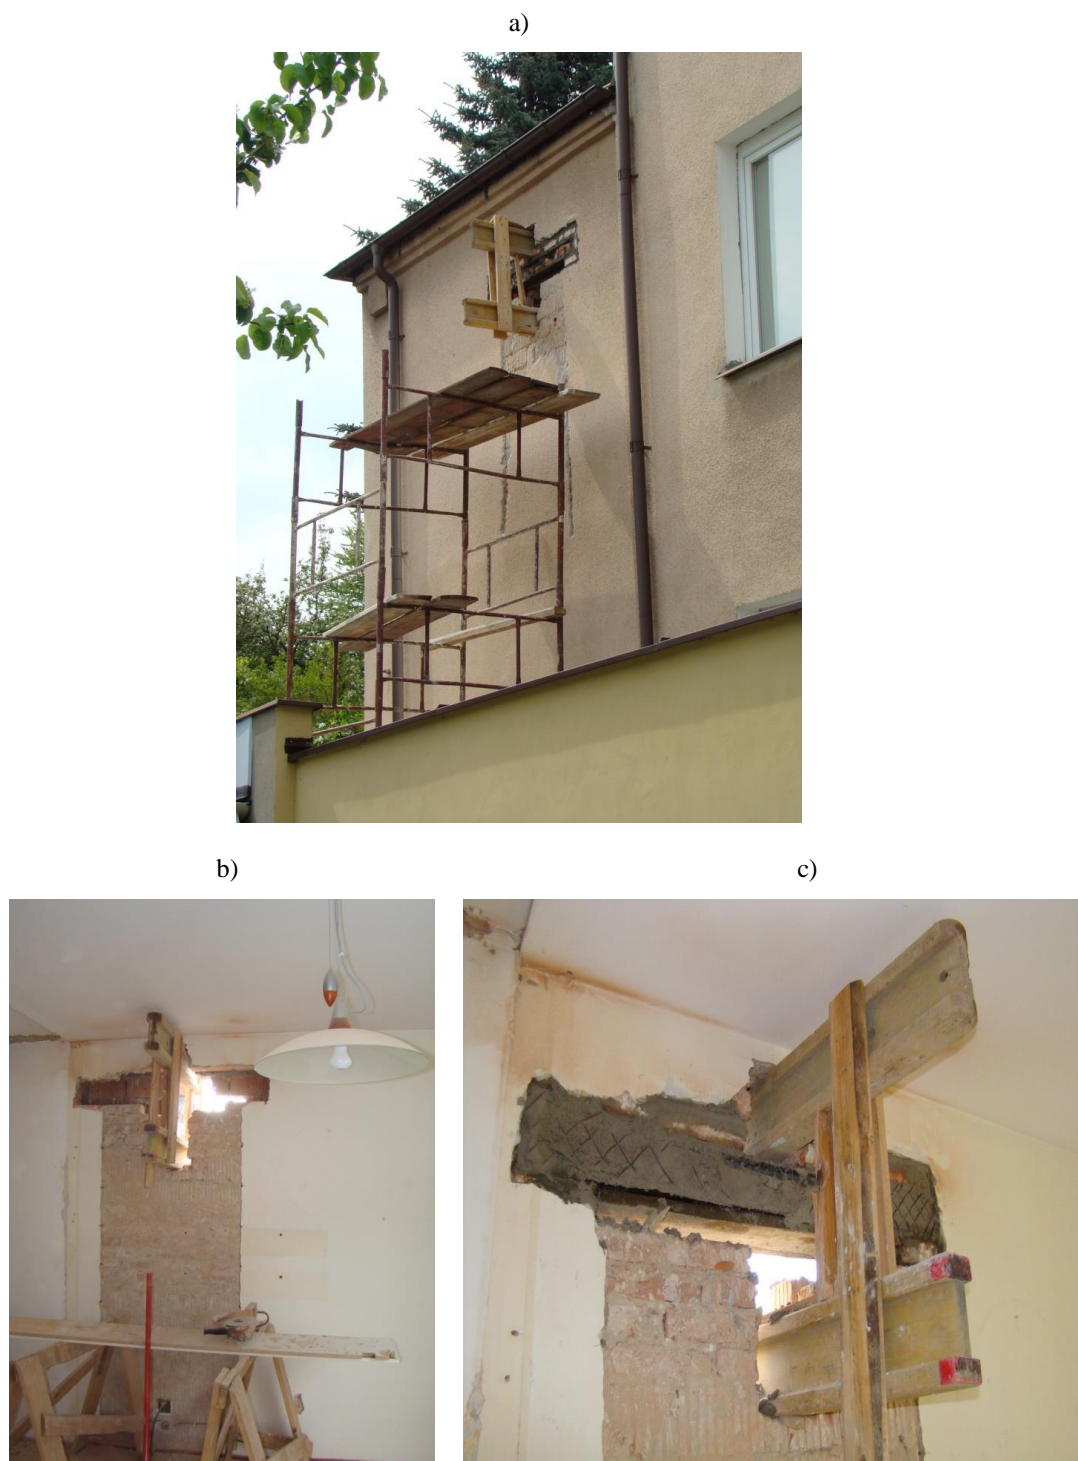
Fig. 16. Realization of the door opening in the layered external wall made of ceramic lattice bricks – stages of realization in the view from: a) exterior, b), c) interior  
(photo: Maciej Niedostatkiwicz)

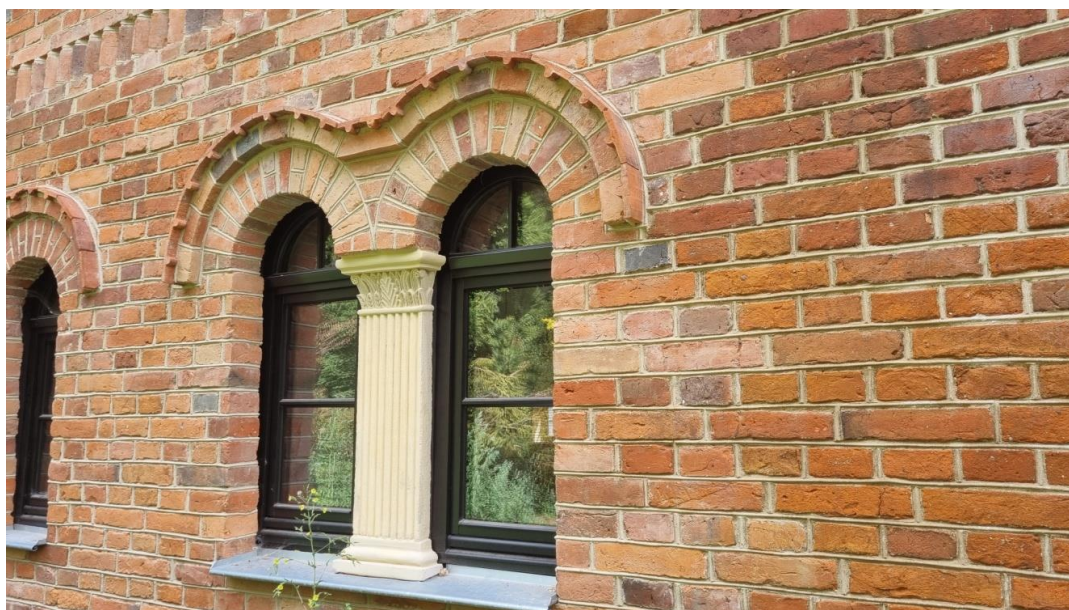
Fig. 19. Revitalization of historic solid ceramic brick wall using contemporary brick  
and ceramic tile and limestone details  
(photo: Maciej Niedostatkiwicz)
