**Ł. Bolewski, M. Szkodo, M. Kmiec**

*Gdańsk University of Technology, Faculty of Mechanical Engineering, Department of Materials and Welding Engineering, 11/12 Narutowicza, 80-233 Gdańsk, Poland*

## CAVITATION EROSION DEGRADATION OF BELZONA<sup>®</sup> COATINGS

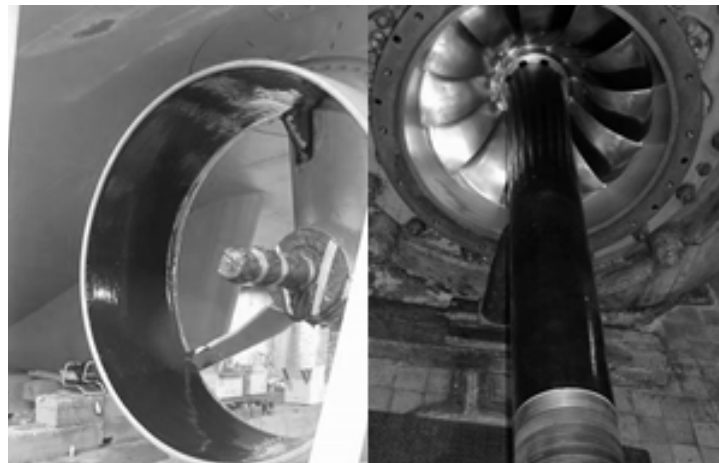
**Fig. 1.** Examples of use Belzona products in Maritime [1]

The paper presents the study on cavitation erosion resistance of three composite materials. The tested materials were Belzona<sup>®</sup> 2141 (acr-fluid elastomer), 1321 (ceramic s-metal) and 5831 (st-barrier). All of those materials were commonly used in hydrocarbon exploration systems and maritime to protect equipment surface from harmful effects of environment. Below in Fig. 1 presents examples of protection marine propulsion and pump elements on effects of cavitation erosion.

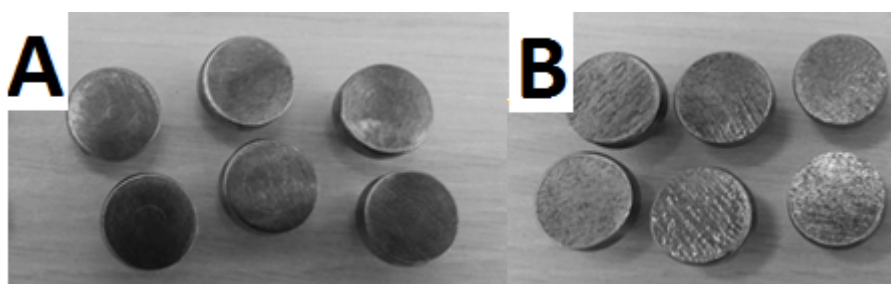
**Fig. 2.** P110 steel probes according to ASTM G32-10. A) Before surface treatment. B) After surface treatment to roughness  $R_z=75 \mu\text{m}$  Belzona® 2141 - ACR-Fluid elastomer

In order to test resistance to cavitation erosion, by courtesy of Belzona the three types of coatings 2141, 1321 and 5831 were obtained. The coatings were prepared and applied according to the instruction on six probes. Probes were prepared with dimensions conforming ASTM G32-10. The front side of probes were prepared with regards to roughness for relevant coating. The suggested roughness of surface stated by the producer was  $R_z = 75 \mu\text{m}$  [8-10]. Samples before and after surface treatment are shown in the Fig. 2. The probes were cleaned in acetone before coating. The instruction for each coating require different time to achieve full mechanical strength of material. The following paper describes applied material in tests and examples of their applications.

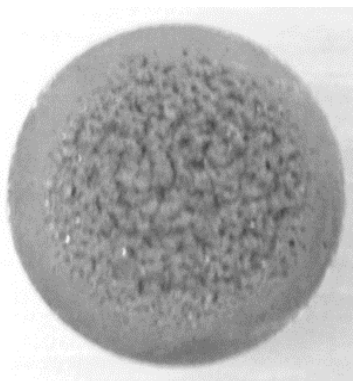
**Fig. 4.** Belzona 1321 applied on P110 probes after cavitation test; Belzona® 5831 - St-barrier

The 2-part ceramic filled epoxy coating designed to provide erosion and corrosion resistance of metal surfaces. This solvent free epoxy coating has high chemical resistance and bonds to any rigid surface. Due to its high compressive strength it can be also used to create a perfect shim. This material is applied without the need for specialist tools in room temperature. The material after cavitation erosion impact is shown in Fig. 4. Examples of applications for Belzona 1321 (Photo 3):

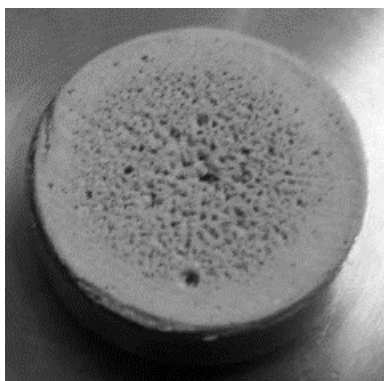
**Fig. 5.** Belzona 5831 applied on P110 probes at counter probe stand

The 2-part epoxy coating which once cured forms a barrier coating for the protection of equipment operating under immersed conditions or in contact with aqueous solutions. This solvent free epoxy coating bonds strongly to steel and other metallic and non-metallic surfaces such as concrete or brick. Belzona 5831 (ST-Barrier) is formulated for application to wet and oil contaminated surfaces that cannot be dry for application, as well as for underwater applications. The coating displaces water from the surface ensuring maximum adhesion to damp or wet surfaces, even underwater. Examples of applications for Belzona 5831 (Fig. 5.):

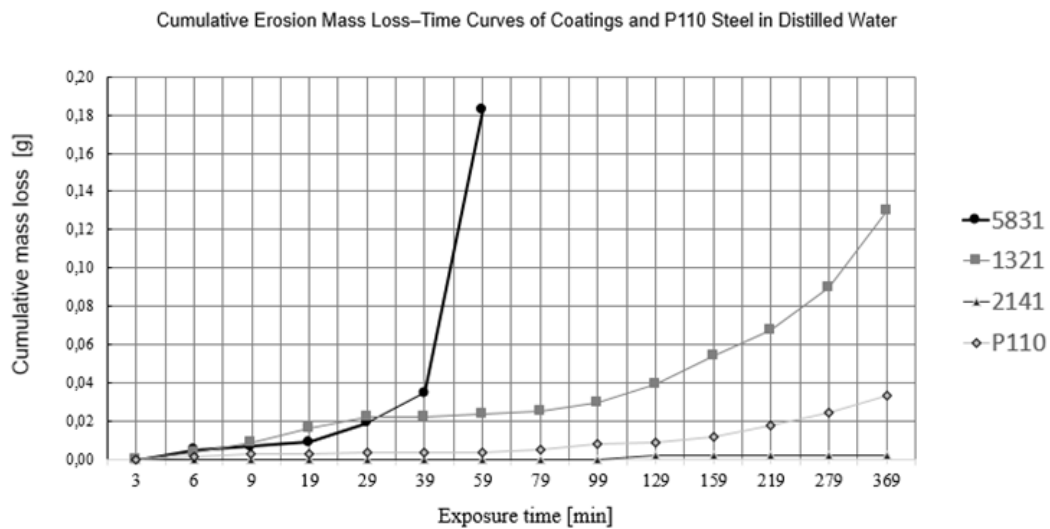
Fig. 8. Results of cavitation tests (erosion curves) in environments of distilled water

weighed. The evaluation parameter of cavitation erosion resistance is the cumulative mass loss versus exposure time determined for each sample and showed in the Fig. 8.

The relationship between materials coatings and steel P110 cumulative mass loss versus time established in Fig. 8 distilled water and Fig. 9 drilling mud. For purpose of comparison, results were listed in Table 3 and 4.

The above tests results indicate cavitation erosion resistance of three different coatings. The all tests was performed on the stand with counterprobe. The cumulative mass losses of the coatings deposited on P110 stainless steel during cavitation test in two environments of water and drilling mud are shown in Fig. 8-9. The conducted studies shows that tests in environmental of drilling mud decreases cavitation erosion rate [18]. The deposition of coating 5831 (St-barrier) has decreased the mass loss middling 90% (Table 3,4) in comparison of coating mass before tests on probes in two different environments. The 2-part polyurethane 2141 coating has the best cavitation erosion protection properties due to its longest incubation period and smallest mass lost among all tested coatings Fig.8-9. The cumulative mass loss of other coatings were higher than reference steel P110 Fig.8-9. The deposition of 5831 coating increase in 1/3 of test time and end 80% detachment of coated layer from probe. This results preventing examination of this sample. The 1321 coating also have good cavitation resistance, which was confirmed by the low cumulative mass loss, but still higher than stainless steel P110. Coating 2141 has received the smallest cumulative mass losses during performed tests. As the further work, number of research of coatings properties used in industry can be investigated and compared with conducted tests.

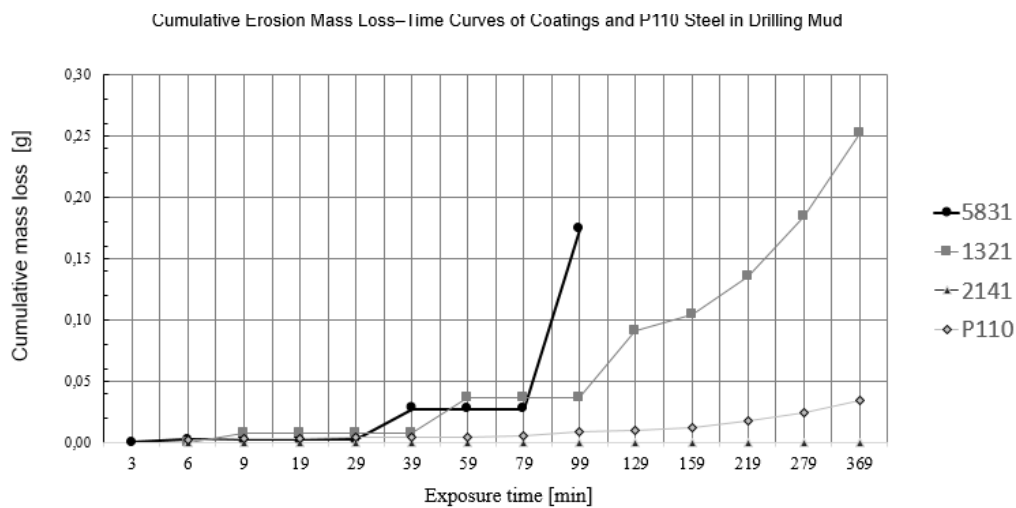
Fig. 9. Results of cavitation tests (erosion curves) in environments of drilling mud

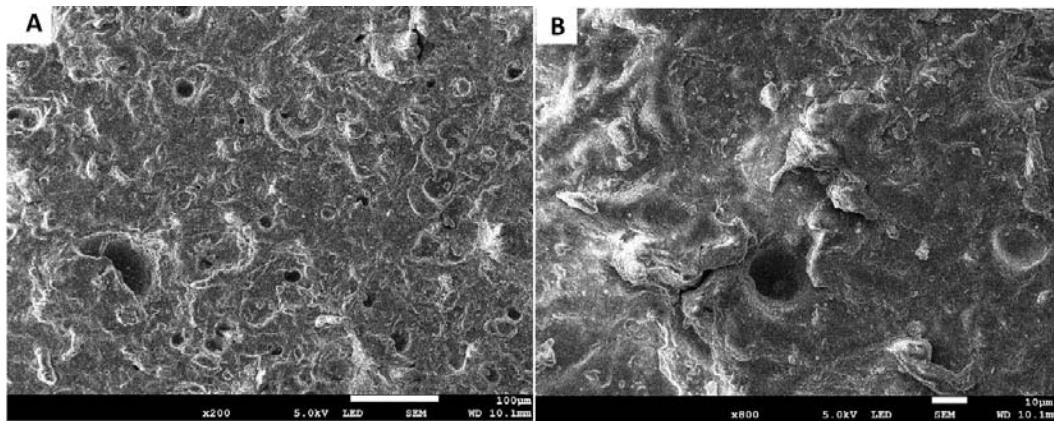
Fig. 12. SEM photos of coating 2141 samples after end of cavitation in distilled water

Material 2141 coating of two-component polyurethane is characterized by high plasticity behaviour reminiscent of elastomer. SEM results shown in Fig. 12 the essence of the impact of cavitation erosion on the material. Fig. 12 A) shown a cavities of spherical shapes, which have causes of micro-jet impact generated during implosion of cavitation bubbles. Fig. 12 B) shows one of such voids and cavitation impacts in the traces formed on the sample surface. Also visible cracks formed in the area near cavitation craters, cavitation load initiate fracture that develop on surface of the eroded material and leading to loose of thin flakes of material (delamination). However, the weight loss was unnoticeable, the accuracy of scales not captured changes in the mass of the coated sample. The outstanding observed results can be attribute of the strong adhesive connection of coating.

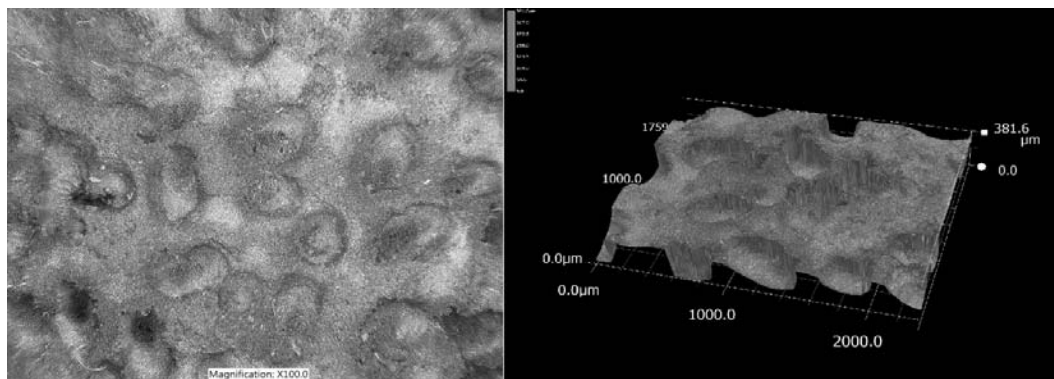
Fig. 13 shows micrographs of tested surface steel P110 sample. Two mechanisms of mass removal were observed. Formation of deep micro-cavities due to micro-jet action and cracking of the material from slip line or grain boundaries.

Fig. 13. Optical microscope photos of eroded surface of P110 sample tests in distilled water
