Chemical, Physical, and Mechanical Properties of 95-Year-Old Concrete Built-In Arch Bridge

Citation: Ambroziak, A.; Hausteina, E.; Niedostatkiwicz, M. Chemical, Physical, and Mechanical Properties of 95-Year-Old Concrete Built-In Arch Bridge. *Materials* **2021**, *14*, 20. <https://doi.org/10.3390/ma14010020>

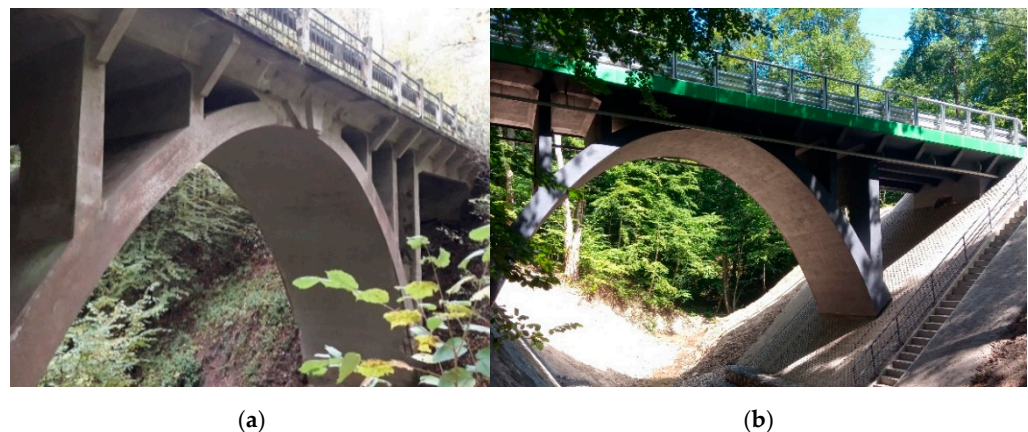
Figure 1. Jagodnik arch bridge before (a) and after (b) reconstruction.

The arch bridge investigated in this study is located above a forest canyon and the Kumieli river (watercourse) (see Figure 1). The structure of the center span bridge (about 12.95 m) is a reinforced concrete slab, monolithically connected to reinforced concrete shields supported on a plate arch. The arch bridge was built in 1925 in Jagodnik (Poland) by Karl Metzger & Co. building company (see p. 181 in [24], where a photo of the investigated arch bridge is inserted). In 1925, Jagodnik (Berendshagen) was part of the district of Elbing in Germany (present-day Elbląg in Poland). The arch bridge was erected under the guidelines of the German Committee for Structural Concrete issued in January 1916 [25] for structural use of concrete, design, and construction. This guideline was in force until September 1925, when the German standard DIN 1045 [26] was introduced.

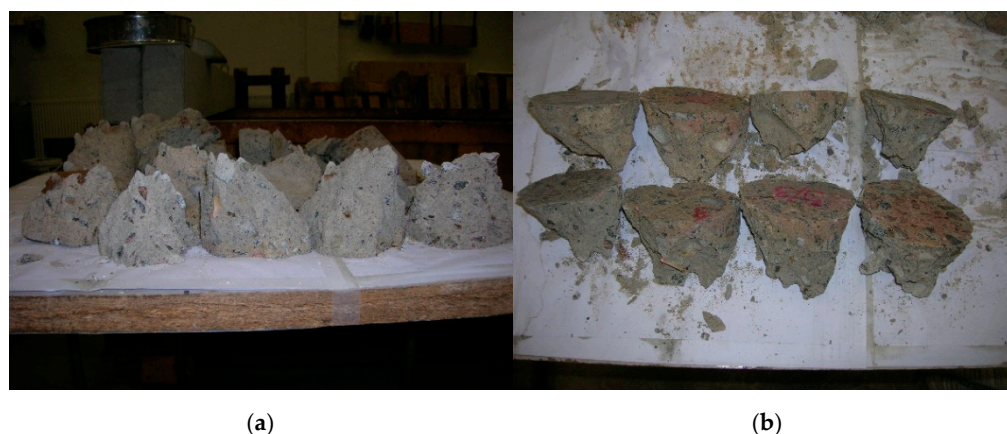
Figure 3. Concrete specimens after uniaxial compressive tests: (a,b) views of the form of failure.

Uniaxial compressive experimental tests were carried out using the Advantest 9 C300KN mechanical testing machine. Experiments were performed on the failure of the concrete cylinder specimens (see Figure 3). The uniaxial tensile test results of compressive strength for cylindrical samples $f_{c,cycl\ 100}$ is presented in Table 3. The mean value of compressive strength of cylindrical samples $f_{c,cycl\ 100}$ was 18.8 ± 0.7 MPa. The strength results of the cylindrical samples $f_{c,cycl\ 100}$ with length/diameter ratio of 1.0 were comparable to the cube strength $f_{c,cube}$ of $15 \times 15 \times 15$ cm concrete specimens according to the EN 12504-1 standard [27], i.e., $f_{c,cycl\ 100} = f_{c,cube} = 18.8 \pm 0.7$ MPa. The variation in compressive strength values of the 95-year-old concrete (see Table 3) can be explained by the production technology, which was probably based on portable concrete mixers with handmade proportions of concrete components. Portland cement was used as a binder in ordinary old concrete mixes. It should be noted that the new cementitious materials, e.g., geopolymer concrete (called alkali-activated materials, see e.g., [42–46]), have higher compressive strength and better durability compared to concrete mixes containing Portland cement.

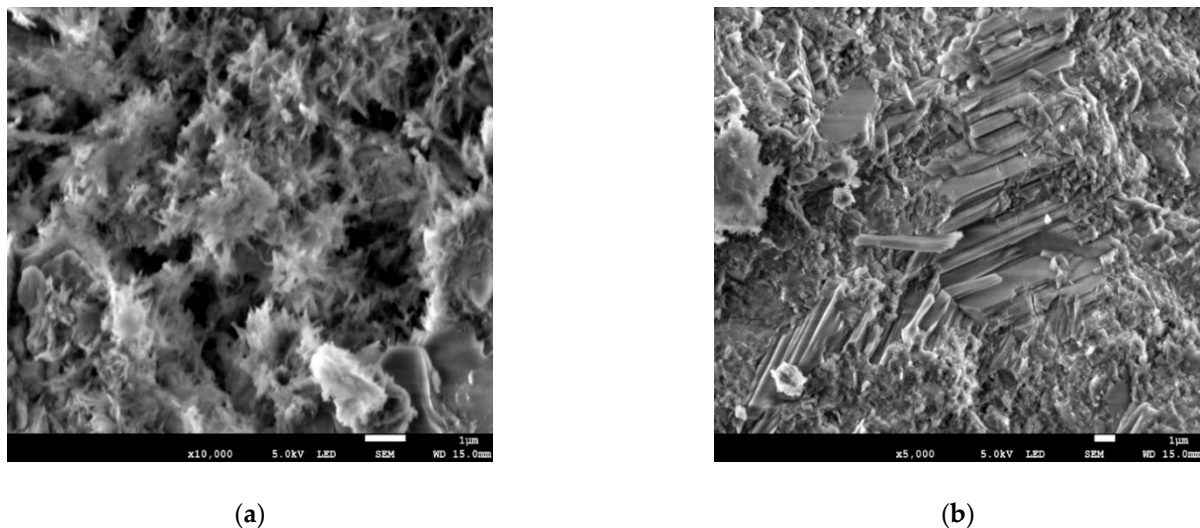
Figure 5. Scanning electron microscope (SEM) images of the samples taken from the cover layer of the concrete structure: (a) ×10,000; (b) ×5000.

Based on the specified chemical properties, samples from 1s and 1c concrete specimens were chosen for XRD analyses to assess the presence of crystalline compounds and identify them. For the tests, specimens measuring 10 × 10 × 10 mm were taken from the cover layer and the center layer (about 7.5 cm below the surface of the concrete) of the tested concrete element. Microstructure tests were carried out for four samples (two samples from the cover and two samples from the center layer of old concrete specimens). Element composition tests (EDS) were carried out for four samples (three samples from the cover and three samples from a depth of about 7.5 cm below the surface). The results of the microstructure (SEM images) and element composition of the tested samples are shown in Figures 5 and 6.

- Portlandite crystals were found in the tested samples, shaped most often as hexagonal platelets. Both isolated and clustered occurrence was noted. The visible portlandite occurred in the form of large pseudohexagonal crystals, forming columnar conglomerates arranged in parallel. In both cases, the resulting products (phases CSH and CH) were due to cement hydration reactions with water. The microstructure of the concrete has a significant influence on its properties, such as its strength and durability.

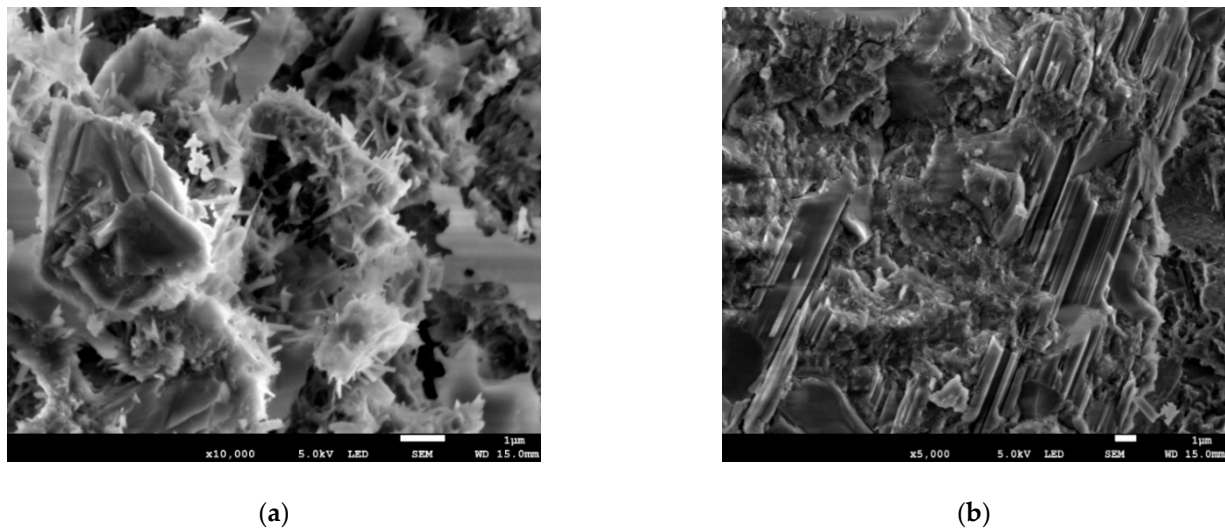
Figure 6. SEM images of the samples taken from center layer of the concrete structure: (a) $\times 10,000$; (b) $\times 5000$.

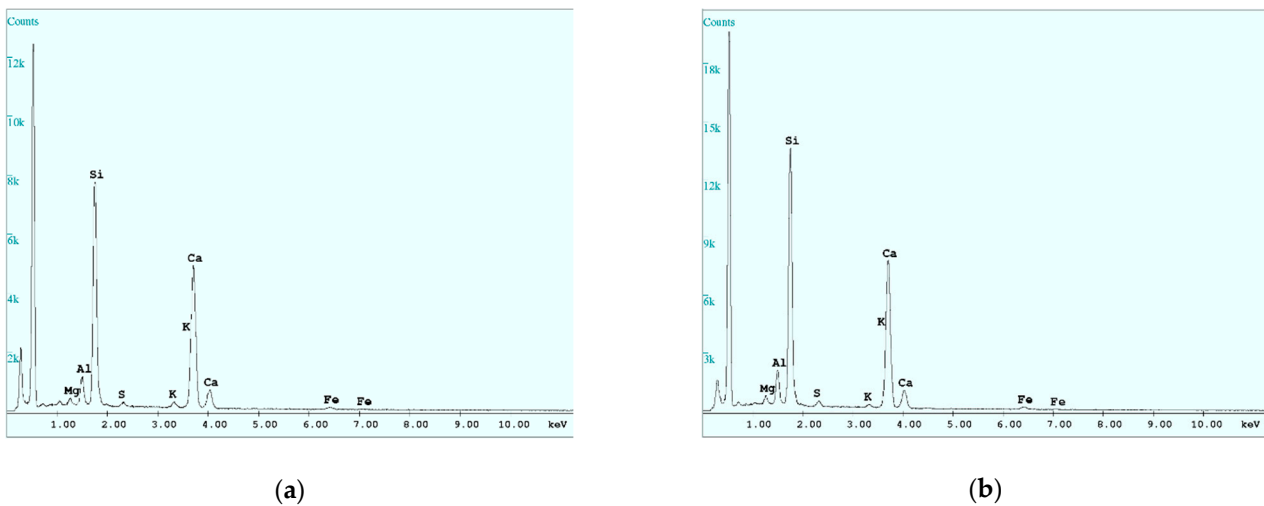
Figure 7. Energy-dispersion X-ray spectrometer (EDS) spectra of samples taken from the (a) cover layer; (b) center layer.

The results of element composition tests are presented in Tables 8 and 9. They indicated the dominance of two main elements in the microstructure of the tested samples: Si (silica) and Ca (calcium) (see Figure 7). The content of these elements for samples taken from the cover layer was 29.4 to 34.7% for silica and 54.1 to 57.5% for calcium. For the specimen samples taken from center layer, the content was 25.6 to 36.8% for silica and 51.6 to 60% for calcium. The content of other elements, such as Al, Fe, Mg, K, and Na, was definitely lower compared to the Si and Ca content in all samples.
