Condition of reinforced concrete structures and their degradation mechanism at the former Auschwitz concentration and extermination camp

The paper presents the results of investigations on reinforced concrete structures present in the former Auschwitz I and Auschwitz II-Birkenau concentration and extermination camp. Field inspection employing non-destructive method of reinforcement potential measurement according to the ASTM-C 876-15 standard, followed by laboratory investigations performed on genuine historic reinforced concrete samples collected from the former Auschwitz camp allowed assessment of the actual condition of this 70-year old construction material. Electrochemical potential measurements allowed mapping of the regions characterized by enhanced reinforcement corrosion risk and the regions of its immunity. Composition of concrete, water absorbency, content of detrimental salts, degree and profile of carbonation as well as mechanical properties were evaluated. The obtained results revealed the most common and probable mechanism responsible for degradation of the reinforced concrete structures in the former Auschwitz camp.

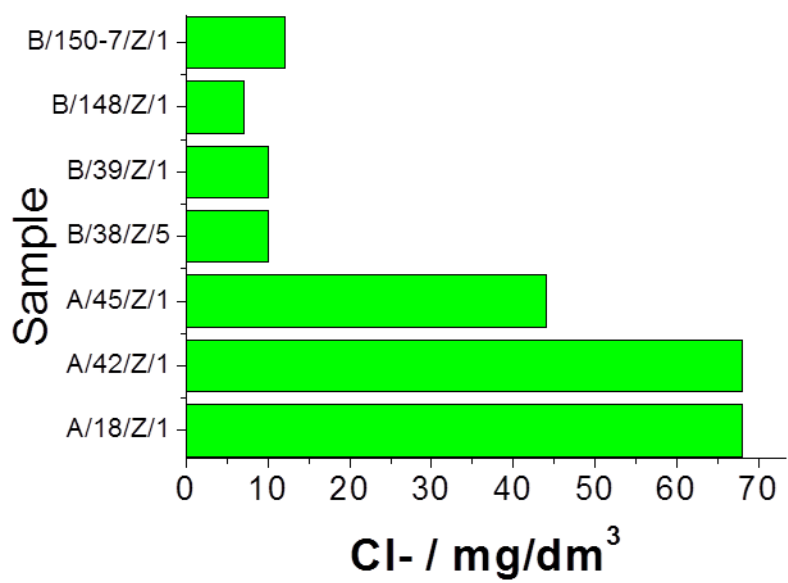
Figure 11

The presence of chloride ions (Cl^-) and sulphate ions (SO_4^{2-}) in concrete is a factor contributing to corrosion onset of reinforcement steel due to destabilization of the protective passive layer. Accordingly, it is important to determine the content of particular ions as well as their depth profile in order to verify if they impose a hazard to reinforcement passivity. The concentration of chloride ions in the investigated samples is from $7\text{mg}/\text{dm}^3$ to $68\text{mg}/\text{dm}^3$ (Fig. 11). These values are relatively low as for instance $800\text{mg}/\text{dm}^3$ is accepted level of chlorides in fresh concrete (Chloride resistance report, 2009). The origin of these ions could be soil (capillary suction via the pores of concrete cover, especially in the lower parts of structures neighbouring soil), air (chlorides carried by the aerosol, possibly from the Sola River located nearby, and deposited on concrete elements) and batched water (intrinsic content of chlorides in water used for preparation of mortar). A higher content of chlorides was detected in the samples collected in the former Auschwitz I camp, due to the fact that the Auschwitz II-Birkenau is located on open, flat area, where wind and precipitation cause partial removal of chlorides from the concrete material.

Fig. 11. Concentration of chloride ions in analysed concrete samples collected at former Auschwitz I and Auschwitz II-Birkenau camp.
