**Michał Kwasek\***

## *Conservation aspects of cast-iron platform shelters on the example of Vistula Pomerania railway stations*

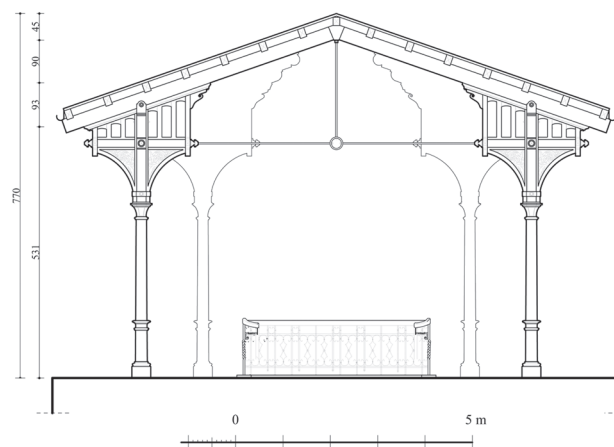
Fig. 1. Gdańsk Główny railway station, cross section through a cast-iron shelter on platform No. 2, inventory 2014 (source: collections of KTPPA, WA PG, elaborated by: A. Urbańska, M. Wachowiak, A. Wyźlic, M. Kwasek)

The standard type of shelter for double-edge platforms is the gable roof (Fig. 1). It is a self-sufficient structure. Cast-iron pillars contain decorative capitals and bases. At the top, they are provided with endings that lengthen the support of the wooden rafters. This also leads to an increased stiffening of their connection with the pillars. The form of this part of the columns imposes the angle of the roof inclination. The cast-iron supports are paired to form load-bearing frames, usually set rhythmically at 6–7.5 m intervals. The elements that bind the pillars together are the wooden rafters. They are the supports for the roof purlins laid perpendicularly on them. The frames are reinforced with metal ties attached above the heads of the columns. To reduce the deformation of these horizontal bars, they were hung to the rafters at mid-span. Such a construction solution was used at least as early as 1850 [12, p. 211] and is representative of the 2<sup>nd</sup> half of the 19<sup>th</sup> century. It was applied at many stations of the railroad line connecting Königsberg with Berlin. They were also made in Gdańsk Główny and Sopot.

At the main station of Pomerania’s capital city, the canopies of platforms 2–5 are historical examples of cast-iron shelters with a large, as for such objects, roof angle. It is about 20 degrees (the slope of the shelters used on this railroad route was usually about 6 degrees) and may derive

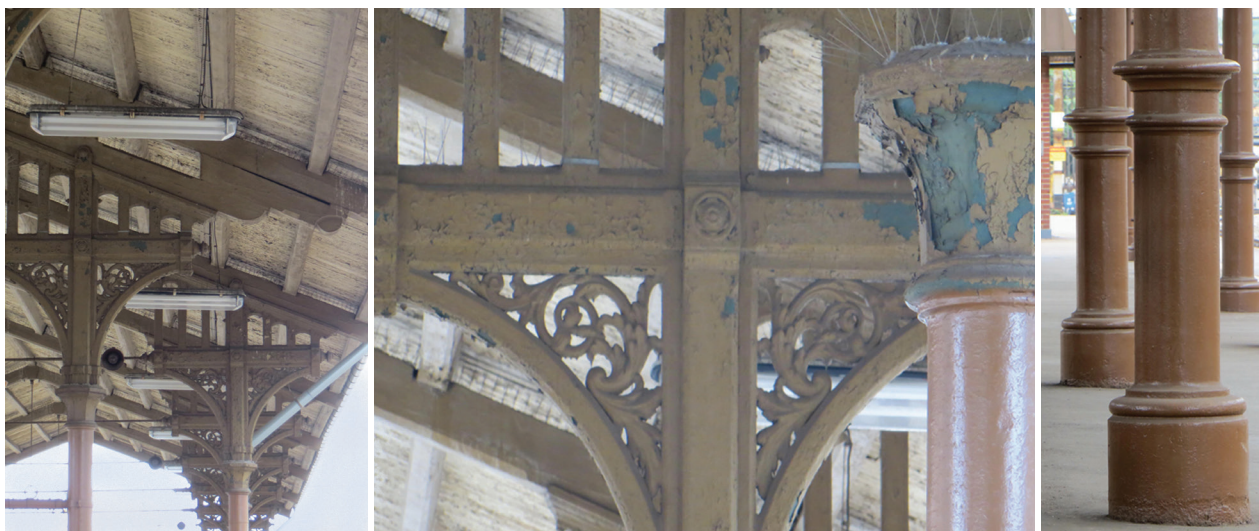
Fig. 2. Gdańsk Główny railway station, platform No. 2 roofing, 2012 (photo by M. Kwasek)

from the large width of the platforms and thus the long span (distance between the pillars) of the frame, which is as much as 8.2 m<sup>12</sup>. Consequently, these shelters reach 7.7 m in height, and the horizontal ties are also fixed in a non-standard way – at 2/3 of their height (Fig. 1). These canopies range in length from less than 100 m to just over 200 m. On platform two (the most extended authentic shelter), the decorated cast-iron columns are unusually arranged in four rows. The vast majority of them are situated at a standard distance from the platform’s edge<sup>13</sup>. However, in places where stairs lead to the platform, the cast-iron pillars were moved 1.3 m further from the platform’s edge (Fig. 2). The purpose of this was to create more space for travellers to move around where, due to the location of the stairs, there was less space. The use of the same cast-iron pillars (of equal height) while maintaining the same roof plane required additional elements to raise the rafter support line. For this purpose, a set of wooden beams was used (Fig. 2).

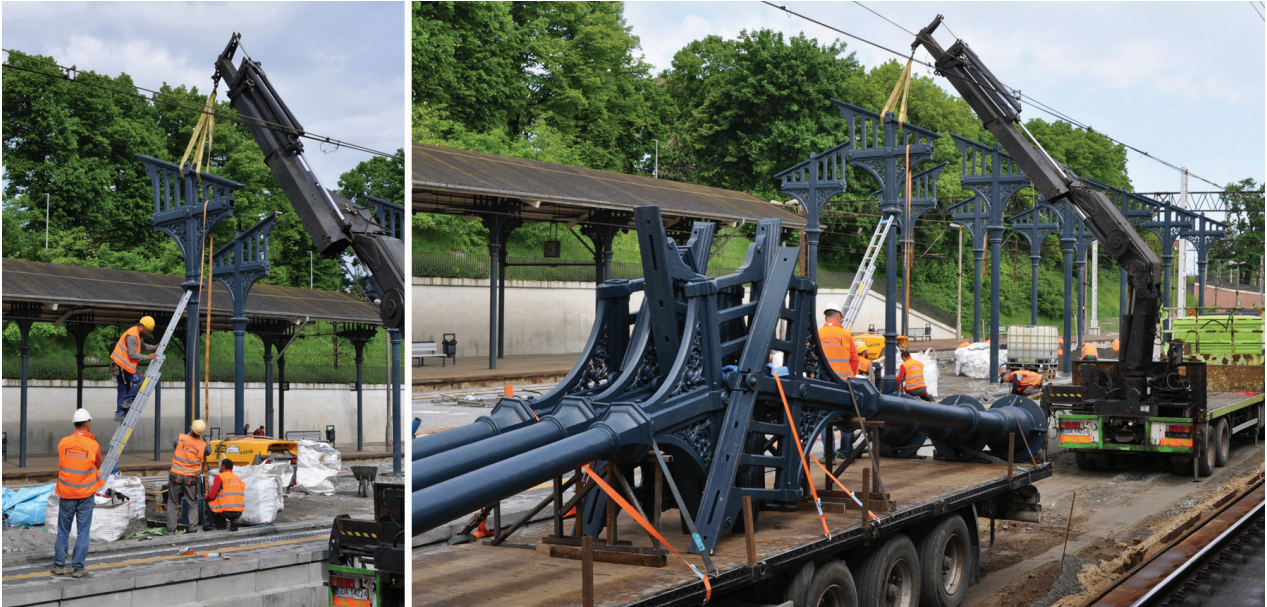
Fig. 3. Gdańsk Główny railway station, works of reassembly of the renovated cast-iron pillars of platform No. 2, 2018 (photo by M. Kwasek)

The pillars have been subject to conservation works. They were thoroughly cleaned of all paint coatings, the original colours were restored, and areas of pitting caused by corrosion were filled in. In 2018, the pillars were repositioned to their former places (Fig. 3), and the wooden elements were replaced with new ones. These were conservative measures, enabling the continuation of such a unique structure, restoring their original appearance from the turn of the 20<sup>th</sup> century. The shelter of platform 1 is a contemporary implementation from the early 1990s. As with the added pillars of platform 3, their upper parts refer to the

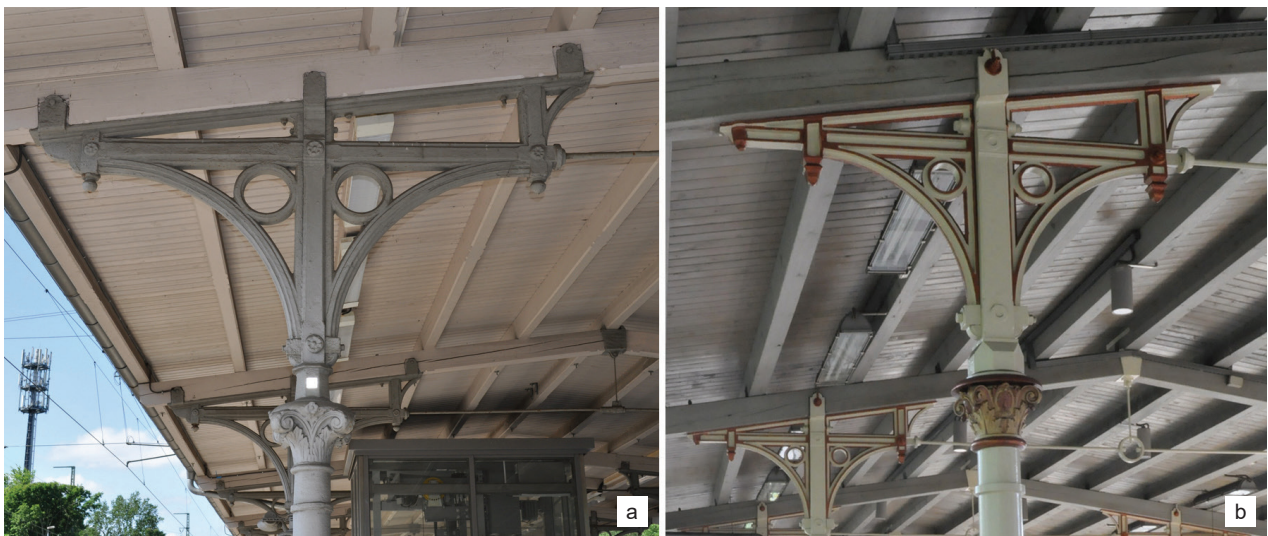
Fig. 4. Comparison of the upper parts of cast-iron columns supporting platform shelters: a) Berlin S Wannsee Bahnhof, 2019, b) Sopot, 2020 (photo by M. Kwasek)

At the Sopot railroad station, there are about 200 m long cast-iron platform shelters. Their form is resembling the ones implemented in numerous S-Bahn stations in Berlin, among others in Yorkstraße, Ostkreuz, Schönhauser Allee, S Wannsee Bahnhof, Potsdam Griebnitzsee and many others (Fig. 4). Occasionally they differ in dimensions, details – the form of decorative capitals or bases, the way of suspension, and the fastening of metal ties<sup>16</sup>. However, structurally and architecturally, they are similar solutions. As in the Berlin's stations mentioned above, the Sopot shelters are characterized by a significantly reduced roof inclination compared to the later construction in Gdańsk – only about 6 degrees. These structures are much lower than in Gdańsk (4.5–4.7 m) and have a shorter span of the metal and wooden frames (5.2–5.5 m). Nonetheless, only one of the presented Sopot shelters is an original structure (Fig. 5). It is located on the platform currently used by suburban trains (SKM). During the 2008–2010 modernization and restoration works, the cast-iron pillars were repositioned, the historic character of the floor was reconstructed, and based on the stratigraphy examination of the pillars, their cream-golden coloration, dating back to the 1870s, was restored<sup>17</sup>.

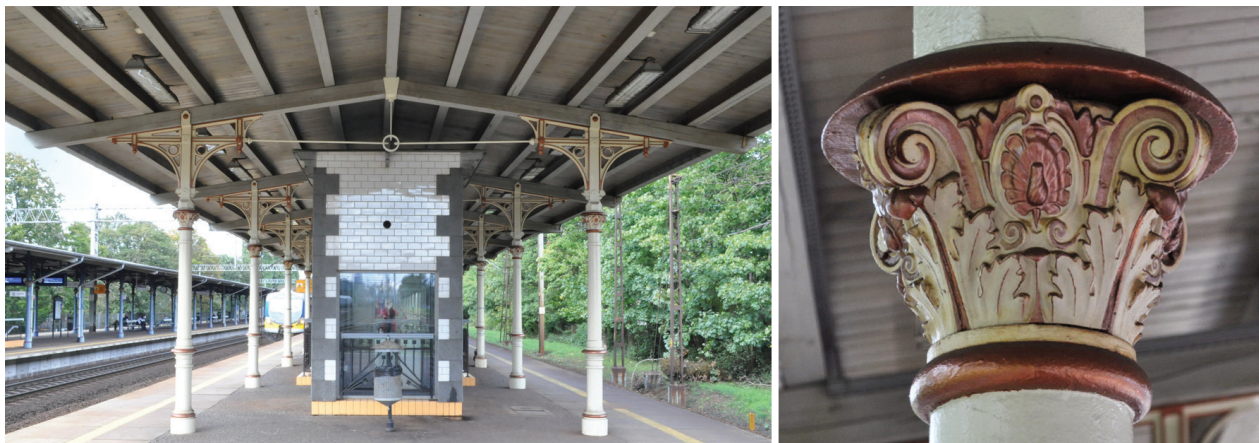
Fig. 5. Sopot railway station, general view and construction detail of the 19<sup>th</sup>-century cast-iron platform shelter on the platform of the SKM (Rapid Urban Railway), 2020 (photo by M. Kwasek)

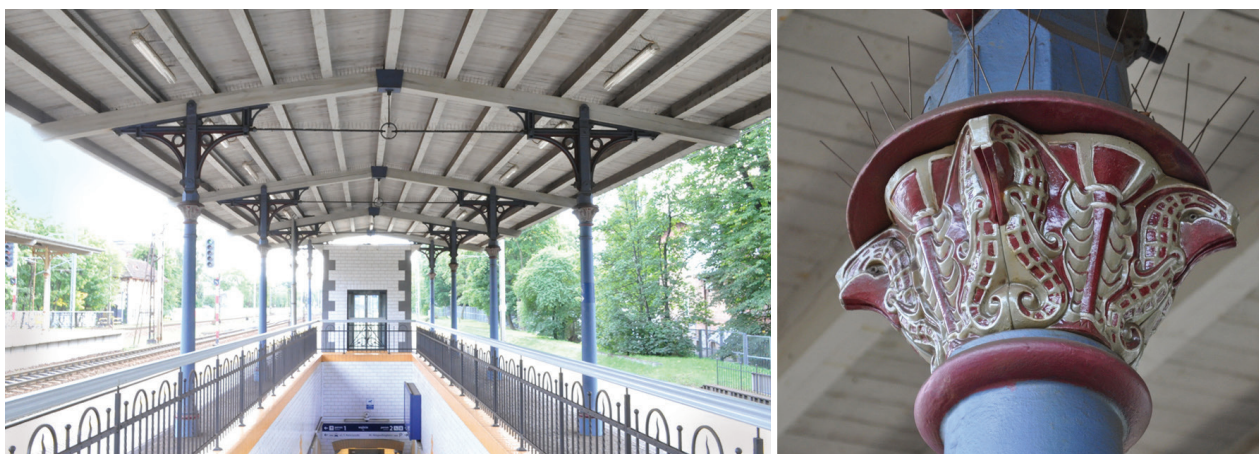
Fig. 6. Sopot railway station, general view and construction detail of the platform shelter on the long-distance platform created about 2011, the state in 2020 (photo by M. Kwasek)

A nearly identical shelter, located on the long-distance platform, is a structural and architectural copy of the 19<sup>th</sup>-century cast-iron construction (Fig. 6). It also applies a similar colour palette, which makes its contemporary

origin hardly recognizable at present. It is distinguished only by individually designed details of the pillar capitals containing maritime motifs. This platform was covered by a double-braced shed of riveted steel construction until ten years ago, presumably dating from the early 20<sup>th</sup> century. It was demolished in 2011. At the same time, the city authorities acquired the historical structural elements from the railroad company. Some of them have been recently renovated and installed as small architecture in front of the Sopot railway station building. Solutions in which authentic elements of railroad infrastructure are used in ur-

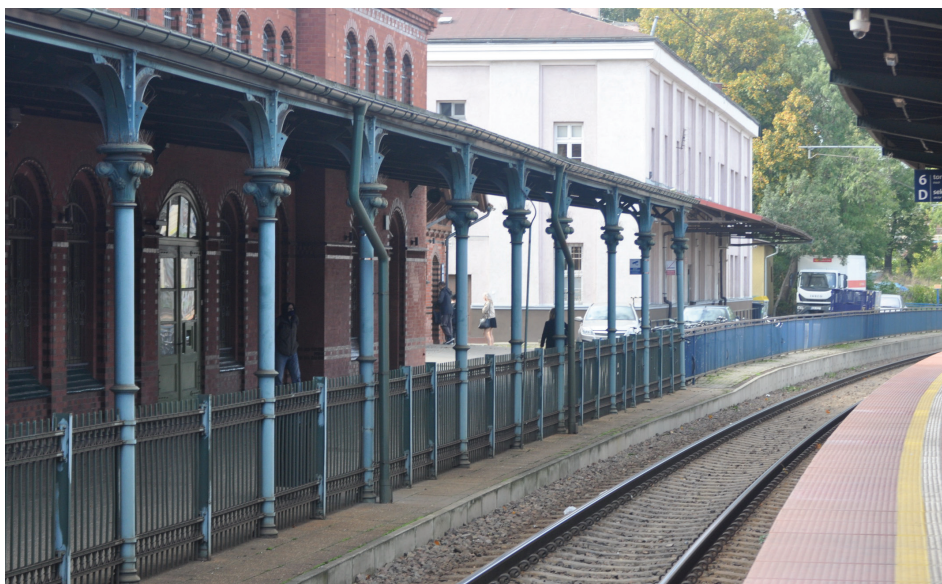
Fig. 7. Malbork railway station, single-pitched platform shelter with cast-iron pillars, the state in 2020 (photo by M. Kwasek)

The railroad station in Malbork presents an intermediate approach between the conservative works in Gdańsk and the Sopot creation, with a strong reference to historical forms. In this facility, a row of cast-iron pillars supports a pent roof, added to the station building from the platforms' side (Fig. 7). During the renovation works carried out in 2014, all elements of this structure were cleaned and painted. Additionally, the pillars were provided with

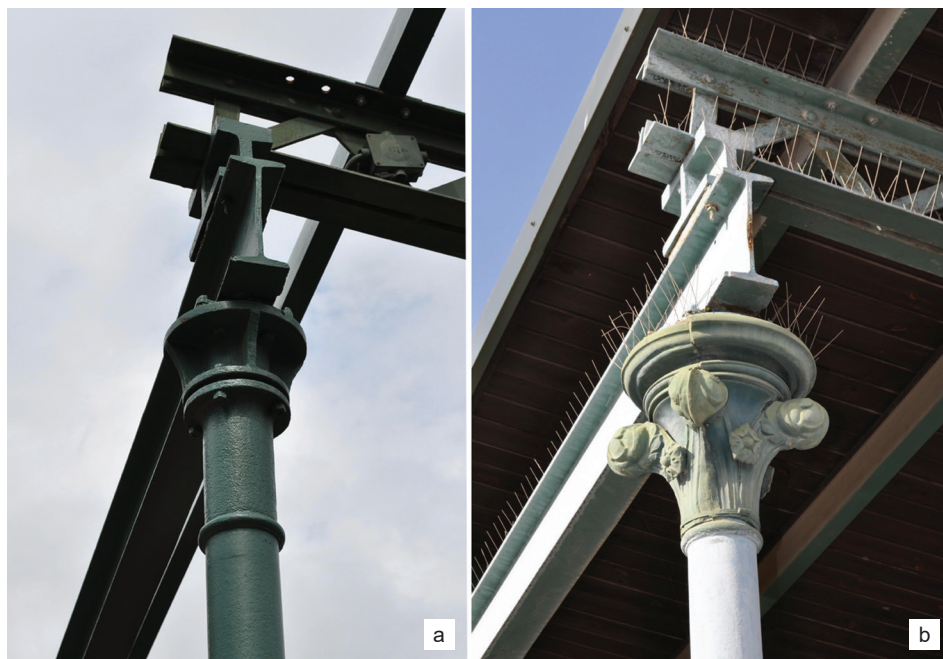
Fig. 8. Malbork railway station, detail of the head of the cast-iron pillar of the platform shelter before and after the installation of the decorative overlays:

- a) the state in 2014,  
b) the state in 2020  
(photo by M. Kwasek)

decorative capitals bonnet (Fig. 8). They replaced the originals, which presumably were present here and were deteriorated over the decades<sup>18</sup>. The contemporary form of the overlays applied is a relatively liberal reference to those used in 19<sup>th</sup>-century capital realizations, and its contemporary origin is recognizable without difficulty. Nevertheless, the material and quality of workmanship are not of the highest standard. They were made of plastic or thin sheet of non-ferrous metal<sup>19</sup>. These materials have aged differently from the painted surfaces of the metal pillar (Fig. 8). While the fastening systems of the cast-iron capital elements remain in most cases invisible, the described bonnets in Malbork were attached to the column using steel clamps. Undoubtedly, such a method of assembly is exposed to easier destruction and may also have a negative impact on the aesthetics of the solution. Commendable in this realization is the decision to restore the pillars' incomplete form and the use of patterns indicating their non-authentic origin. To some extent, the selection of material applied may be justified by the nowadays difficulty of replicating a historic building fabric – in preference to a readily available plastic. Nevertheless, as the examples illustrate:

<sup>18</sup> The form of the upper part of the column (Fig. 8, condition as of 2014), with an isolated section (with the use of a minor, simple band), indicates that cast-iron decorative bonnets have initially been mounted there, which were usually attached around the shaft to form decorative capital.

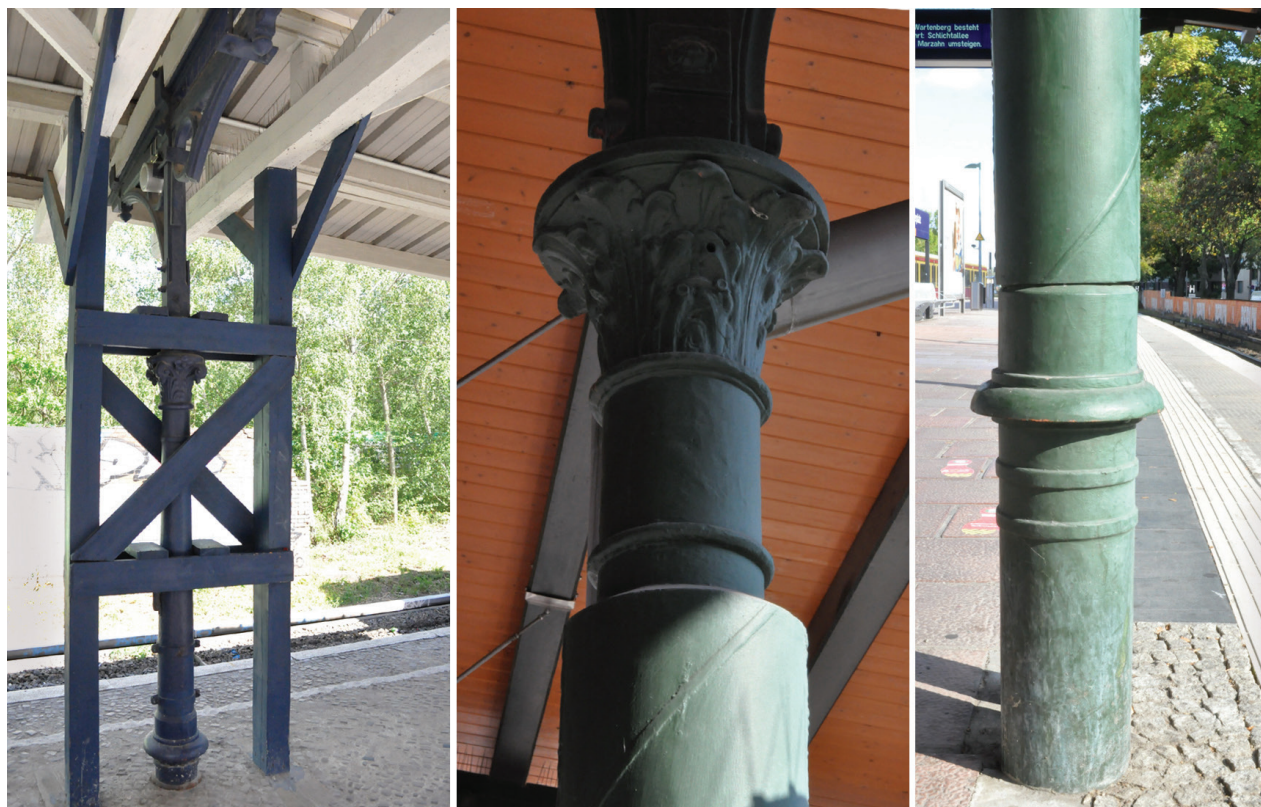
Fig. 9. Berlin, examples of repair work on cast-iron columns of platform shelters in S-Bahn stations, the state in 2019 (photo by M. Kwasek)

Potentially the most serious difficulties that may occur during the exploitation of a cast-iron structure may be generated by possible reparatory works. As indicated by unsuccessful attempts to repair cast-iron pillars [22, p. 58], identifying an adequate intervention method is then crucial. Similarities in the applied forms, material, and construction solutions of cast-iron platform shelters in Poland and abroad permit analogous and proven repair means. In Germany, techniques have been developed that allow for the temporary or permanent strengthening of such damaged pillars, using additional external metal jackets or an auxiliary wooden structure (Fig. 9). The conducted experimental studies indicate that cast-iron columns' reinforcement is also possible using composite fibres, which does not significantly affect the columns' aesthetics [23].
