CONSTRUCTION SOLUTIONS FOR HISTORICAL OBJECT FOUNDATIONS IN THE CONTEXT OF CHANGING THEIR FUNCTIONAL USE

Kazimierz GWIZDAŁA¹, Sylwia FLORKOWSKA²
Gdańsk University of Technology,
Civil and Environmental Engineering, Gdańsk, Poland

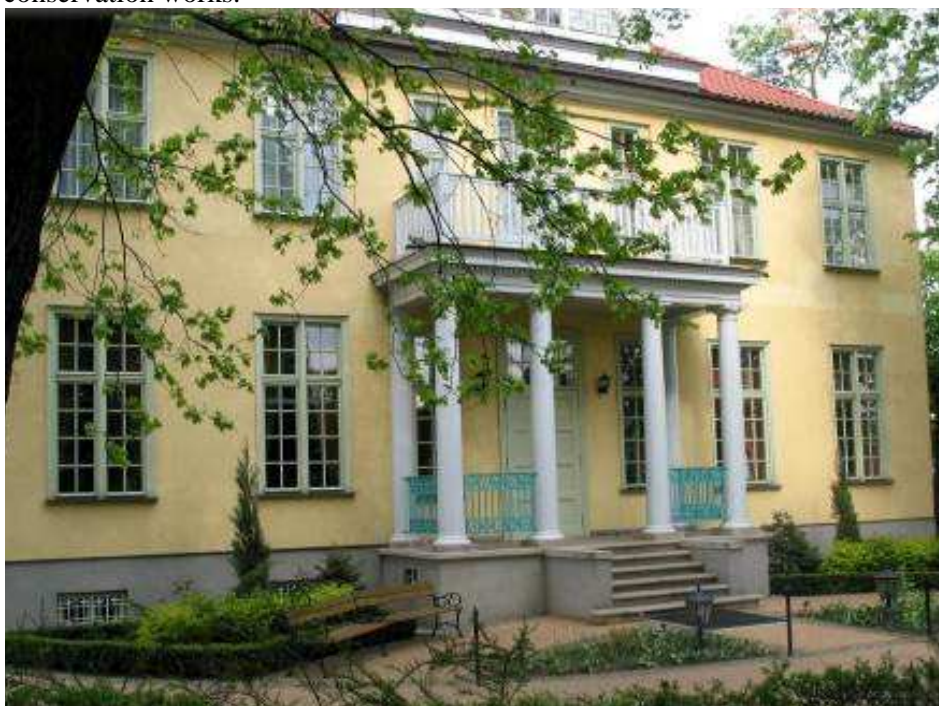
Fig. 6. Młyniska Manor after completion of construction-conservation works

Moreover, as a result of inclining the columns in various directions and crowning them with a reinforced concrete cap, it was possible to obtain stiffness of the foundation construction. An advantage of the technology is surgeless drilling and applying small diameters of boreholes, thanks to which it is especially useful when reinforcing the foundations of grade listed buildings. Fig. 6 shows Młyniska Manor after completion of construction and conservation works.
