Chinese Journal of Aeronautics

Effect of selective laser treatment on initiation of fatigue crack in the main part of an undercarriage drag strut

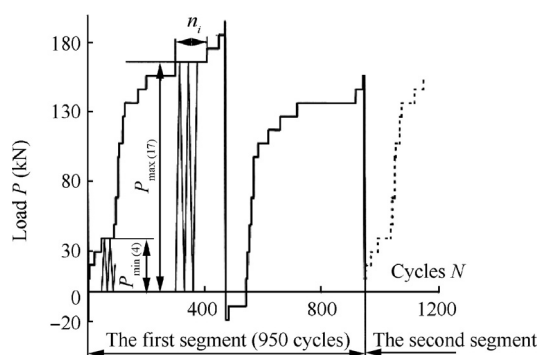
**Fig. 3** Set of loads program occurred during the fatigue test.

of loading force and elongation of the drag strut were recorded during the fatigue test. One set of loads, consisting of 950 different cycles, represented all loads during one aircraft landing and taking off. 32 stages of loads occurred in one set of loads. The maximum magnitude of the force in each set of loads was $F = 195.4$ kN, and the minimum was $F = -19.54$ kN. The maximum loads and their numbers in a certain stage of the set of loads are shown in Table 4. A graphical form of one program of the set of loads is shown in Fig. 3 as the n_i number of cycles at the i -th level of loads. The rate of the change of loadings was constant during the fatigue test, and it was 200 kN/s. The duration of one program of the set of loads was 18.56 min. The temperature during the test ranged between 20 and 25 °C, and the air humidity was 40–60%. The drag strut was tested by axial cycling in a laboratory environment at stress ratios R from 0 to $-\infty$ (the minimum stress to the maximum stress). The stress ratio R was 0 for 880 cycles, and $-\infty$ for 70 cycles in each stage. The load frequency was 0.85 Hz. On one end, the drag strut was fixed in the testing machine by the eyelet of the drag strut, and on the other end by the eye bolt screwed into the drag strut (see Fig. 4).

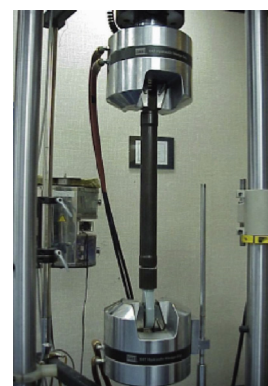
**Fig. 4** Stand for the fatigue test.

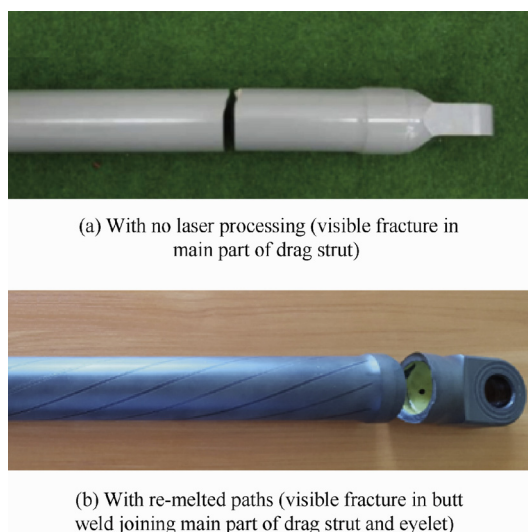
Fig. 7 Two drag struts of landing gear after testing fatigue.

Fig. 7 presents a view of the drag strut after the fatigue test. The fracture in the drag strut occurred in its main part, about 15 cm from the butt weld, joining the main part of the drag strut with the eyelet of the drag strut. The laser re-melted drag strut was able to withstand 1700 simulated cycles of landing. In contrast to the drag strut with no laser re-melting, the fracture in this drag strut occurred in the butt weld. It follows that the laser treatment can increase, for the same loading, the number of cycles to failure of the drag strut by about 70%. Subsequently, metallographic research was performed in order to verify the microstructural changes caused by the laser treatment. For this purpose, a sample was cut from the laser re-melted drag strut. The location of the cut corresponded to the spot of fracture in the drag strut with no laser re-melting. Then, a metallographic cross section was made. Structural examination of the cross section revealed that the laser treatment led to re-melting the surface layer to a depth of about 70 μm .

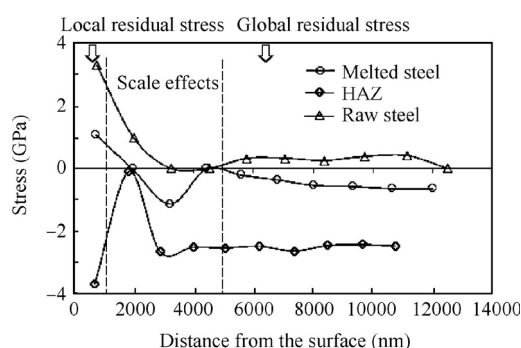
Fig. 18 Residual stress profiles for analyzed areas.

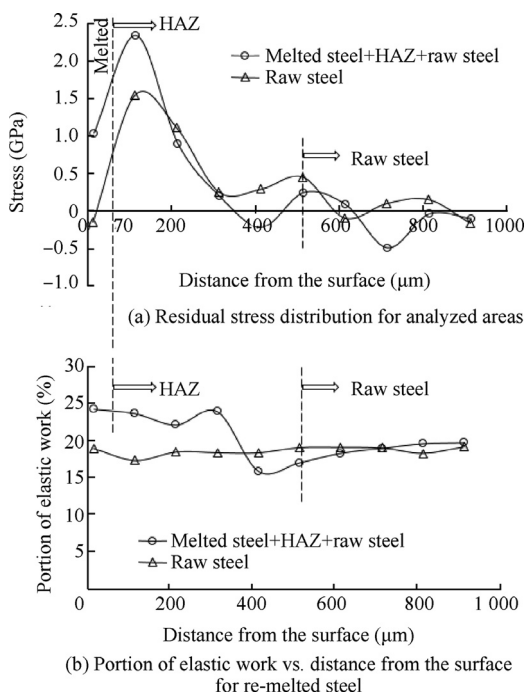
Fig. 19 Residual stresses and elastic properties measured on the cross section.

Fig. 19(a) shows residual stress distributions in the range of 15–915 μm from the surface, and Fig. 19(b) shows distributions of portion of elastic work. As is apparent from Fig. 19(a), the residual stress changes from compressive to tensile in zone II in the melted material. At a distance of 70 μm from the surface, the melted zone passes into the HAZ, and the stress oscillates from tensiling to compressing. Residual stresses of the raw material pass from tensile to compressive, similar to that in the HAZ. In turn, the portions of elastic work in the melted zone and the HAZ at a distance of 315 μm from the surface

are still high and about 25%. Only at a distance greater than 315 μm from the surface, the elastic properties reaches the same values as those of the raw materials before the laser treatment. Due to the fact that the process of fatigue was caused by interior crack initiation, it can be assumed that the residual stresses on the surface and in the subsurface layers have delayed the initiation of fatigue cracks. In the re-melted steel and the HAZ, there were high compressive residual stresses in the surface and subsurface layers, which inhibited the initiation of fatigue in these areas. According to the linear elastic fracture mechanics superposition concept, the total stress intensity factor value consists of the part due to the applied external load and the part due to residual stresses. If the resid-

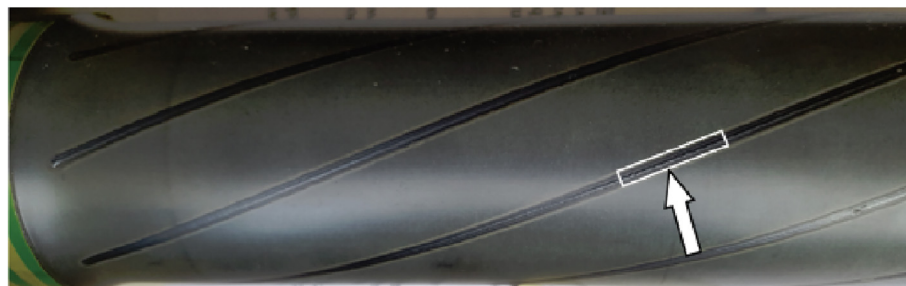
Fig. 20 Sample for CT testing.

(a) CT scan of the sample with marked areas for detection of fatigue crack initiation sites

(b) A sample scheme with marked areas of different nature of residual stresses and microstructure

(c) Place of sample cutout for testing-depicted by arrow the sample size 0.526 mm×2 mm×14.64 m

In order to determine the effects of the microstructure of steel and the residual stress on the rate of initiation of fatigue cracks, a sample was scanned using a computer microtomograph. Fig. 20 presents the sample used for the study with the marked areas for detection of fatigue cracking initiation sites. To determine the content of defects in alloy subjected to laser treatment, four volumes of metal were extracted in

the scanned sample. The volumes of material in which fatigue crack initiation sites were searched corresponded to the nature of the residual stresses in those volumes or the type of microstructure of the material. Figs. 21 and 22 show the results of these analyzes (MZ I – melted “zone I”, MZ II – melted “zone II”, RM – raw material, and HAZ – heat affected zone). As shown in Figs. 21 and 22, the lowest number of defects are in the volume of material extracted from a depth of 0–15 μm . In this volume of material, there are high compressive residual stresses. The microstructure of this volume of material is partly as in “zone I” (about 30%) of the re-melted material and partly as in the HAZ (about 70%). In turn, the greatest number of defects due to fatigue occur for the volume of the re-melted steel extracted from a depth of 15–350 μm . The microstructure of this volume of material consists of about 2% of the microstructure of the melted material such as in “zone II”, 90% of the microstructure such as in the HAZ,
