Article

Effect of Thermal Treatment and Erosion Aggressiveness on Resistance of S235JR Steel to Cavitation and Slurry

Alicja K. Krella ^{1,*}, Dominika E. Zakrzewska ¹, Marta H. Buszko ¹ and Artur Marchewicz ¹

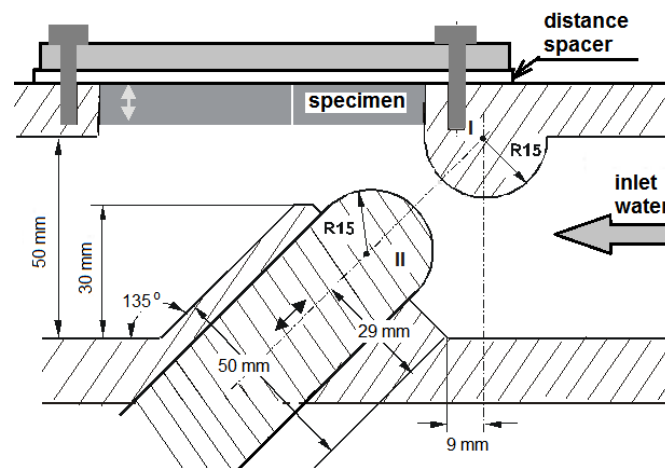
Figure 1. Scheme of the cavitation tunnel.

In order to investigate the effect of cavitation intensity on the erosion process, four tests were carried out using a cavitation tunnel equipped with a system of barricades. The scheme of the cavitation tunnel is shown in Figure 1 and it has been described by Krella et al. [18]. As a working fluid tap water with a temperature of 20 ± 2 °C was used. The intensity of cavitation is governed by the fluid flow rate, which is controlled by the inlet and outlet pressures, which in turn are regulated by the inlet and outlet valves. Flow speed was measured using a portable ultrasonic flowmeter Fluxus® model ADM 6725 (FLEXIM, Edgewood, NY, US) with a measurement accuracy of $\pm 0.5\%$ of the measured value. In the presented investigations, the water flow velocities were 35 m/s, 37.9 m/s, 40.5 m/s, and 43 m/s in the slot between the barricades. The total duration of the test was 600 min.

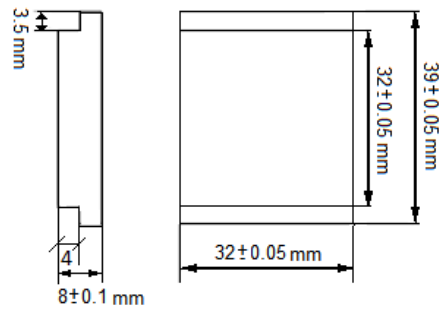
Figure 2. The shape and dimensions of a specimen for cavitation erosion tests.

In order to obtain the cavitation curves and erosion rates, the mass of tested specimens was measured using an analytical balance of 0.1 mg accuracy. Mass measurements were carried out before the tests and after each exposure. Before each mass measurements, the specimens were cleaned and dried. The shape and dimensions of the specimens are shown in Figure 2.

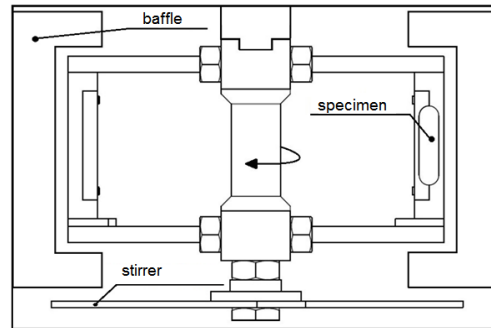
Figure 3. Scheme of a slurry pot tester.

The slurry tests were performed using a slurry pot tester (Figure 3). The pot capacity is 6.4 l. The tester allows simultaneous examination of two specimens. At the inner wall of a slurry pot, four baffles are mounted to minimize centrifuging of the fluid due to the rotation of the specimens. Additionally, a stirrer is mounted to prevent the sedimentation of the solid particles. The rotation speed is adjusted by a power inverter ABB ACS 300 (ABB Asea Brown Boveri Ltd, Zurich, Switzerland). To analyze an effect of erosion intensity on the erosion process, four slurry tests were carried out at rotational speeds of 565 rpm, 786 rpm and 1012 rpm. The duration of the slurry tests was 600 min, similar to cavitation erosion tests. Tap water with a temperature of 18 °C was used as a working liquid. Spherical steel solid particles with a diameter of 520 μm and hardness of 51 HRC were used as erodents. The concentration of erodent was 12.5 wt. %. The impact angle was 90°. The shape and dimensions of the specimens are shown in Figure 4. Before the tests and after each exposure, the specimens were cleaned, dried, and reweighed using an analytical balance of 0.1 mg accuracy.

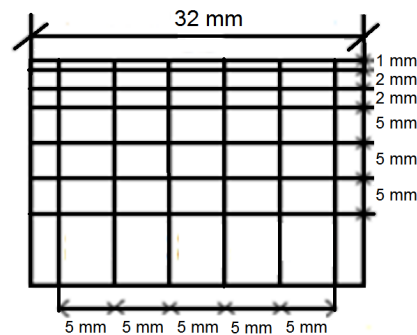
Figure 5. The scheme of the network for surface roughness measurements.

After each erosion test, the microscopic studies were carried out using a scanning electron microscope EVO-40/Zeiss (Oberkochen, Baden-Württemberg, Germany) and a SU3500 scanning electron microscope, Hitachi (Tokyo, Japan), in the Research Centre in Jablonna, Poland. Moreover, the microhardness measurements on the cross-sections were carried out using the FALCON 401 Vickers Hardness (INNOVATEST, Shanghai, China) tester with 300 gf load and dwell time of 10 s. The first measurement was made 35 μm from the eroded surface and the measurements were carried out at the distance of 200 μm to eliminate an influence of the other indents on the result obtained. Moreover, to characterize the eroded surfaces, surface roughness (Ra parameter) was determined using the SJ-301 Mitutoyo Surface Roughness Tester (Mitutoyo Corporation, Kanagawa, Kawasaki-shi, Japan). The Ra parameter is an arithmetical mean of the absolute values of the profile deviations from the mean line of the roughness profile. In the case of the cavitation erosion tests, the surface roughness was measured after the tests along the scheme of the network shown in Figure 5. In the case of slurry erosion tests, the specimen surface was eroded evenly. Therefore, the surface roughness was measured at five arbitrary chosen places. Additionally, surface roughness measurements were performed after each test exposure.

The distributions of surface roughness along the network shown in Figure 5 that developed during the entire cavitation erosion tests are shown in Figures 12 and 13, respectively for S235JR-AR and S235JR-TT steel. In order to show the effect of flow conditions on the roughness, the same maximum Ra value was used in the color bar despite the different maximum Ra values. During the slurry test, the entire surface of the specimens was uniformly eroded, so five measurements of the Ra parameter were taken after each exposure. The development of the Ra surface roughness parameter is shown in Figure 14.

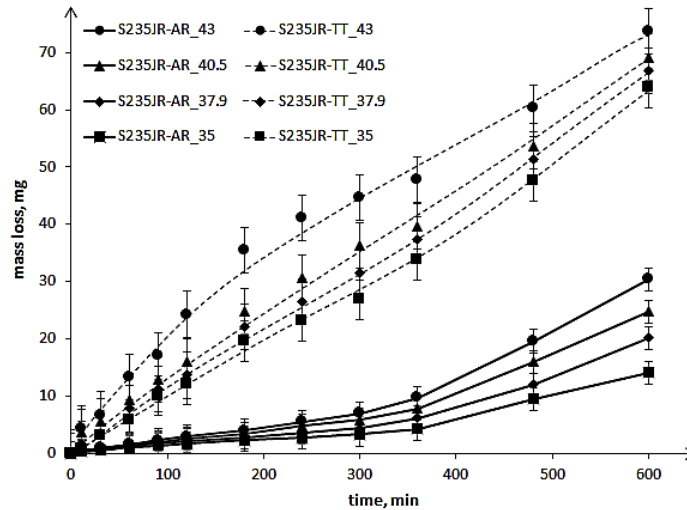
Figure 6. Cavitation erosion curves of S235JR steel in as-received state and after thermal treatment.

The results of cavitation erosion tests are shown in the form of the cavitation erosion curves (Figure 6) and the cavitation erosion rate curves (Figure 7).

These curves show that a decrease in steel hardness and an increase in flow velocity increased the mass losses and erosion rates. These results are consistent with the expectation and investigation obtained by Kahraman et al. [6]. The decrease in steel hardness by 34.2 HV as a result of thermal treatment caused an increase in mass loss after the entire tests by about 43 mg to about 49.7 mg, depending on the test conditions. Thus, the high impact of the hardness of this steel on the erosion resistance was confirmed, although the tests carried out were tests of cavitation erosion, not slurry. However, an

increase in flow velocity did not cause a proportional increase in mass loss of the tested steel, either in the as-received state or after thermal treatment (Figure 6). Moreover, the shape of the cavitation erosion curves indicates the different degradation processes. In the case of the S235JR-AR steel, the cavitation erosion curves indicate two main erosion periods: the first one lasting about 300 min and the second starting from about 360 min. While in the case of the S235JR-TT steel after thermal treatment, the mass losses increased more or less evenly throughout the cavitation erosion tests. This also confirms a high effect of the hardness of this steel on the degradation process.

In the case of the cavitation erosion tests conducted at the highest flow velocity of 43 m/s, the hardness of the S235JR-AR steel increased up to 194 HV at a depth of 35 μm, but the maximum value was 197 HV at a depth of 235 μm (Figure 10a). Such a hardness peak underneath the surface was also obtained in the tests of Fe–Cr–Ni–Mn stainless steels [19,20]. This makes that the maximum strain hardening effect determined from Equation (1) was 10% at a depth of 235 μm (Figure 10b). Moreover, the hardening effect was noted down to a depth of 4 mm. In the case of the S235JR-TT steel tested for resistance to cavitation erosion in these conditions, the maximum increase in hardness was only about 8% (157 HV) at a depth of 235 μm and the hardening effect was noted down to a depth of 2.5 mm. Thus, the initial hardness of the steel prior to the cavitation test had an effect on the hardenability. Steel with lower initial hardness underwent less hardening, and steel with higher initial hardness - stronger. Moreover, as the strengthening of the surface layer increased, the mass loss (Figure 6) and the erosion rate (Figure 7) decreased.

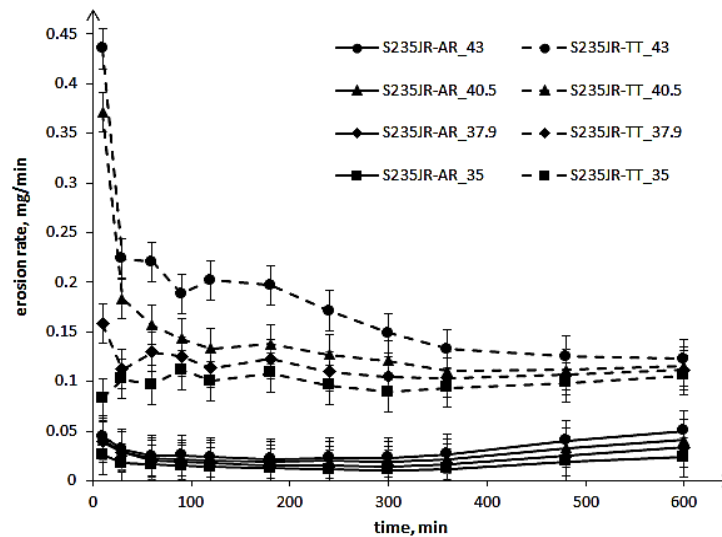
Figure 7. Cavitation erosion rate curves of S235JR steel in as-received state and after thermal treatment.

Figure 7 shows that the mass loss of the tested steel started with a high erosion rate, regardless of the steel hardness. Only the thermal-treated steel tested at 35 m/s failed this rule. After reaching the maximum value, the erosion rate decreased. In the case of the S235JR-AR steel, the erosion rate decreased only until about 180 min of testing. After that, the erosion rate increased. In the case of S235JR-TT steel, the most rapid decrease in erosion rate occurred during the initial 30 min and then the erosion rate decreased more

slowly. The period of erosion rate decrease depended on the flow velocity. In the case of the tests carried out at 35 m/s and 37.9 m/s, this period lasted until about 300 min and then the erosion rate slightly increased. In the case of the tests carried out at 40.5 m/s, the period of the erosion rate decrease lasted until about 360 min. While in the case of the tests carried out at 43 m/s, this period lasted until the end of the test, but after 360 min of testing, this decrease was much slower. Figure 7 also shows that the greatest difference in erosion rate was at the start of the study to approximately 180 min, and as the duration of the study increased, the difference in erosion rate decreased. Thus, the influence of steel hardness on the erosion rate decreased with the duration of the tests. This indicates changes in the structure and properties of the tested steel, i.e., hardness, as a result of impacting the micro-jets formed during the implosion of cavitation bubbles.

In the case of cavitation and slurry erosion, degradation occurs as a result of repeated impacts. The erosion curves (Figures 7 and 9) show changes in the properties of

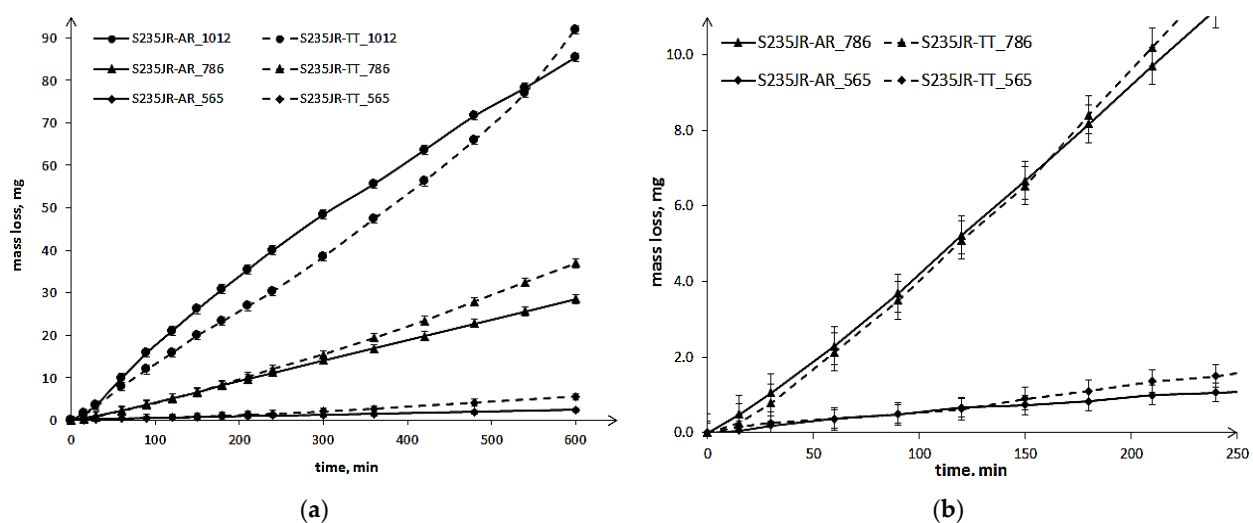
Figure 8. Slurry erosion curves of S235JR-AR and S235JR-TT steels: (a) full test duration, (b) initial 250 min of testing steels at 786 and 565 rpm

The results of slurry erosion tests are shown in the form of the erosion and erosion rate curves (Figures 8 and 9, respectively). The maximum mass losses obtained in the tests carried out with the highest rotational speed of 1012 rpm (Figure 8) are slightly higher than those obtained in cavitation erosion tests, i.e., tests performed at a flow velocity of 43 m/s (Figure 6). This indicates that the maximum rotational speed was chosen correctly. The mass losses increased along with the increase in rotational speed. The increase from 565 rpm to 786 rpm resulted in more than a 12-fold increase in the mass loss of the as-received steel, while a further increase in speed to 1012 rpm only resulted in an almost 3-fold increase. In the case of thermal-treated steel, the increase in rotational speed caused a 6.7-fold and 2.5-fold increase in mass loss, respectively. Thus, the influence of steel hardness on the mass losses is visible. Nevertheless, the slurry erosion curves have a completely different shape than the cavitation erosion curves. Moreover, in the initial periods of tests, a decrease in mass loss was noted for steel after thermal treatment with lower hardness compared to steel in the as-received state with higher hardness. However, after some time of testing, the mass losses of S235JR-TT steel became greater. The duration of the test, in which the mass loss of the S235JR-TT steel became greater than that of the S235JR-AR steel, increased with increasing rotational speed, which was unexpected. The obtained results, especially a decrease in mass loss of the steel with lower hardness, were in opposition to those obtained in cavitation erosion tests and by Kahraman et al. [6], who also tested the resistance of this steel to slurry erosion.

In the case of the tests performed at 565 rpm and 786 rpm, the mass loss difference in the initial period was very slightly, in fact, it was in the measurement error. The increase in mass loss of the S235JR-TT steel in relation to the S235JR-AR steel occurred after 120 min and 160 min, respectively, and then this difference increased. For tests performed at the highest rotational speed (1012 rpm), this difference in mass losses was already significant. The highest (10 mg) occurred between 240 and 300 min of testing. The time when the mass loss of the S235JR-TT steel become bigger than that of the S235JR-AR steel was about 550 min. Thus, the difference in mass losses of S235JR-TT steel and S235JR-AR steel, and the test duration, when the mass loss of the S235JR-TT steel become bigger than for the S235JR-AR, increased with increasing rotational speed.

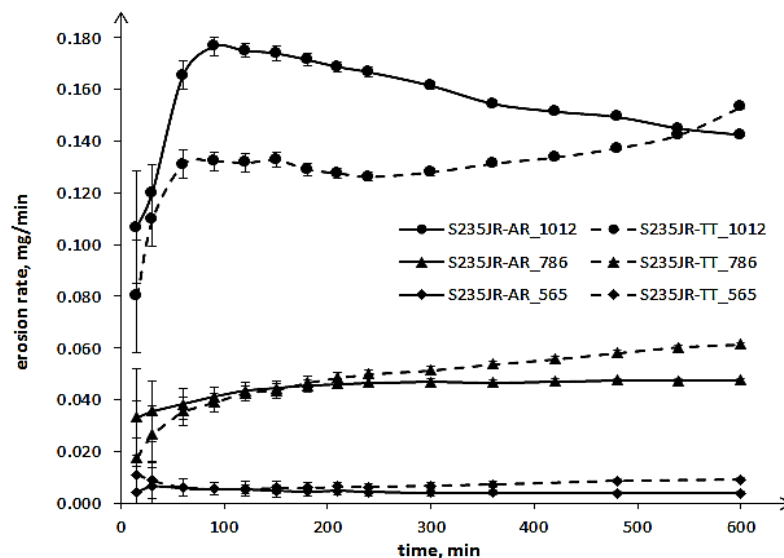
Figure 9. Cavitation erosion rate curves of S235JR steel in as-received state and after thermal treatment.

The influence of thermal treatment on the degradation process is more visible when analysing erosion rates (Figure 9). In the case of tests performed at 565 rpm and 786 rpm, the erosion rate of the S235JR-AR steel increased to the maximum value that remained unchanged until the end of the tests. In the case of the S235JR-TT steel, such a stable erosion rate was not observed. Thus, the lower hardness of the S235JR-TT steel and changes in the structure caused by the action of erodents made it impossible for this steel to achieve a stable erosion rate. The erosion rates increased through the entire tests, but the intensity of this increase was related to rotational speed.

In the case of tests performed at 1012 rpm, the erosion rate of the S235JR-AR steel increased to the maximum value, which was obtained after 90 min of testing, and then decreased. The process of erosion rate decrease lasted until the end of the test. The decrease in erosion rate was likely caused by a surface layer hardness increase. In the case of S235JR-TT steel, the erosion rate increased rapidly during the first 60 min of testing, then it slightly decreased. After 240 min, the erosion rate increased again, but after about 480 min, this increase accelerated. This shape of the erosion rate curve indicates that the surface strain hardening process did not occur or was very small, despite the low hardness of this steel. The high intensity of the dynamic loading probably caused a much faster crack growth than the strain hardening of this mild steel. Thus, the steel hardness and the intensity of loading strongly influenced the degradation mechanism.

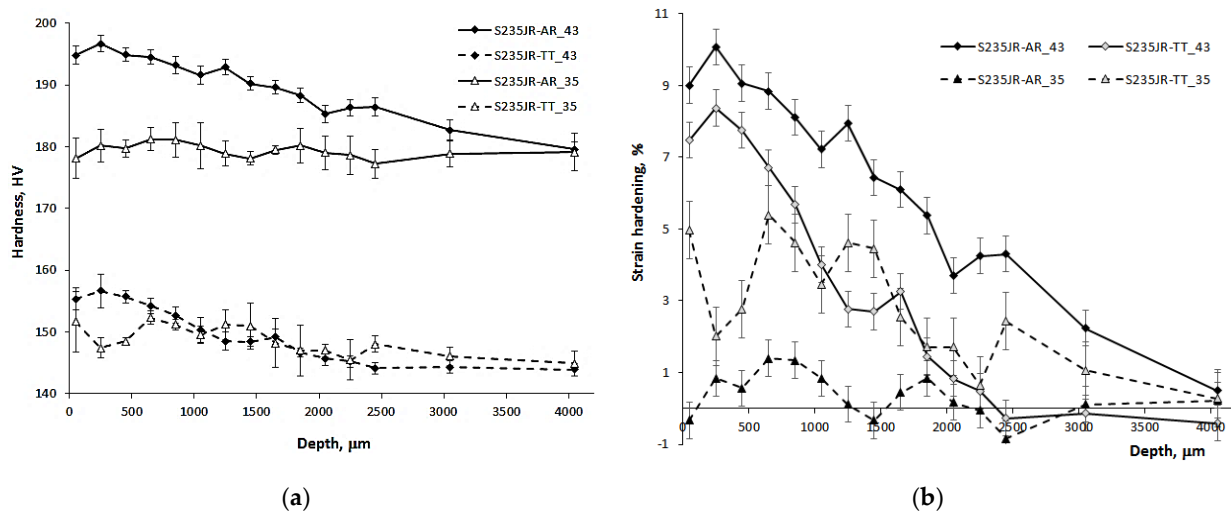
Figure 10. Hardness (a) and strain hardening effect (b) along the specimen depth caused by cavitation

Although mass losses of S235JR-AR steel tested at the highest erosion intensity were comparable, the surface hardness changes and the hardening effect were different (Figures 10 and 11). The effect of cavitation on surface hardness was more pronounced than that of the slurry. This is evidence of the different degradation mechanisms involved in any erosion process.

depth of 35 μm . With increasing depth, hardening ranged from 2% to 5%. The total depth of hardening was 4 mm. Thus, at the flow velocity of 35 m/s, the supplied impact energy resulted in the opposite development of the degradation process to that at the flow velocity of 43 m/s. This is due to a change in the distribution of the cavitation load - the number of high-amplitude pulses and the number of low-amplitude pulses. In the case of harder S235JR-AR steel, only the initiation and growth of cracks leading to mass loss was noted. It was caused by high-amplitude pulses, low-amplitude pulses were not able to cause any effect because of high hardness of the tested steel. Meanwhile, in the S235JR-TT steel with a lower hardness, strain hardening was also noted despite greater mass loss (Figure 6). Strain hardening was likely an effect of large number of low-amplitude pulses and low hardness of the tested steel.

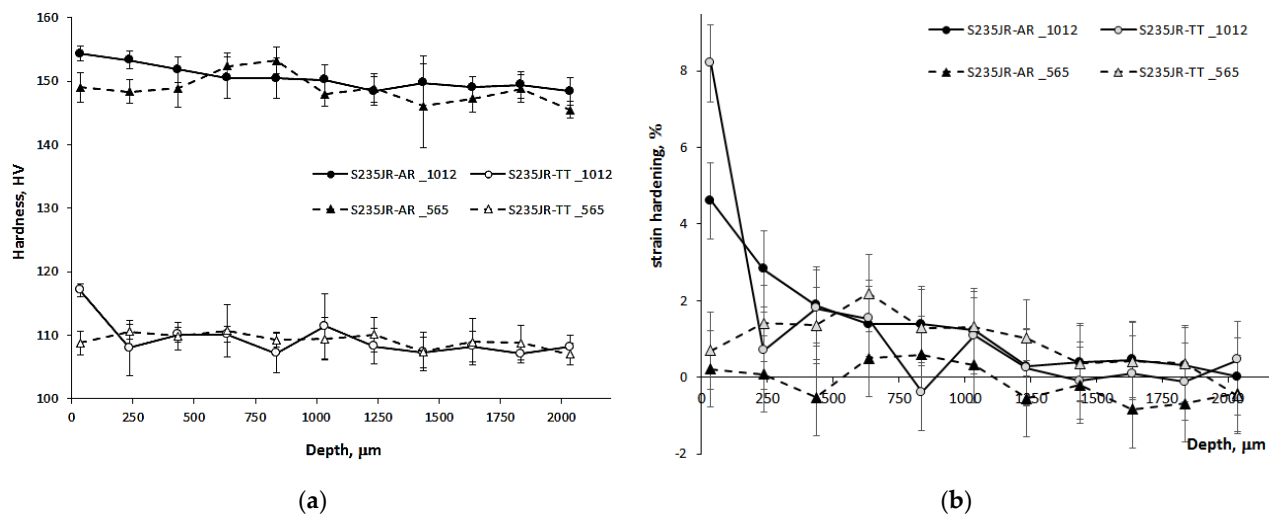
Figure 11. Hardness (a) and strain hardening effect (b) along the specimen depth caused by slurry

In the case of the slurry erosion tests performed at the highest rotational speed of 1012 rpm, the hardness of the as-received steel and the thermally treated steel increased to about 159 HV and 120 HV at a depth of 35 μm (Figure 11a). Thus, the strain hardening effect was about 5% and 8%, respectively (Figure 11b). This indicates that a higher strain hardening effect was obtained for the thermally treated steel, which had lower initial hardness. This effect was in opposition to that obtained during cavitation erosion tests at the flow velocity of 43 m/s. Moreover, the strain hardening of the as-received steel was much lower than that obtained in cavitation erosion tests, while the thermally treated steel was comparable to that obtained in cavitation erosion tests (Figure 10b). The depth of strain hardening was about 1800 μm and 1400 μm , respectively. However, the biggest decrease in strain hardening occurred at a distance of about 200 μm (from 8.2% at 35 μm to 0.7% at 235 μm). These depths are much smaller than those obtained in cavitation tests (about 4 mm). This indicates the different degradation mechanism. In cavitation erosion, cavitation pulses impact the surface with a wide range of amplitudes, from a few kPa to GPa. In slurry erosion, all erodents impact with comparable energy, so the dispersion of impact energy is small. Due to the high rotational speed, which influenced the high impact velocity, the impact energy is used mainly on the initiation and development of cracks, resulting in a significant mass loss and less strain hardening than in the case of cavitation erosion, where low energy impacts also occurred.

In the case of tests carried out at the lowest slurry erosion intensity, i.e., at a rotational speed of 565 rpm, the hardness of the S235JR-AR steel at a depth of 35 μm was about 152 HV. It means that the hardness increase did not occur. All changes in hardness oscillated around the initial value. In the case of S235JR-TT steel, the impacts of solid

particles caused a slight increase in hardness to about 112 HV at a depth of 35 μm . The strain hardening effect was about 1%. The highest hardness (113.4 HV) was obtained at a depth of 635 μm . This makes that strain hardening increased to 2.2%. Then, hardness decreased to an initial value that was reached at a depth of about 1800 μm . Thus, the depth of strain hardening was bigger than in the tests performed at the highest rotational speed. The likely reason for this was the lower impact energy supplied by erodents to the steel surface that caused significant less mass loss and much less removal of the hardened layer.

speed increases, this interaction is likely to increase. A low depth of strain hardening at the highest rotational speeds (Figure 11) is consistent with the assumption that the particles interact with each other.

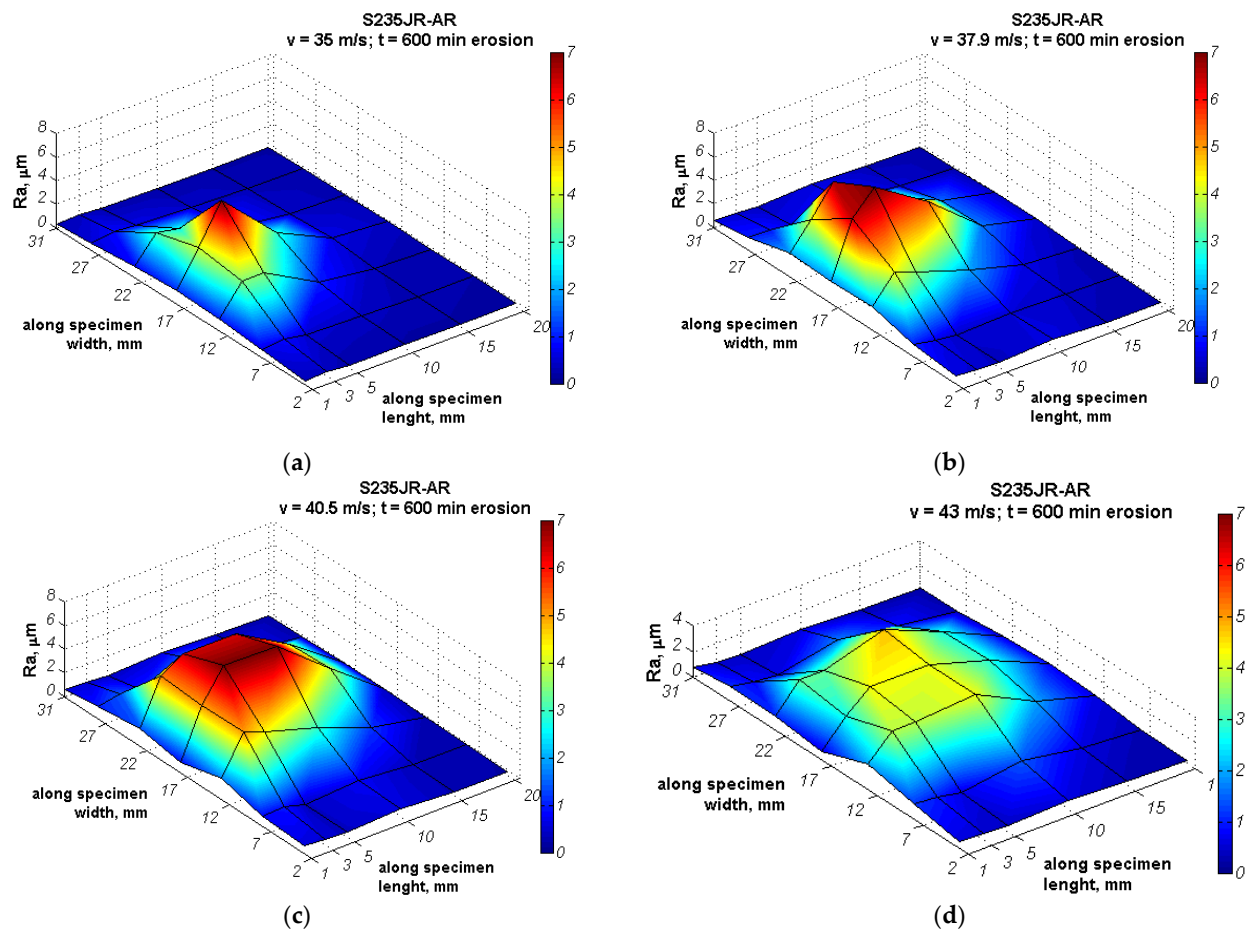
Figure 12. Distribution of the Ra parameter on the surface of the S235JR-AR steel tested for resistance to cavitation erosion at a flow velocity of (a) 35 m/s, (b) 37.9 m/s, (c) 40.5 m/s and (d) 43 m/s.

Roughness measurements of specimens tested in cavitation erosion tests revealed areas of high roughness $Ra > 5 \mu\text{m}$ that are at approximately half the width of the

specimens close to the upper barricade (Figures 12 and 13), regardless of the hardness of the tested steel (steel state) and the flow velocity. With increasing flow velocity, the area with $R_a > 1 \mu\text{m}$ also increases, but it is not followed by the increase in the maximum roughness value. Also, the distribution of R_a parameters changed its character depending on the flow velocity. In the case of tests conducted at a flow velocity of 35 m/s, the maximum R_a value was $7.38 \pm 0.16 \mu\text{m}$ and $8.71 \pm 0.21 \mu\text{m}$, respectively for S235JR-AR and S235JR-TT steel. Thus, higher roughness was obtained on softer steel. The surface roughness increased rapidly to a maximum value, which was reached 5 mm from the specimen edge nearest to the upper barricade, and then decreased, regardless of the steel state. However, the rate of decrease in roughness was related to the hardness of the steel. In the case of softer steel after thermal treatment, this rate was lower. Although the maximum surface roughness had higher values, the roughness (R_a parameter) of less than $1 \mu\text{m}$ was only recorded at a distance of 20 mm from the upper barricade. Nevertheless, in both steel states, the roughness distribution formed a sharp peak.

For the tests carried out at a flow velocity of 37.9 m/s, the maximum R_a value was $8.47 \pm 0.15 \mu\text{m}$ and $11.60 \pm 0.27 \mu\text{m}$, respectively (Figures 12b and 13b). Thus, the maximum R_a value increased $1 \mu\text{m}$ and nearly $3 \mu\text{m}$, respectively. Moreover, the area with $R_a > 2 \mu\text{m}$ increased significantly. The roughness peak was still obtained and located 5 mm from the upper barricade. The roughness peak was sharp in S235JR-TT steel (Figure 13b), while slight in S235JR-AR steel (Figure 12b). Moreover, the eroded surface with $R_a > 6 \mu\text{m}$ formed a large area indicating a zone of high erosion level.

In the case of tests carried out at a flow velocity of 43 m/s, surface roughness decreased even more (Figures 12d and 13d). The maximum Ra values were $4.31 \pm 0.11 \mu\text{m}$ and $5.48 \pm 0.12 \mu\text{m}$, respectively. Thus, the Ra parameter decreased by nearly $3.5 \mu\text{m}$ and $4 \mu\text{m}$, respectively. Besides, the Ra parameters were lower than those obtained in the tests carried out at the lowest flow velocity. This decrease was caused by the effect of overlapping damages. The surface with the highest surface roughness formed a large, flattened area with a comparable erosion level. The conducted tests showed that the steel of lower hardness was characterized by higher roughness regardless of the flow velocity. This is in agreement with the mass losses and erosion rates.

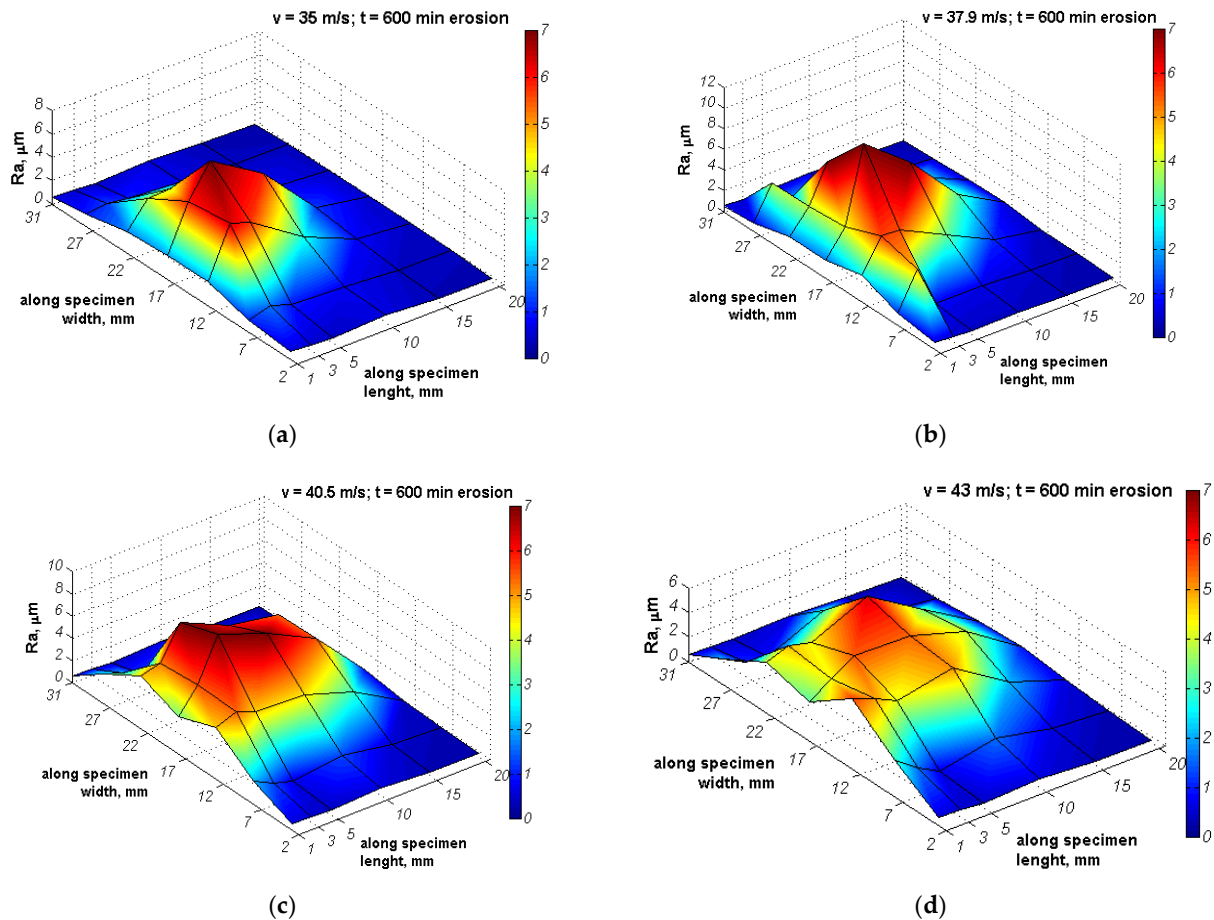
Figure 13. Distribution of the R_a parameter on the surface of the S235JR-TT steel tested for resistance to cavitation erosion at a flow velocity of (a) 35 m/s, (b) 37.9 m/s, (c) 40.5 m/s and (d) 43 m/s.

A further increase in a flow velocity to 40.5 m/s caused an increase in the area with $Ra > 2 \mu\text{m}$. However, the roughness values lowered concerning those obtained at a flow velocity of 37.9 m/s. The maximum Ra values of S235JR-AR and S235JR-TT steel were $7.71 \pm 0.19 \mu\text{m}$ and $9.38 \pm 0.28 \mu\text{m}$, respectively. Thus, the maximum Ra value decreased by nearly $0.8 \mu\text{m}$ and over $2 \mu\text{m}$, respectively. Considering that with increasing flow velocity the mass loss also increased (Figure 6), a decrease in surface roughness was caused likely by overlapping damages. However, the surface with $Ra > 6 \mu\text{m}$ increased without any roughness peaks indicating a comparable erosion level.

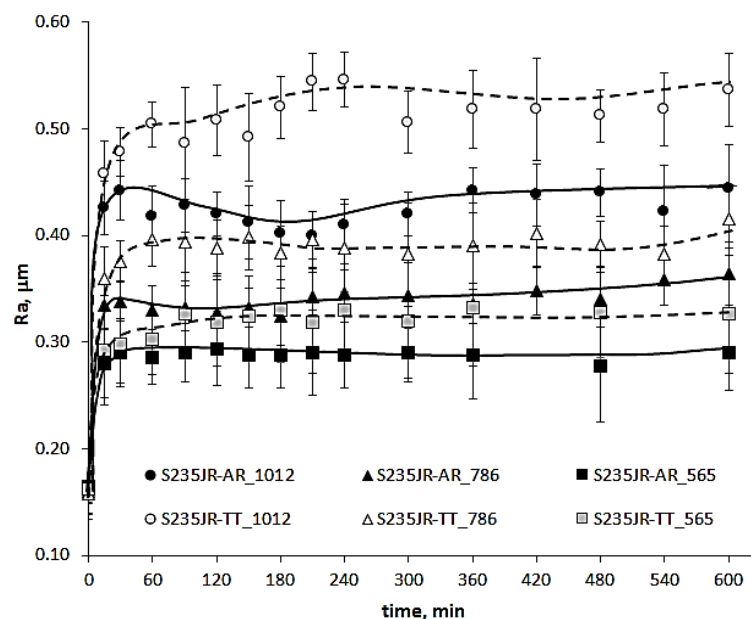
Figure 14. Development of surface roughness (Ra parameter) during slurry tests.

Slurry erosion tests also caused an increase in surface roughness (Figure 14). The highest increase took place during the first 60 min of testing. After reaching the maximum value, the Ra parameter remained stable until the end of the tests. The obtained fluctuations result from the nature of the roughness measurement and should be disregarded in further analysis. The S235JR-TT steel with lower hardness had higher Ra parameters, regardless of the test conditions. This result is comparable to the result obtained in cavitation erosion. Nevertheless, the highest Ra parameters were much lower than those obtained in cavitation erosion tests. In the case of the tests carried out at a rotational speed of 565 rpm, the Ra parameters of S235JR-AR steel and S235JR-TT steel after the entire tests were $0.29 \pm 0.04 \mu\text{m}$ and $0.33 \pm 0.06 \mu\text{m}$, respectively. In the case of the tests performed at a rotational speed of 786 rpm and 1012 rpm, the Ra parameters were $0.36 \pm 0.03 \mu\text{m}$ and $0.42 \pm 0.03 \mu\text{m}$, and $0.44 \pm 0.04 \mu\text{m}$ and $0.54 \pm 0.03 \mu\text{m}$, respectively. Thus, the Ra parameter increased with the increase of the rotational speed, as well as the difference in the surface roughness values. Thus, there was no overlapping damage effect, as was the case with cavitation erosion.

degradation is consistent with the roughness results (Figure 14). As shown in Figure 18c,d, the surface of S235JR-AR steel is slightly undulated, similar to the surface of the thermal-treated steel. However, the undulation of the latter (Figure 18d) seems to be bigger. Yet, the surface looks much smoother. There is no flaking, but pits and short cracks. The number and size of pits depend on the steel state. In the case of the as-received state, pits are much smaller, but their number is much bigger than on the surface of S235JR-TT steel (Figure 18c,d). The pit seen in Figure 18d was likely due to steel removal and not shearing as with cavitation erosion.

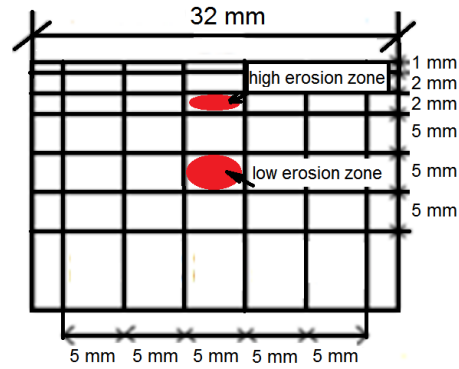
Figure 15. The observation areas of damage developed on the surface of S235JR steel during cavitation erosion tests.

Based on the roughness measurements, the zones of low and high erosion in cavitation tests were determined and showed in Figure 15. The surface damages of the S235JR-AR and S235JR-TT steels developed during tests performed at the lowest (35 m/s) and highest (43 m/s) flow velocity in these zones are shown in Figures 16 and 17, respectively.

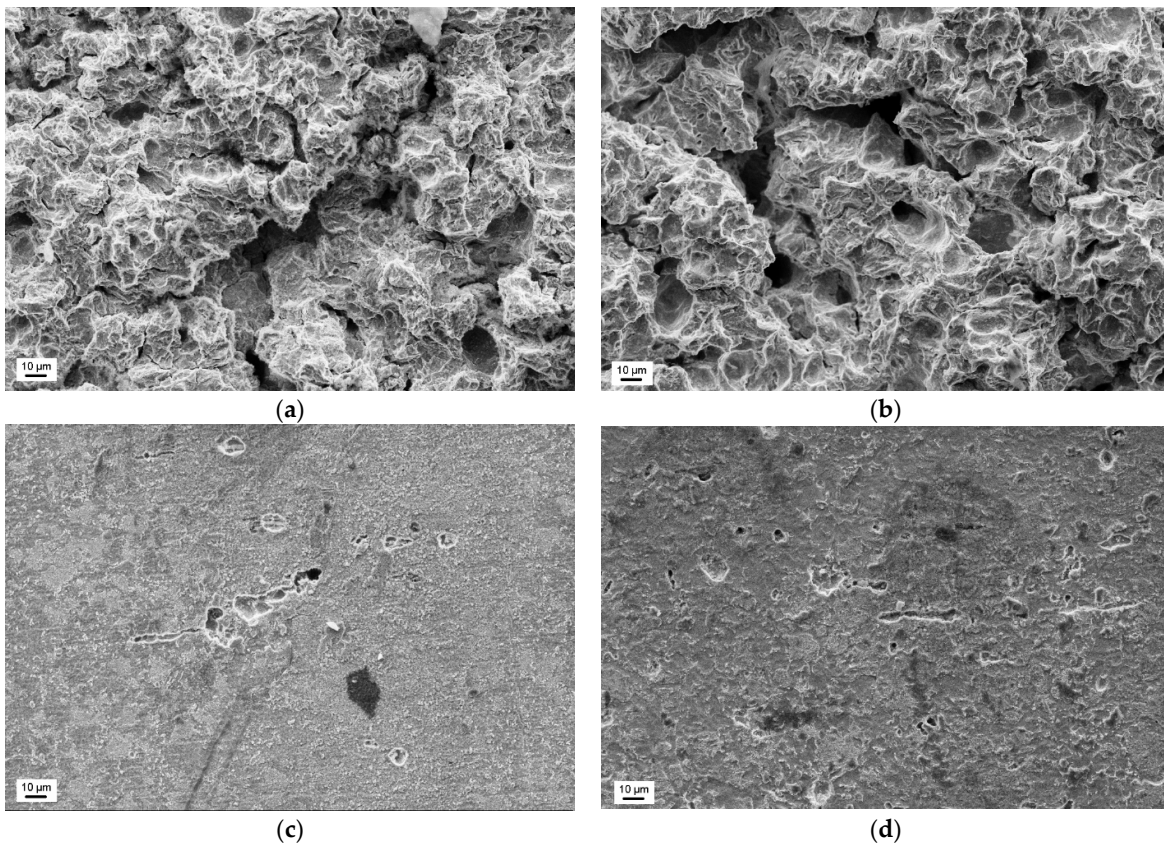
Figure 16. Surface damages developed during cavitation erosion tests carried out at a flow velocity of 35 m/s in the high erosion zone of (a) S235JR-AR steel and (b) S235JR-TT steel, and in the low erosion zone of (c) S235JR-AR steel and (d) S235JR-TT steel.

Damages to the surface of hard S235JR-AR and soft S235JR-TT steels in the strongly eroded zone and tested at a flow velocity of 35 m/s have the form of pits or so-called

cavitation tunnels, voids and cracks developing in a ductile mode (Figure 16a,b). Cracks are a bit wider for soft S235JR-TT steel, indicating the effect of the steel hardness. Although the diameter of some voids or pits can be determined, all damages overlapped. Besides, the damage mentioned above is greater for soft S235JR-TT steel, which complies with the roughness measurements (Figures 12 and 13) and steel hardness. Ductile fracture is in line with the steel grade (low carbon steel) and low hardness (178.7 ± 3.5 HV and 144.5 ± 2.9 HV, respectively) and ferritic-pearlitic structure. In the case of the low erosion zone (Figure 16c,d), the damage is mainly in the form of pitting, but several short cracks are also observed. The damage density is much lower on the surface of the S235JR-AR steel, which had a higher hardness. The pits are well seen and can be divided into two groups: the first with a diameter up to $10 \mu\text{m}$ and the second with a bigger diameter (above $10 \mu\text{m}$). The pits of the first group are much deeper than those of the second. This indicates that the pitting of the first group was the result of shearing by micro-jets impacted at high speed. Such pits do not occur on the surface of hard S235JR-AR steel. Considering that the tests were carried out at the same condition, the S235JR-AR was more resistant to such impacts because of steel hardness.

case with cavitation erosion (Figures 16 and 17), contributed to a constant increase in roughness, not its decrease as in cavitation erosion.

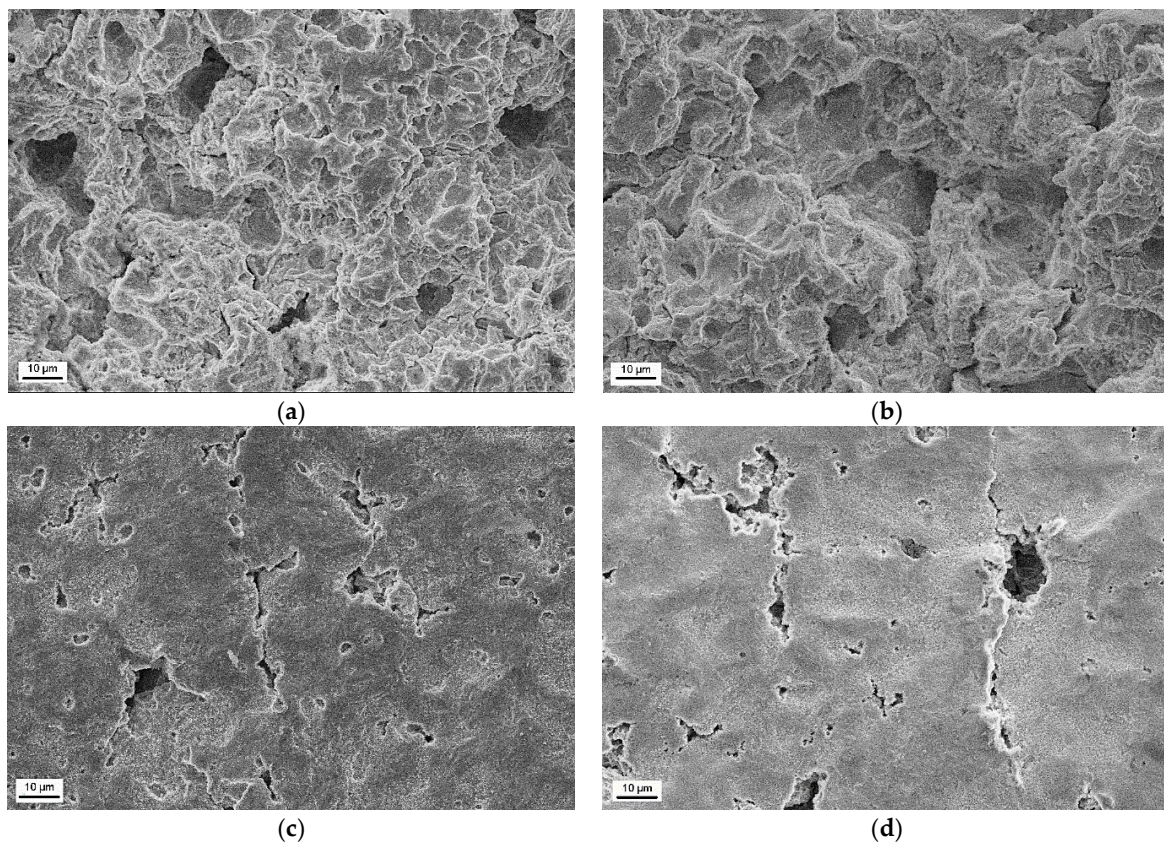
Figure 17. Surface damages developed during cavitation erosion tests carried out at a flow velocity of 43 m/s in the high erosion zone of (a) S235JR-AR steel and (b) S235JR-TT steel, and in the low erosion zone of (c) S235JR-AR steel and (d) S235JR-TT steel.

Damages on the surface of S235JR-AR and S235JR-TT steel in the strongly eroded zone and tested at a flow velocity of 43 m/s also have the form of ductile cracks, cavitation pits/tunnels and voids (Figure 17a,b). Thus, all these failures are typical of this steel and this erosion process. Nevertheless, the intensity of cavitation affected the number and width of the cracks, which are much narrower than those observed at a flow rate of 35 m/s. The diameter of some pits/cavitation tunnels in hard S235JR-AR steel ranges from about $10 \mu\text{m}$ to $20 \mu\text{m}$ (Figure 17a), but such pits are not seen in soft

S235JR-TT steel (Figure 17b). It is related to the hardness of the steel and the mass losses. Taking into account the greater loss of mass on the S235JR-TT steel in the cavitation test, the most likely reason for the lack of such pitting is the removal of such a heavily damaged surface layer. On the other hand, the damage size of the steel as received is smaller than that of thermal-treated steel, which is consistent with the hardness measurements (Figure 10). Also, more severe damage developed during tests with a flow velocity of 35 m/s is consistent with the hardness measurements. Moreover, the observation of the degree of destruction of S235JR steel in both states is consistent with the roughness measurements (Figures 12 and 13).

In the case of the low erosion zone (Figure 17c,d), the damage is mainly in the form of pitting, but several cracks and surface undulation are also observed. The cracks are likely developed along the grain boundaries. The length and width of cracks, as well as the size of pits, are much bigger for the thermal-treated steel. The pits were caused by shearing due to the impacts of high-velocity micro-jets. The bigger size of pits indicates that this steel is more susceptible to such impacts. However, damage density is much bigger for steel in the as-received state. The lower size of pits and cracks length are connected with a higher hardness of this steel.

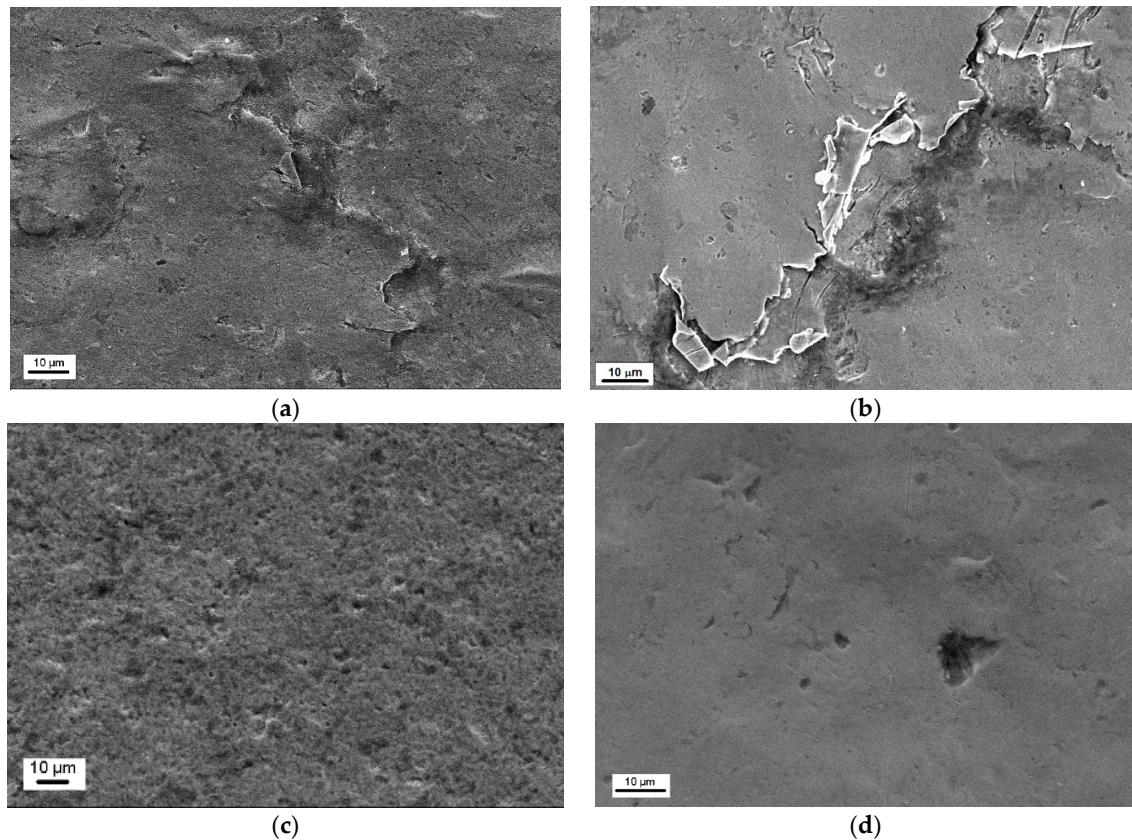
Figure 18. Surface damages developed during slurry erosion tests carried out at a rotational speed of 1012 rpm in (a) S235JR-AR steel and (b) S235JR-TT steel, and at a rotational speed of 565 rpm in (c) S235JR-AR steel and (d) S235JR-TT steel.

The damage from slurry erosion testing is completely different (Figure 18). In the case of tests carried out at a rotational speed of 1012 rpm (Figure 18a,b), flaking and undulation of the surface are visible, regardless of the steel state. There are also some tiny and shallow pits. The surface is much less degraded concerning that developed in cavitation tests (Figures 16 and 17). The level of surface degradation is consistent with the roughness results (Figure 14). Also, damage developed at a rotational speed of 565 rpm

In the case of slurry erosion tests, a linear increase in surface roughness with increasing rotational speed was obtained (Figure 21b). This correlation was independent of the steel hardness. A similar correlation was obtained by Abedini et al. [40]. As in the case of cavitation erosion, higher Ra values were obtained for thermally treated steel that had lower hardness. Besides, the difference between Ra values increased with increasing rotational speed. Taking into account the changes in hardness (Figure 11b), the steel after thermal treatment underwent greater strain hardening than the steel in the as-received state. However, the surface roughness did not follow it. This was likely caused by more intensive mass loss (Figure 8). The lack of overlapping damage (Figure 18), as was the

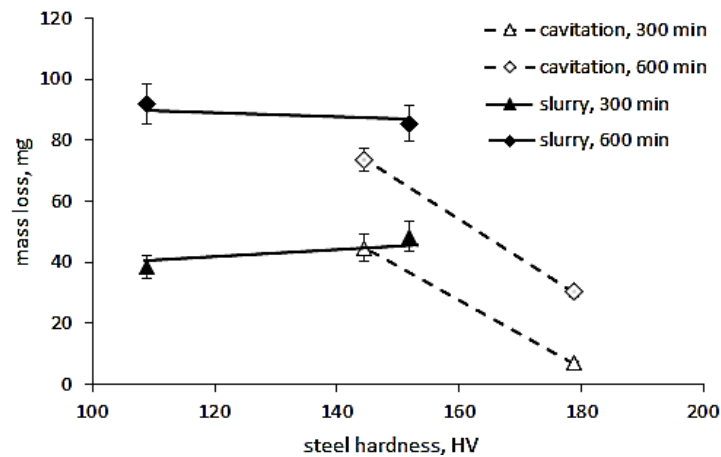
Figure 19. The effect of steel hardness on mass loss.

The performed thermal treatment of the tested steel decreased the hardness by over 30 HV and allowed learning the impact of steel hardness on the resistance of S235JR steel to cavitation and slurry erosion. According to the test results obtained by Hammit [21], Kwok et al. [22] and Rajput et al. [23], resistance to cavitation erosion increases exponentially with increasing hardness. Similar correlation occurs for slurry. Sheldon [24] and Desale et al. [25,26] obtained that resistance to slurry erosion increases exponentially with increasing hardness. Based on the data obtained by Kwok et al. [22] and Rajput et al. [23], this exponent is close to 3. However, when this exponent was determined on the basis of the results obtained by Baghel et al. [27], it was close to 1, while Moore's [28] - to 0.4. Nevertheless, the exponent can range from about 0.5 to over 3 in both types of erosion. On the other hand, investigations of titanium alloys have not confirmed this relationship either in cavitation erosion or in slurry [1], as well as tests of X10CrAlSi18 steel annealed at different temperatures [29]. Slurry tests of aluminum, copper, carbon steels and stainless steels confirmed that material hardness and impact velocity affect the erosion rate [30]. However, no clear single trend of change was achieved. Depending on the tested materials with a given hardness range, the erosion rate may decrease with increasing hardness, but it may also increase, or no effect may be obtained. Kahraman et al. [6], who tested the same steel, have obtained a significant decrease in mass loss in the slurry tests with the increase in steel hardness. The results obtained in these investigations did not confirm such a relationship in the study of slurry erosion (Figure 8a), but showed a big impact of steel hardness on the mass loss in cavitation erosion tests (Figure 6). To better see the effect of steel hardness on the mass loss, a graph was made which takes into account the mass loss obtained at the highest flow velocity (43 m/s) or rotational speed (1012 rpm) after 600 min (the entire tests) and e.g., after 300 min, when the highest difference in mass losses occurred. Figure 19 shows that for S235JR steel, steel hardness strongly influenced the cavitation resistance, i.e., mass loss. The hardness change by 34 HV caused a change in the mass loss by about 40 mg (38 mg after 300 min of testing and 43 mg after the entire tests). Thus, this relationship was slightly dependent on the duration of the test. In the case of slurry tests, the decrease in hardness from 151.7 HV to 109 HV slightly affected mass loss and erosion resistance. Similarly, such a result was independent of the duration of the test. This result was unexpected in the light of the tests carried out by Kahraman et al. [6] and also by Desale et al. [25,26]. However, Oka and Yoshida [30] found that for some materials, some hardness values and specific types of erodent, there may be no change in mass loss caused by a change in the hardness of the steel. Thus, the obtained difference in hardness and mass losses shown in Figure 19 fit in with that observation. Figure 19 shows also that the steel hardness plays a much stronger influence on the mass loss in cavitation erosion resistance tests than in the case of slurry erosion.

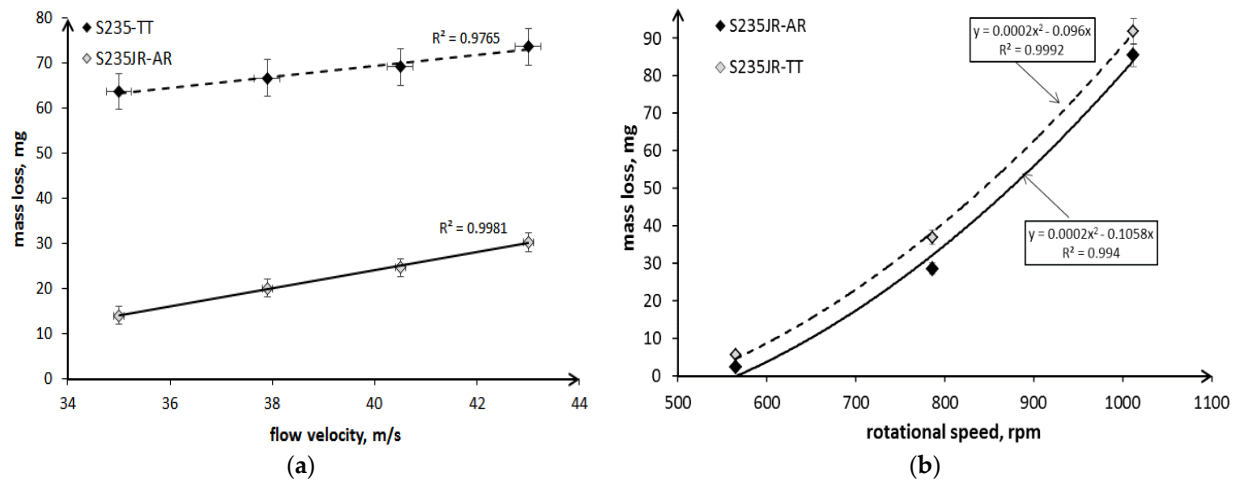
Figure 20. Correlation between the mass loss and (a) a flow velocity in cavitation erosion tests, and (b) a rotational speed in slurry erosion tests.

The other factor influencing the mass loss in cavitation and slurry erosion tests is erosion aggressiveness/intensity. In the case of cavitation erosion, the intensity of the erosion depends on the flow velocity or inlet and outlet pressures in the flow devices, e.g., in a cavitation tunnel or a cavitating jet device, and the frequency and/or amplitude of the vibrations in the vibrating device. Investigations of pure aluminum, copper, bronze, carbon steels and also stainless steels with the use of the cavitating jet apparatus showed an exponential dependence the mass losses with injection and tank pressures [31]. While, in the case of the vibrating apparatus, the relationship between vibrating amplitude and mass losses of pure aluminum and copper was linear [15,32]. In the case of slurry erosion, the impact velocity of erodents is the parameter that affects the erosion intensity and the mass loss the most [26,33–35]. Moreover, erosion rate increases exponentially with the impact velocity and an exponent is usually about 2–3 for metallic alloys, but it can also vary from 0.34 to 4.83 [35]. The correlations between the flow velocity in cavitation erosion tests or rotational speed in slurry tests and the mass loss after the entire erosion tests obtained in these investigations are shown in Figure 20. In the case of cavitation erosion tests, a linear relationship for both steel states was obtained for the tests carried out in the cavitation tunnel and flow velocities ranging from 35 m/s to 43 m/s (Figure 20a). This linear correlation is in accordance with the results obtained by Okada et al. [15] and Hattori et al. [32], although other testing materials and various apparatus were used. However, based on the results obtained by Krella [36], it can be seen that the type of correlation depends on the flow velocity range, and the linear correlation may occur above a certain threshold value of the flow velocity. Figure 20a also shows that the trend line determined for hard S235JR-AR steel is parallel to that determined for the soft steel after thermal treatment. This means that the difference in the mass losses obtained after the entire tests was comparable for all flow velocities and the character of the trend line was independent of the steel state and steel hardness.

In the case of slurry tests, for rotation speed range from 565 rpm to 1012 rpm, the best relationship is a polynomial relationship, not exponential (Figure 20b). In the case of the exponential dependence, the maximum dispersion may reach even 42% for steel in the as-received state or 17% for heat-treated steel. This indicates that the exponential relationship cannot be taken into account. The trend lines of hard S235JR-AR and soft S235JR-TT steels are parallel to each other, so the nature of the correlation does not depend on the state of the steel and steel hardness, as was the case with cavitation erosion, but on the steel grade. The other factors that may affect the relationship are the type of test device, erodent concentration and the range of rotational speed. Also, in the tests of ferritic X10CrAlSi18 steel with the use of a slurry pot, no exponential but rather a linear correlation was obtained by Krella et al. [37]. In a slurry pot, the solid particles can collide with each other, which affects the actual speed and direction of the particles. As
