Article

Effect of Thermal Treatment and Erosion Aggressiveness on Resistance of S235JR Steel to Cavitation and Slurry

Alicja K. Krella ^{1,*}, Dominika E. Zakrzewska ¹, Marta H. Buszko ¹ and Artur Marchewicz ¹

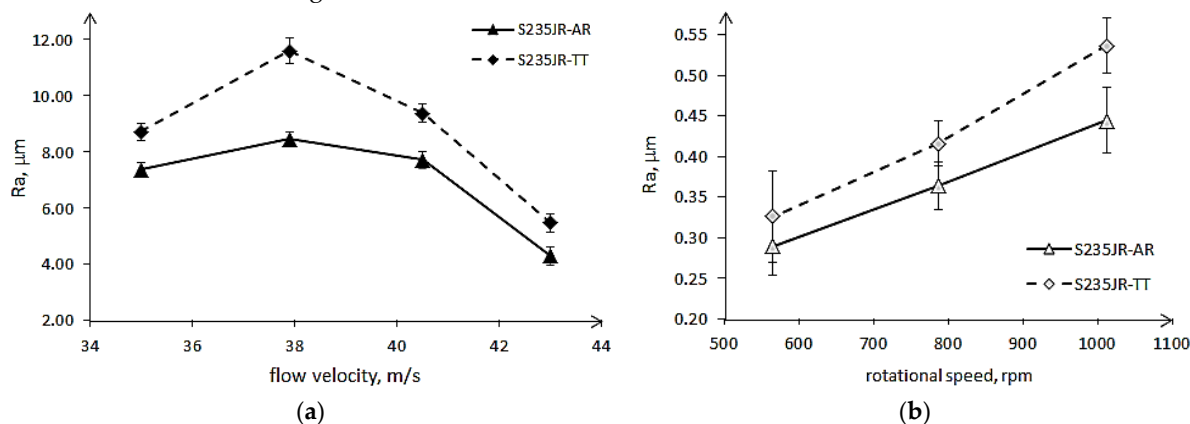
Figure 21. Correlation between (a) the maximum Ra parameter and a flow velocity in cavitation erosion tests, and (b) the mean Ra parameter and a rotational speed in slurry erosion tests.

Although erosion processes concern mainly the degradation of the material surface layer, the investigations of surface roughness development in relation to erosion intensity are not so extensive. According to Chiu et al. [38], in cavitation erosion, surface roughness (Ra parameter) increases up to limit value that is related to the steel grade with increasing testing time and then remains unchanged. However, Dojcinovic et al. [39] showed that the mean surface roughness Ra of ductile cast iron exposed to cavitation increases with testing time, although the rate of roughness change decreases. In the presented results, in cavitation erosion, surface roughness depends also on the cavitation intensity, i.e., flow velocity (Figures 12 and 13). Taking into account the maximum Ra parameter obtained on the exposed surface after 600 min of testing and flow velocity, the correlations shown in Figure 21 a are obtained. As shown in Figure 21a, the Ra parameter increases with increasing flow velocity from 35 m/s to 38 m/s, but for flow velocities greater than 38 m/s, a decrease in surface roughness with increasing flow velocity was obtained. This decrease was probably due to the strain hardening (Figure 10b), the intensive development of surface damage and an increase in overlapping damage (Figures 16 and 17). Regardless of the flow rate, higher roughness values were obtained for thermally treated steel, probably due to its lower hardness. Taking into account the strain hardening, the greater the increase in hardness the lower Ra parameter is observed only for cavitation erosion tests conducted at 43 m/s, but not at 35 m/s. Intense overlapping damage and intensive mass loss may cause a decrease in surface roughness. As a result, the surface roughness obtained at 43 m/s was lower than that obtained at 35 m/s.

In the case of slurry erosion tests, a linear increase in surface roughness with increasing rotational speed was obtained (Figure 21b). This correlation was independent of the steel hardness. A similar correlation was obtained by Abedini et al. [40]. As in the case of cavitation erosion, higher Ra values were obtained for thermally treated steel that had lower hardness. Besides, the difference between Ra values increased with increasing rotational speed. Taking into account the changes in hardness (Figure 11b), the steel after thermal treatment underwent greater strain hardening than the steel in the as-received state. However, the surface roughness did not follow it. This was likely caused by more intensive mass loss (Figure 8). The lack of overlapping damage (Figure 18), as was the
