Effect of wet Hydrogen Sulfide on Carbon Steels Degradation in Refinery Based on Case Study

Abstract

Keywords Wet H₂S corrosion · Hydrogen embrittlement · Catalytic Cracking Unit · Mechanical testing

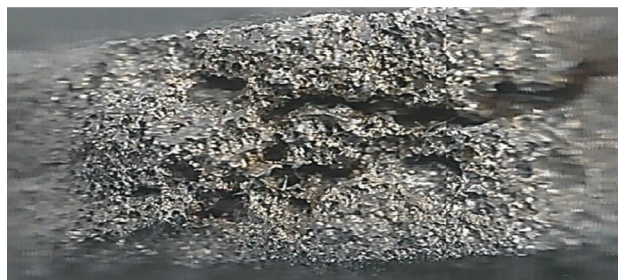
Fig. 1 Image of the corrosion coupon surface after exposition in the aqueous environment with H₂S

Mechanism wet H₂S can be observed in four different forms: blistering, hydrogen-induced cracking (HIC) and stress-oriented hydrogen-induced cracking (SOHIC) and sulfide corrosion cracking (SSC). Hydrogen blisters may be formed as a surface bulge, and HIC-, SOHIC- and SSC-based cracking processes may occur at many different depths by interconnecting cracks caused by hydrogen blisters. SOHIC is potentially more damaging appearing as arrays of cracks stacked on the top of each other. The SSC is defined as cracking of metal under combined action of tensile stress and corrosion described above. Example of HIC/SOHIC degradation by Wet H₂S is shown in Fig. 1

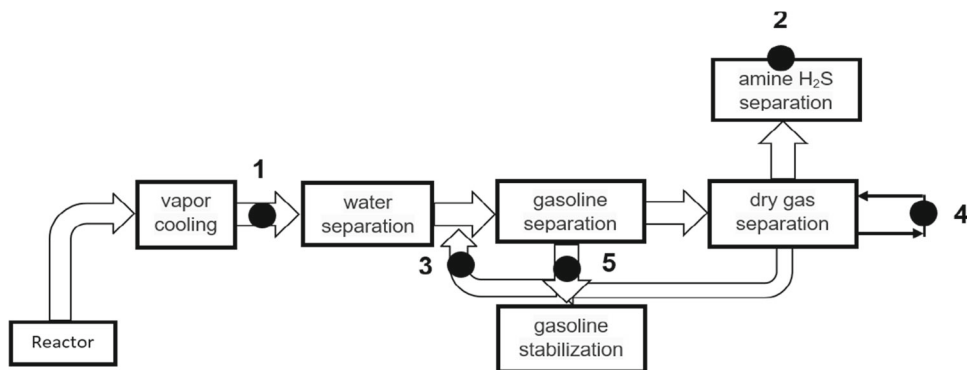
Fig. 3 The scheme of the catalytic cracking unit with marked points selected for degradation threat analysis

Corrosion monitoring was done using corrosion coupons according to G4-84 Standard [26]. The results are average value from 2 years. The results were taken from catalytic cracking unit, where 5 points were selected for analysis. The samples were taken from pipelines with diameter of 50 mm and were properly cut for mechanical and permeated hydrogen analysis. The scheme of the catalytic cracking unit with marked points of analysis is presented in Fig. 3.

There are few streams in catalytic cracking unit which can be evaluated under wet H₂S risk. The composition of those process streams (marked by points in Fig. 3) is presented in Table 2. The water environment with hydrogen sulfide was present in all fluids with potential wet H₂S mechanism existence.
