Case study

Electrolytic corrosion of water pipeline system in the remote distance from stray currents—Case study

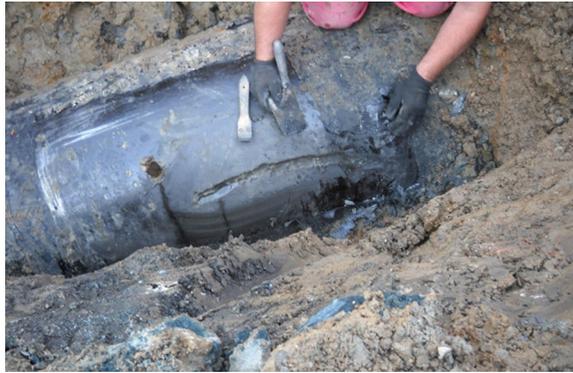
Fig. 1. View of pipeline corrosion failure.

Described corrosion damage occurred on the steel water pipe DN 300 in bitumen isolation. The age of this fragment of pipeline is estimated to be about 18 years and actual thickness of the pipe wall in the place of damage is slightly more than half of its normal thickness and it is in the range of 9–11 mm. Pipeline in the place of damage is buried in the sandy type of soil. Uncovered damage after digging out the pipeline, removing the bitumen coating and cleaning the surface is presented in Figs. 1 and 2. The failure occurred at the beginning of branching of the pipeline. The figures show the circular pipe wall perforation having a diameter of about 4 cm, containing the soil with corrosion products. On the right side of the defect, just below it, significant loss of metal within the distance of tens of centimeters and a width of approximately 3–4 cm is visible. This broad defect is probably caused by mechanical damage occurred during the mounting of water pipe system in the ground. In this wide scratch the losses of metal in the shape of circular cavities of different diameters are clearly visible. The shape of these cavities on the surface of a metal pipe wall reminiscent of the effect that would be obtained by destroying surface using drilling tool. Such losses of metal are typical for electrolytic corrosion caused by stray currents flowing from the pipe into the ground through the metal/electrolyte phase boundaries in the protective coating defects [13].

The initial diagnosis of the causes of the corrosion of water supply system based on the appearance and shape of corrosion cavities pointed to the effects of stray currents. Suspicion of such impact in this side of water supply network raised certain astonishment, due to the considerable distance from the sources of stray currents. The place of pipeline failure is 800 m away from passes under the tracks of the tram line and after next 200 m it passes under the railroad tracks.
