# Experimental investigations of damage evolution in concrete during bending by continuous micro-CT scanning

Ł. Skarżyński and J. Tejchman

Faculty of Civil and Environmental Engineering, Gdańsk University of Technology, Poland

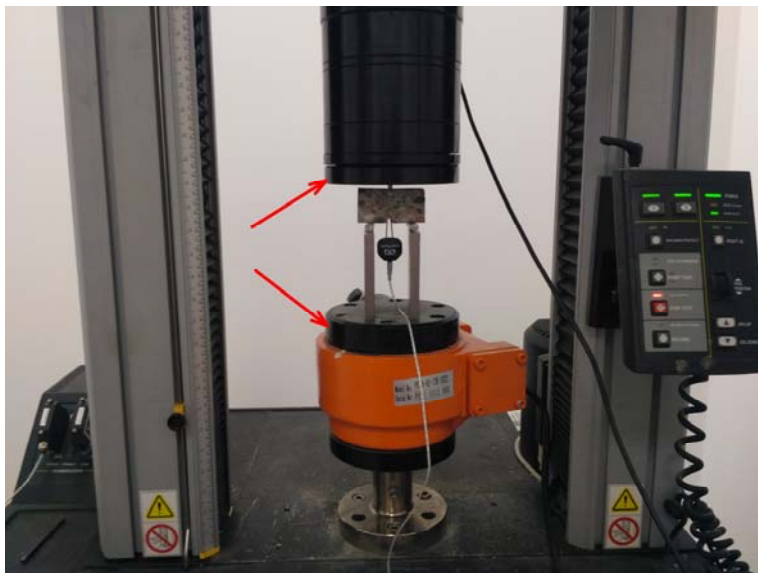
**Fig.2:** Views on micro-CT tomography system Skyscan 1173 mounted to loading machine Instron 5569: a) general view, b) rotating frame (marked with arrows) with concrete specimen prepared for bending and c) stepper motor

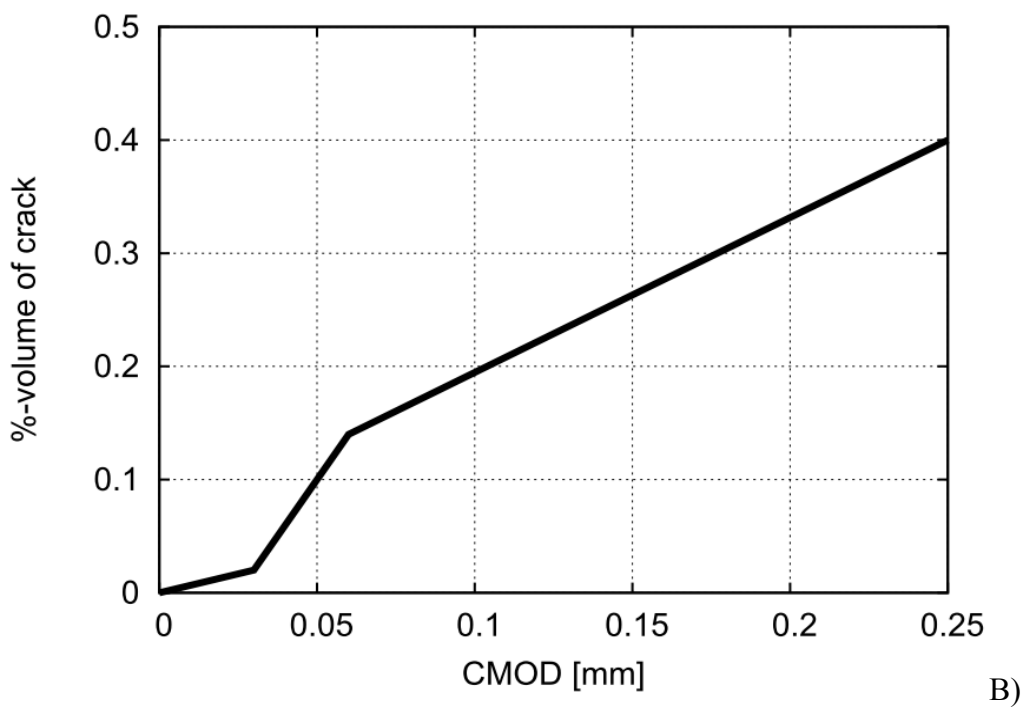
384 **Fig.13:** Relationship between %-volume and CMOD during bending for beam '3': A) pores (a)  
 385 open pores, b) closed pores and c) total pores) and B) cracks

3 Figure 13 presents the evolution of the %-volume of pores and cracks (Tab.4). The evolution of  
 4 fracture volume of cracks against CMOD (that was linearly prescribed) was composed of three clear  
 5 linear regions with the different intensity: 1) region of micro-cracks (CMOD=0-0.03 mm),  
 6 2) transitional region (CMOD=0.03-0.06 mm) and 3) region of the macro-crack formation

377 (CMOD=0.06-0.25 mm). The largest normalized crack volume's growth (expressed by %-volume  
 378 divided by CMOD) was in the transitional region.  
 379
