Gdańsk University of Technology, Poland

EXPERIMENTAL INVESTIGATIONS ON CONCRETE BEAMS REINFORCED WITH CFRP LAMELLAS

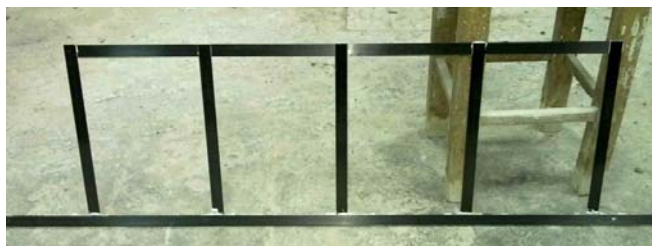
Fig. 3. Reinforcing cage before covering with sand

The reinforcement was prepared as a series of frames which were fixed together with the appropriate segments of the lamellas. The mounting material was a two-ingredient epoxy resin glue, also provided by S&P.

In order to improve the bond between the reinforcement and the concrete, the frames were covered with 1.0-2.0mm grain sand, following the application of the epoxy resin. The same epoxy resin was used for the mounting of the separate reinforcement parts. Gaps were left for strain gauges only.

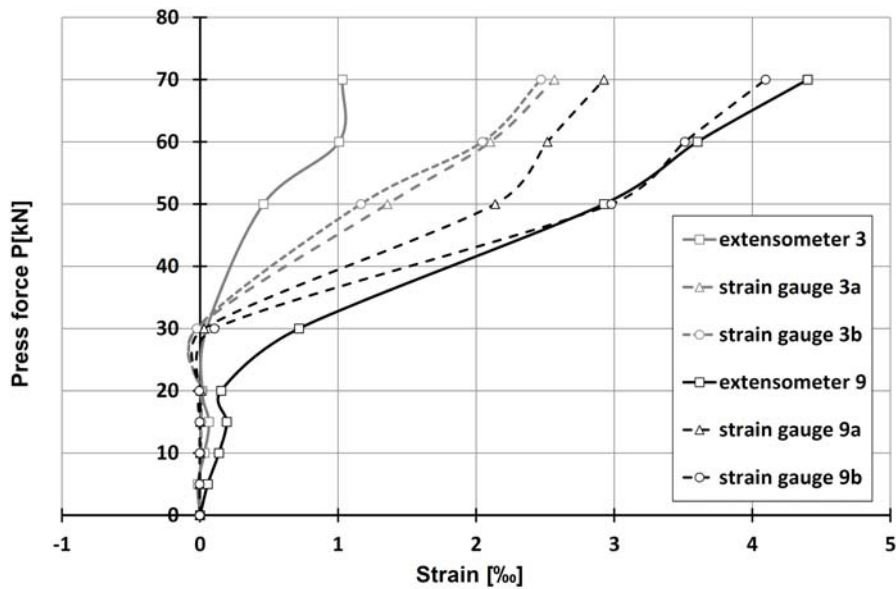
Fig. 11. Comparison of the strains as measured at the extermometers' bases with strain gauge readings for beam 2

Based on the graph above it becomes apparent that both reading methods indicated the appearance of the inclined cracks with the increase of the strains. In case of base 9 and tensometer 9 the readings are almost the same. This confirms the good collaboration between the concrete and the lateral reinforcement. Strains measured

at base 3 are lower than the ones read from the strain gauges. The difference may be a result of a different course of the main crack which did not cross base 3, as it did for base 9. The lack of the situation where the extensometer reading was higher than the strain gauges reading confirms that the slide of the vertical reinforcement did not appear.
