Experimental ultimate strength assessment of stiffened plates subjected to marine immersed corrosion

Krzysztof Woloszyk^a, Yordan Garbatov^{b,*}, Jakub Kowalski^a

^a Institute of Naval Architecture, Gdansk University of Technology, G. Narutowicza 11/12 st., Gdansk 80-233, Poland

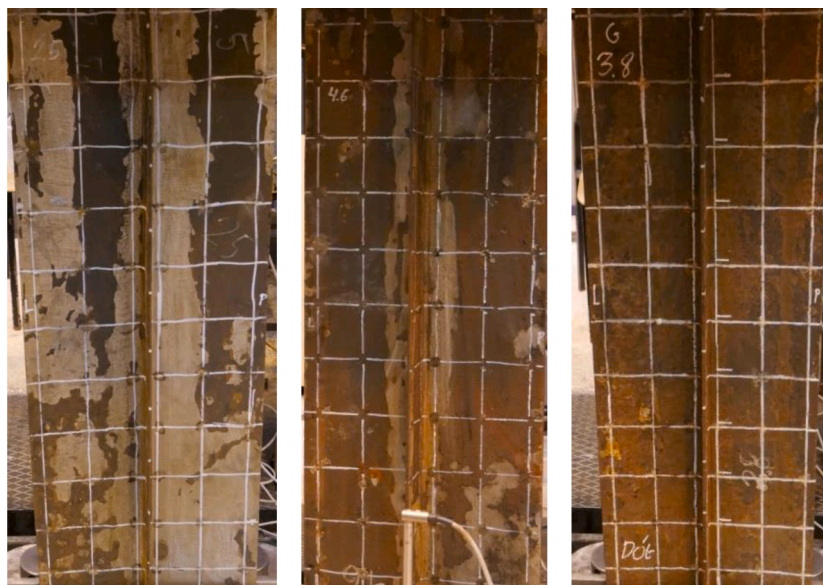
Fig. 3. Corroded stiffened plates: 2.5 mm (left); 4.6 mm (mid); 3.8 mm (right) (Woloszyk et al., 2021b).

The examples of corroded specimens are presented in Fig. 3. The thickness distribution of each specimen was measured using an ultrasonic thickness gauge in the grid points, as is visible in Fig. 3. The detailed maps with thickness distributions can be seen in Woloszyk et al. (2021b). The mean value corrosion rate was between 0.75 up to 1.15 mm/year, which shows a significant acceleration of the corrosion degradation process concerning typically observed values in the natural sea corrosion environment (Zayed et al., 2018).
