# Failure Monitoring and Condition Assessment of Steel-Concrete Adhesive Connection Using Ultrasonic Waves

Magdalena Rucka

Department of Mechanics of Materials and Structures, Faculty of Civil and Environmental Engineering, Gdansk University of Technology, Narutowicza 11/12, 80-233 Gdansk, Poland; magdalena.rucka@pg.edu.pl or mrucka@pg.edu.pl; Tel.: +48-58-347-2497

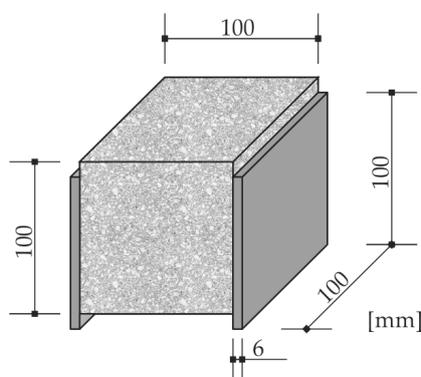
Nine steel-concrete specimens (#1 to #9) were tested in this study. Each push-out specimen consisted of two steel plates and a concrete cube (Figure 1). The plates of dimensions  $6 \times 100 \times 100 \text{ mm}^3$  were made of structural steel S235. The cube of dimensions  $100 \times 100 \times 100 \text{ mm}^3$  was made of concrete including the following ingredients: Portland cement type CEM I 42.5R ( $325 \text{ kg/m}^3$ ), sand 0–2 mm ( $764 \text{ kg/m}^3$ ), fine aggregate 2–8 mm ( $573 \text{ kg/m}^3$ ), coarse aggregate 8–16 mm ( $573 \text{ kg/m}^3$ ) and water ( $175 \text{ kg/m}^3$ ). The adhesive connection at the steel-concrete interface was made with the use of high-strength, two-component structural epoxy paste adhesive SIKADUR 30. The bonded area was  $100 \text{ mm} \times 90 \text{ mm}$  on each surface of the concrete cube and the lap-joint thickness was about 1 mm.

Figure 1. Geometry of push-out specimen.

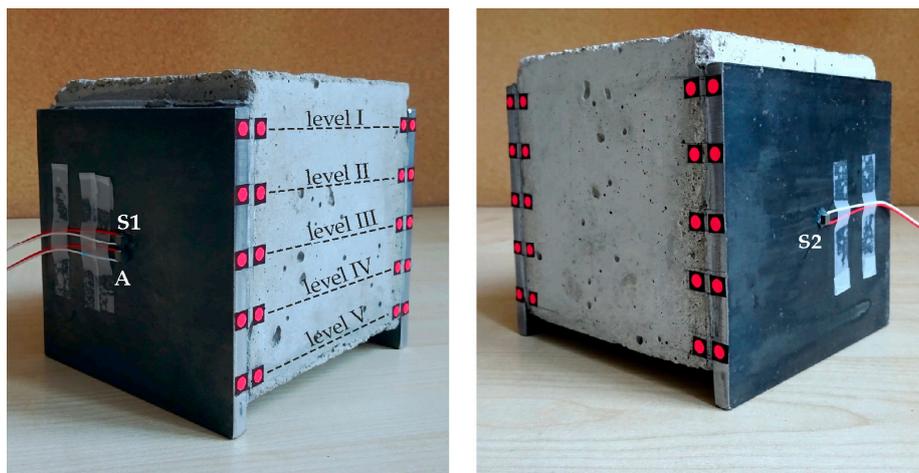
piezoelectric actuators NAC2024 manufactured by Noliac were used for both excitation and registration of wave propagation signals. They were adhesively bonded to the steel plates using petro wax (PCB 080A109). The configuration of piezoelectric transducers is given in Figure 2. The actuator (A) was bonded at the center of the left steel plate. The first sensor (S1) was attached next to the actuator, while the second one (S2) was attached at the center of the right steel plate. An arbitrary waveform generator (Tektronix AFG3022C) created an excitation signal in the form of a wave packet composed of a 5-cycle sine with a central frequency of 60 kHz modulated by the Hanning window (Figure 4). Then the signal was amplified 20 times by a high voltage amplifier (FLC Electronics AB A400DI). A digital oscilloscope (PicoScope 4824) was used to collect time signals of propagating waves with a sampling frequency of 20 MHz.

Figure 2. Steel-concrete specimen with attached piezoelectric actuator (A) and sensors (S1, S2).

Experimental procedure included simultaneous push-out and wave propagation testing. Push-out tests were performed in the testing machine Zwick Z400 equipped with a compression test kit. The force and the displacement of the cross-head were recorded. The preload applied to the specimen was equal to 100 N. Then, each steel-concrete specimen was loaded with the speed of the crosshead of 0.1 mm/min up to the failure. Additionally, photographs were taken every 2 s on the front side of the specimen by the Canon EOS 5D III digital camera to observe the damage evolution and to determine the slip between steel and concrete. At each specimen, 10 pairs of magenta points with a diameter of 4 mm were attached at five levels (levels I to V, as indicated in Figure 2).

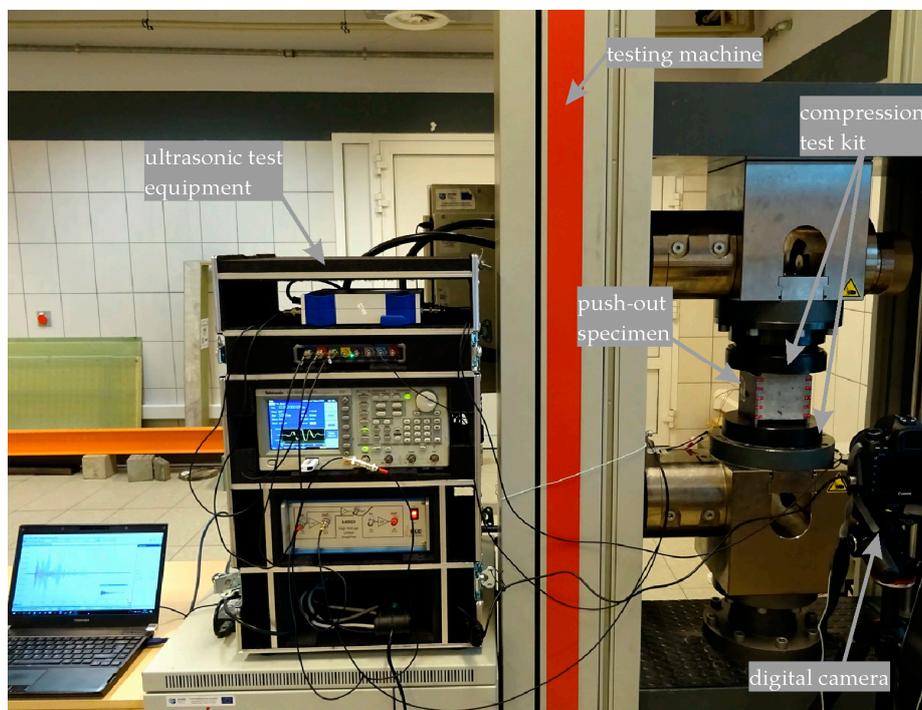
During the mechanical degradation in the testing machine, ultrasonic waves were induced and acquired every 2 s, until the specimen failure. Figure 3 shows the experimental setup. Three multilayer

Figure 3. Experimental setup for push-out and ultrasonic tests.

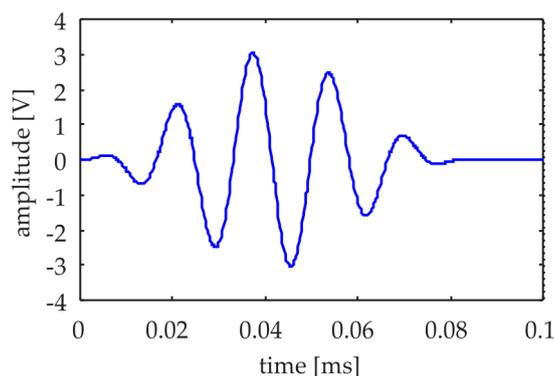
Figure 4. Excitation signal.

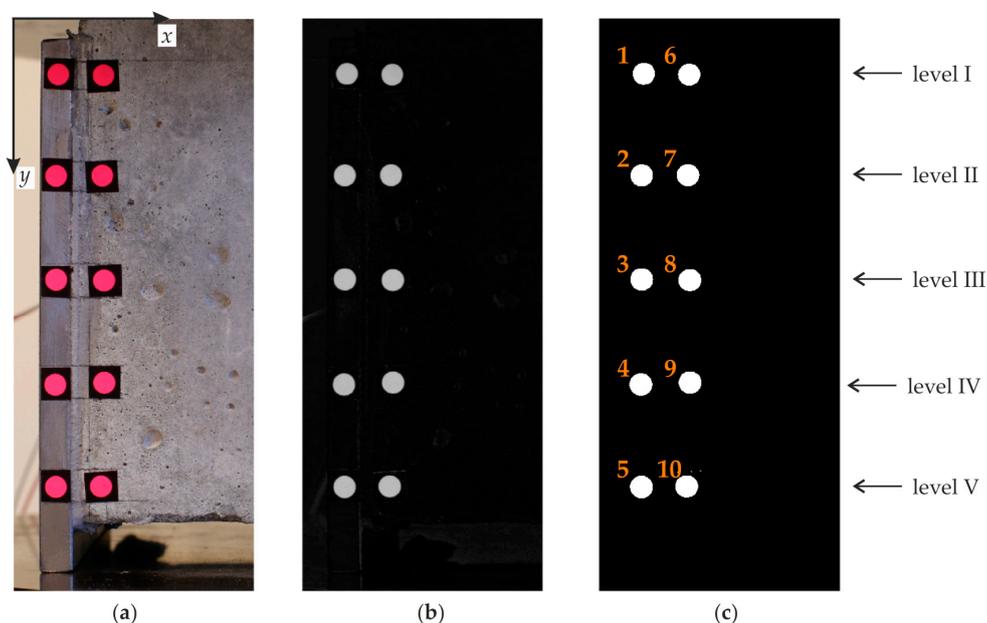
The interface slip between the steel plate and concrete cube was determined using a photogrammetric technique (c.f. [34]). The digital RGB photograph (Figure 5a) was transformed into the CMYK space according to the formula

where colors are marked as follows: *c*—cyan, *m*—magenta, *y*—yellow, *k*—black, *r*—red, *g*—green, *b*—blue. From the CMYK space, a component connected with magenta color was chosen for further processing (Figure 5b) in which the photograph was converted into a binary image with a threshold of 0.25 (Figure 5c). Then, for given points, the centers of gravity were calculated and the interface slips in *x* and *y* directions were determined at five levels (levels I to V).

Figure 5. Digital photograph of the left adhesive joint: (a) RGB photograph; (b) magenta component; (c) binary image.

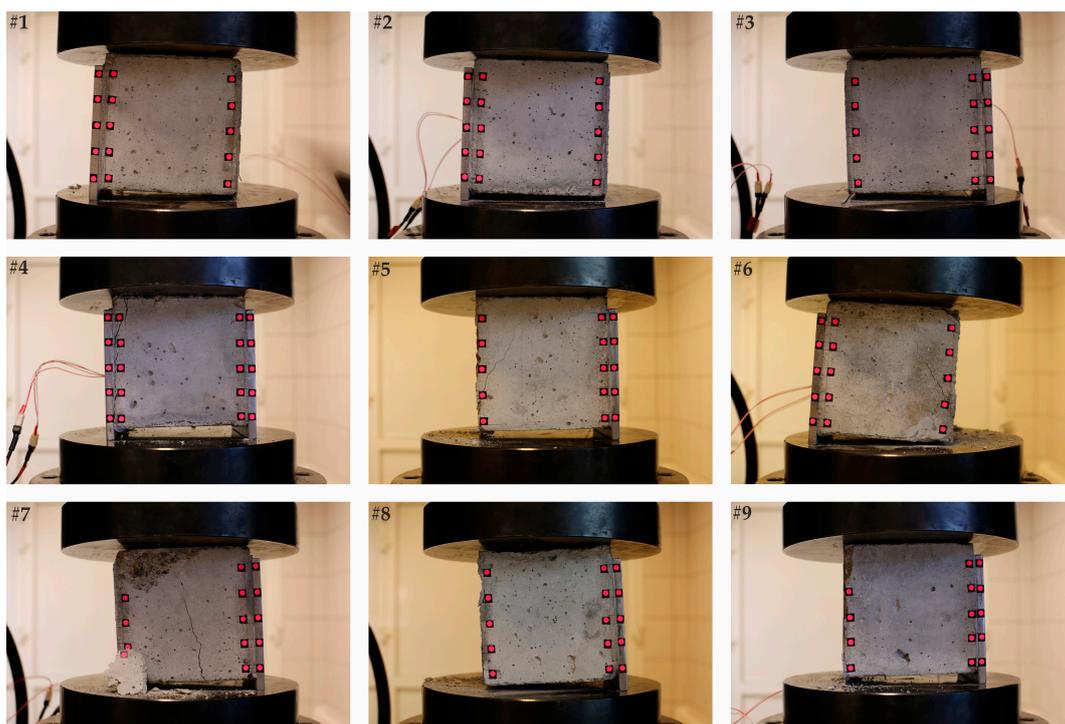
Figures 6 and 7 illustrate all push-out specimens after failure. The specimens were divided into two sets according to observed failure modes. Mode I (specimens #1–#3) was an adhesive-type failure occurring at the interface between the steel plate and the adhesive layer. No damage was observed in the concrete cube. The entire adhesive layer remained on the concrete. Mode II (specimens #4–#10) included a cohesive-type failure or mixed cohesive-adhesive failure. In mode II, three sub-groups were distinguished: mode IIa (specimens #4–#6), mode IIb (specimen #7) and mode IIc (specimens #9–#10). The damage in modes IIa and IIb included two phases. In the first phase, the damage was mainly cohesive with a failure in the bulk of the concrete cube. The second phase was a separation of the steel plate from the concrete. In mode IIa, a single diagonal crack originated from the interface between steel and concrete, and then the cohesive (specimen #6) or mixed cohesive-adhesive failure (specimens #4, #5) occurred in the bulk of the adhesive layer. In mode IIb, a crack appeared in the middle of the concrete cube and then the adhesive failure occurred. The failure in mode IIc was cohesive (specimen #8) and mixed adhesive-cohesive (specimen #9) with a separation in the bulk of the adhesive layer.

**Figure 6.** Failure modes of tested steel-concrete specimens (last stage in the testing machine): mode I including specimens #1 to #3—adhesive failure and mode II including specimens #4 to #10—cohesive-type failure or mixed cohesive-adhesive failure.

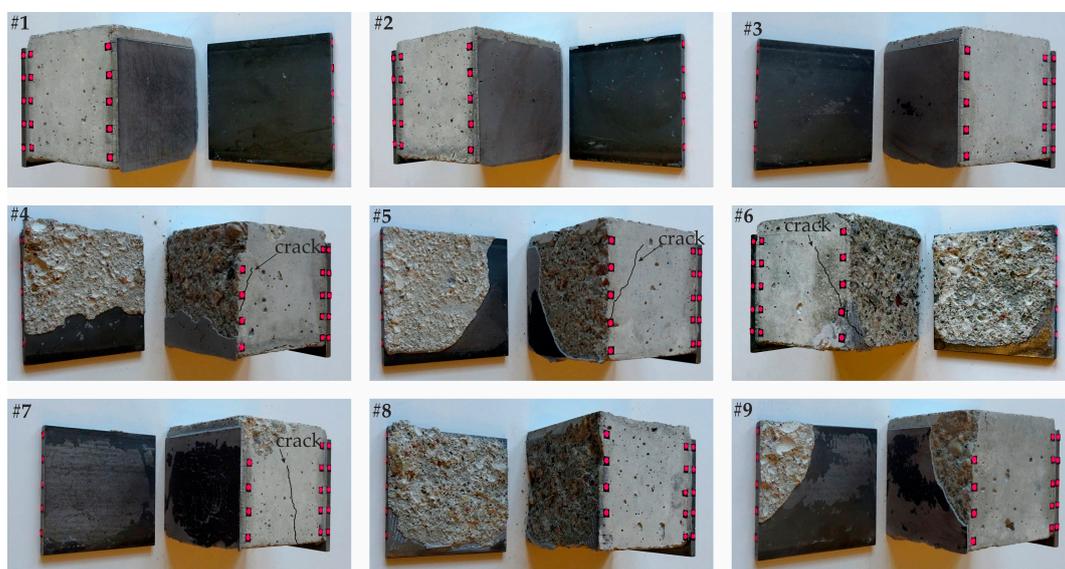
**Figure 7.** Failure modes of tested steel-concrete specimens (photographs of the damaged steel-concrete interface after removing from the testing machine): mode I including specimens #1 to #3—adhesive failure and mode II including specimens #4 to #10—cohesive-type failure or mixed cohesive-adhesive failure.

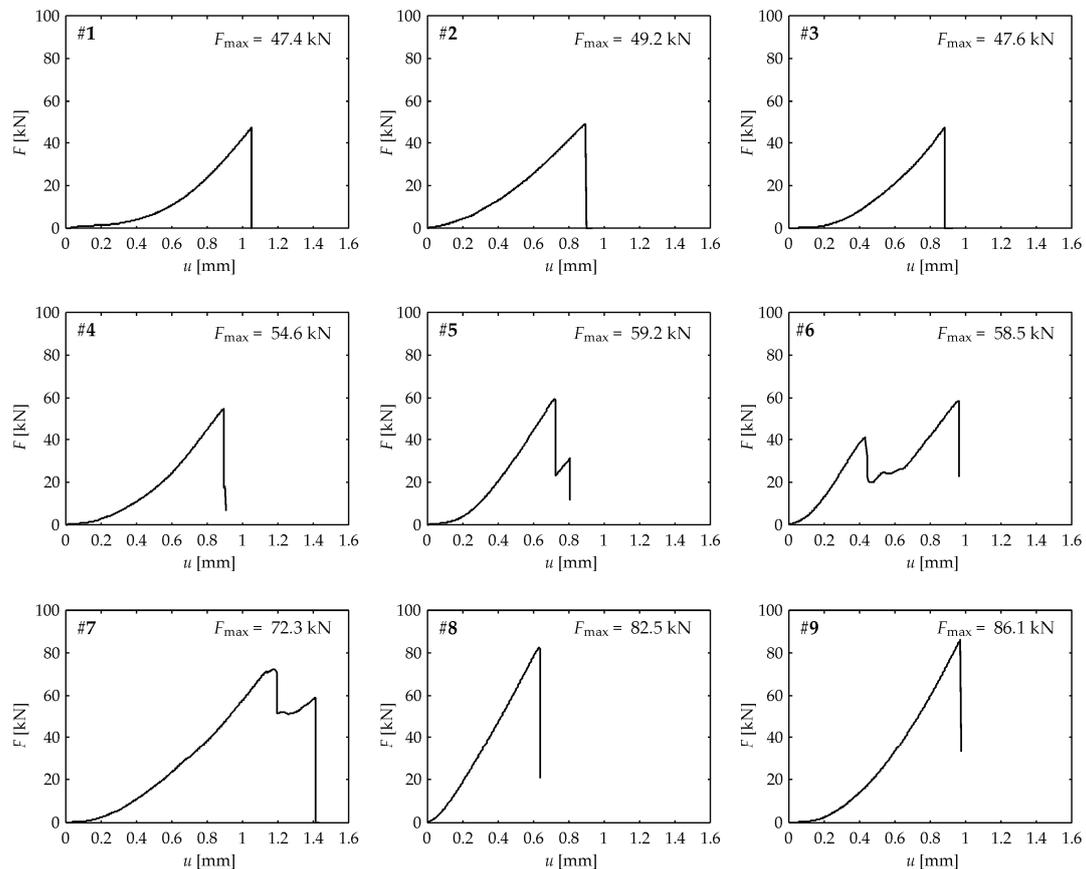
Figure 8 shows the force-displacement curves for all tested specimens. In mode I, the shape of curves for each specimen is similar. The sudden drop of the force at the moment of the adhesive failure can be observed. The maximum force was 47.4 kN (specimen #1), 49.2 kN (specimen #2) and 47.6 kN (specimen #3). The curves for the specimen failures categorized as modes IIa and IIb exhibited two drops of the force. The first drop is associated with the appearance of the crack in the concrete,

while the second is associated with the separation of the steel plate. In the case of specimens with diagonal cracks, the maximum force was 54.6 kN (specimen #4), 59.2 kN (specimen #5), 58.5 kN (specimen #6). For the specimen with the crack in the middle of the concrete cube (specimen #7), the maximum force was 72.3 kN. The last two curves corresponding to mode IIc are characterized by the sudden drop of the force at the moment of the cohesive or mixed adhesive-cohesive failure. The maximum force was 82.5 kN (specimen #8) and 86.1 kN (specimen #9).

**Figure 8.** Experimental force-displacement ( $F$ - $u$ ) curves of tested push-out specimens (#1–#9).

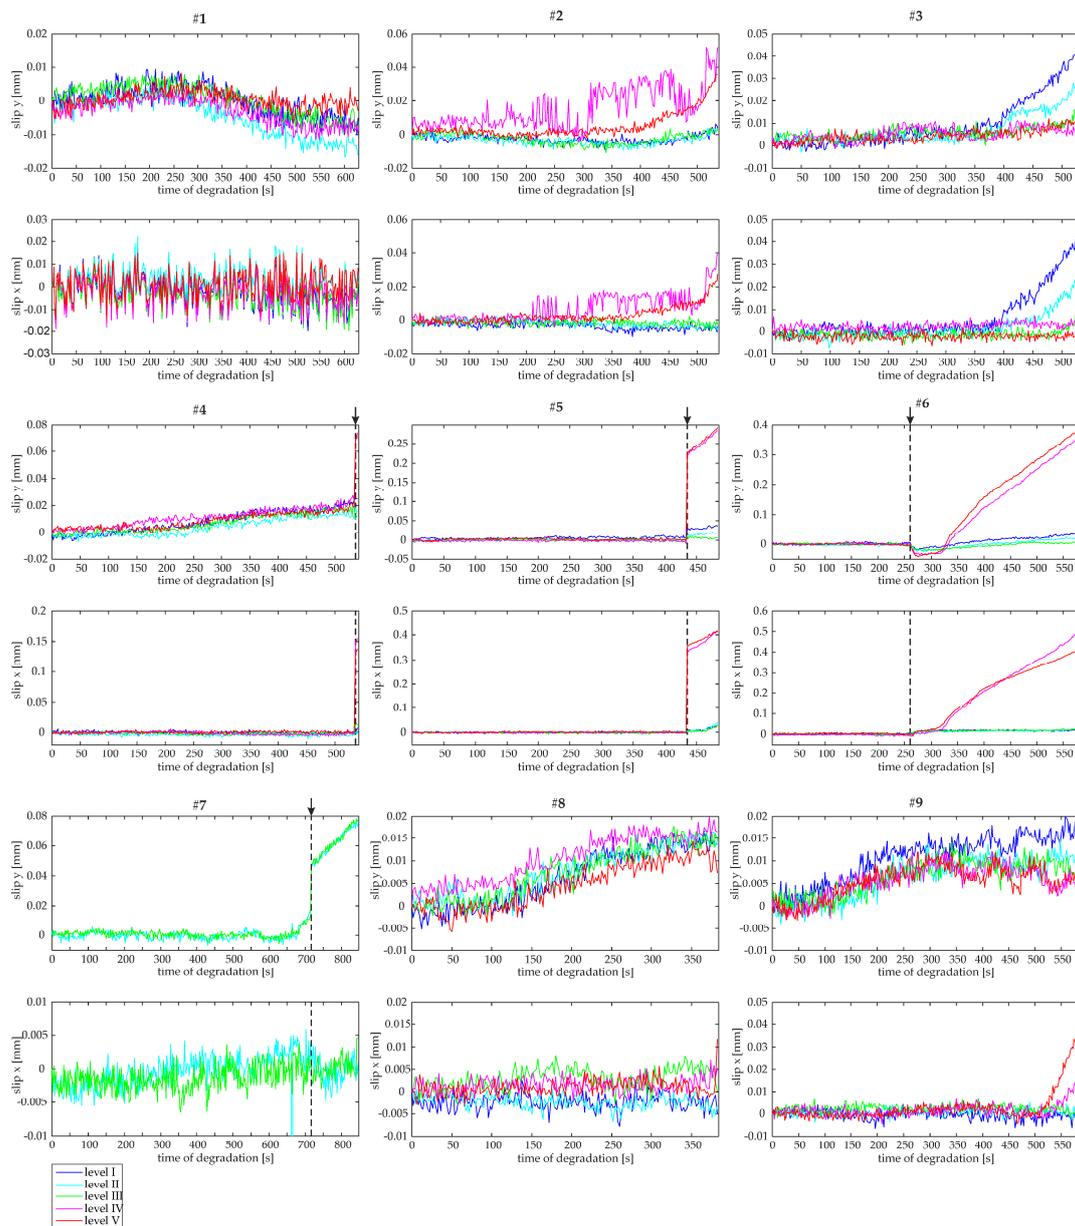
Results of the interface slip between the steel and concrete in both vertical and horizontal directions are presented in Figure 9. For each specimen, the slip values are given for this interface at which the failure occurred (i.e., the right interface for specimens #1, #2, #6 and the left interface for specimens #3, #4, #5, #7, #8, #9). The moment of initiation of the crack in the concrete cube was indicated by the dashed lines (specimens #4–#7). In the case of the adhesive or mixed adhesive-cohesive failure, the measured slip varied around zero almost to the end of the degradation process. For specimens #2, #3 and #9, the monotonic increase of the slip was observed at the end of the test. The maximum values of the slip for the specimens representing mode I and mode IIc was about 0.05 mm. In the case of specimens with the cohesive failure in the bulk of the concrete cube, a sudden increase of the slip was observed in specimens #4, #5 and #7. A different behavior can be seen for specimen #6 for which the monotonic increase occurred after the cracking of concrete cube. The maximum values of the slip for specimens representing modes IIa and IIc were about 0.4 mm.

Figure 9. Interface slip between steel and concrete for tested push-out specimens (#1–#9).

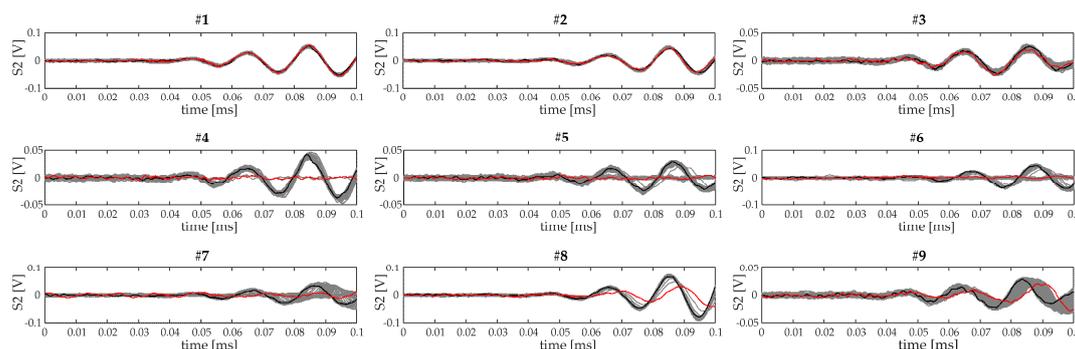
The ultrasonic waves were registered automatically every 2 seconds during push-out testing. All signals acquired by sensor S2 for specimens #1 to #9 are illustrated in Figure 10. Only an initial part of the signal with a length of 0.1 ms was analyzed to reduce the influence of interactions of waves with the compression test kit of the testing machine. The reference signal, i.e., the signal registered at the beginning of the push-out test is marked in black and the last acquired signal is marked in red. For specimens #1–#3, representing the adhesive-type failure (mode I), signals relating to successive states of mechanical degradation are similar and no significant changes in the magnitude or phase can be observed. In the case of push-out specimens #4–#10, for which the cohesive or mixed adhesive-cohesive failure occurred (mode II), experimental waveforms changed considerably during mechanical degradation.

**Figure 10.** Wave propagation signals registered during monitoring of steel-concrete push-out specimens (#1–#9); the first signal (reference) is given in black, the last registered signal in given in red, all other signals are given in grey.

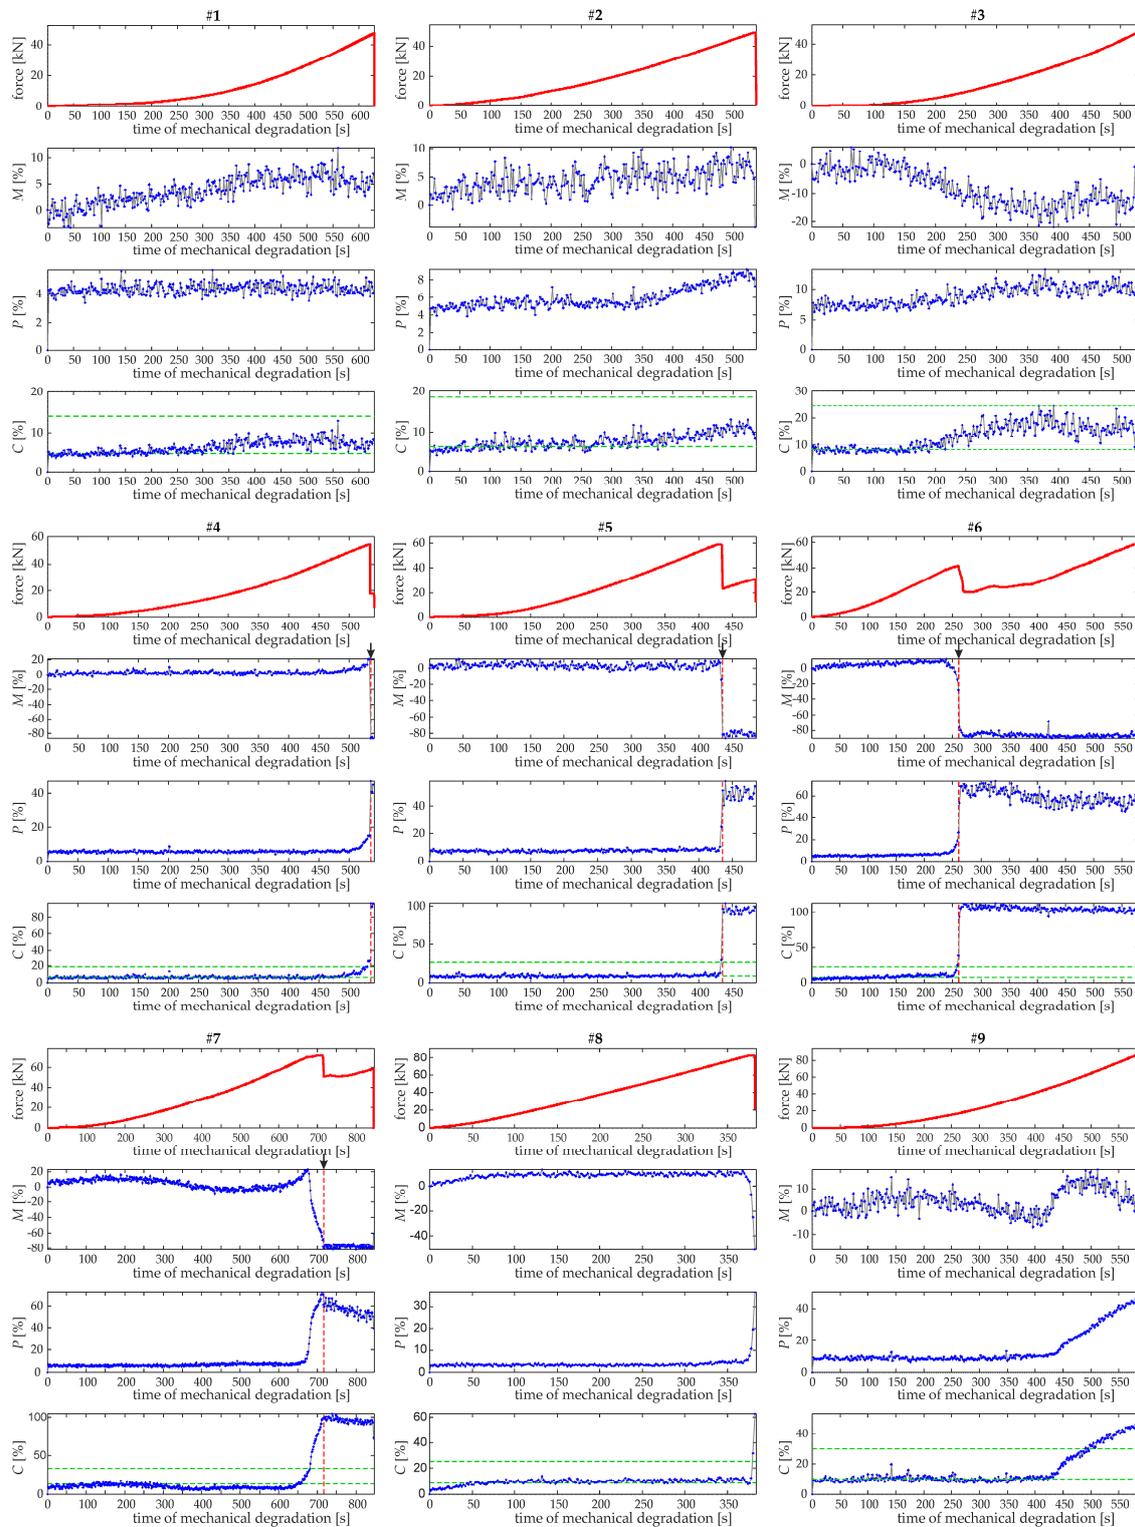
The results of applying the Sprague and Geers metric to all signals registered during the monitoring of the push-out test are presented in Figure 11. For clarity of observation, the load-time curves were provided for each specimen. Additionally, for specimens #4–#7, red dashed lines were drawn at the moment of initiation of the crack in the concrete cube. The S&G metric expresses the difference between the reference signal and the other signals registered during the push-out test. The error measures can range from 0 to 1 or more. The perfect agreement of time histories results in a zero value of the error measures, while the value of unity indicates a difference of 100%. The value of the  $P$ -error is always positive while the value of the  $M$ -error can be positive or negative, depending on whether the monitored signal has higher or lower amplitude than the reference signal. At the beginning of the process, the  $P$ -error fluctuated around the value of about 5% and the  $M$ -error around the value of about 0%. These values resulted from the presence of measuring noise in the subsequently triggered measuring signals.

Considering the specimens with the adhesive-type damage (the first row in Figure 11), all error measures are rather constant during the entire push-out test. A slight increase in the  $P$ -error value was observed for specimen #6; however, based on these errors it was not possible to detect incoming damage before the failure.

The second group are specimens belonging to failure modes IIa and IIb, for which the separation between the steel plate and concrete was preceded by the cracking of concrete. For specimens #4, #5 and #6, the increase in the  $P$ -error can be observed before the initiation of the diagonal cracks. This increase was quite sudden for specimen #5, but for specimens #4 and #6 it was gradual signaling incoming damage. Moreover, for specimen #6, the  $M$ -error gradually decreased before the initiation of the diagonal cracks. In the case of specimen #7, for which the crack appeared in the middle of the concrete cube, the gradual increase of the  $P$ -error and the decrease in the  $M$ -error can be seen, enabling detection of the micro-crack zones in the concrete long before the appearance of the macro-crack.

The last two specimens represented the failure of mode IIc. For the specimen #8, the detection of the cohesive failure was possible based on both the  $M$  and  $P$ -errors. In the case of specimen #9, the gradual increase of the  $P$ -error was observed (similarly as for specimen #2) indicating the increase in the load but not the appearance of the failure. This was because, the failure of specimen #9 was mainly adhesive, with a small area at which the cohesive failure occurred.

As a damage indicator, the  $C$ -error is proposed because it contains both the magnitude and phase errors. For each specimen, two horizontal lines were drawn in the plots of the comprehensive error (Figure 11). The first line is a mean of the 100 first values of the  $C$ -error and it determines a baseline. The second line is the baseline multiplied by a coefficient and it represents the state of possible damage. In this study, the value of the coefficient was set a priori as 3, however, in potential applications of structural monitoring, it should be verified based on comprehensive experimental data. Based on the indicator, it was not possible to recognize the upcoming separation between steel and concrete in any specimen with the adhesive failure (specimens #1–#3). In the case of specimens exhibiting the cohesive

or mixed adhesive-cohesive failure, the gradual increase of the C-error enabled earlier detection of potential damage.

**Figure 11.** S&G metric errors (magnitude error  $M$ , phase error  $P$ , comprehensive error  $C$ ) during subsequent phases of degradation of push-out specimens (#1–#9).
