FATIGUE RESISTANCE INVESTIGATION OF THE IC ENGINE MB11 BEARINGS, WORKING UNDER CONDITIONS OF DYNAMIC UNIDIRECTIONAL LOADINGS

Jan Sikora, Jan Kłopocki, Wojciech Majewski

Gdańsk University of Technology
Mechanical Engineering Faculty
Narutowicza Street 11/12, 80-952 Gdańsk
tel.: +48 58 3471844, fax: +48 58 3472742
e-mail: jklopock@pg.gda.pl
jsikora@pg.gda.pl

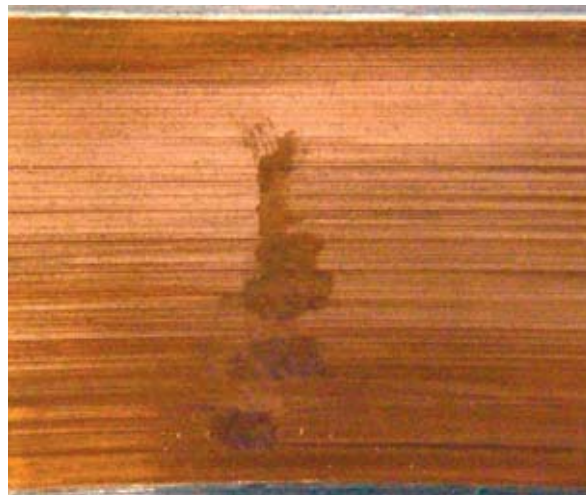
Fig.3. Fatigue cracks on the slide bearing surface for the alloy MB11, obtained after the test on SMOK stand

Microscopic pictures of the fatigue damages are presented in Fig. 3 and Fig. 4.

Fatigue cracks are appeared at the centre of the lower half-bearing. The position of the cracked area is reflecting the stress distribution (being the result of bearing housing design) in the bearing alloy. It can be concluded that the cracked area is placed in accordance with the maximum oil film pressure position and maximum circumferential pressure gradient (between 275° and 290° angular position) as it is stated in the literature [3]. The cracks initiation can start at any time of fatigue process but it can be detected only after first or second test section (after 10 or 20 hours). It results in lower precision of the determination of the cracks initiation angular position. The picture of the cracks net, that is visible on the slide surface allows to conclude that circumferential and axial normal alternating stresses are developing in the slide layer.
