Finite element modelling of a historic church structure in the context of a masonry damage analysis

Damage analysis of historic masonry church
Laser scanning
Homogenization
Geotechnical investigation
FEM analysis – damage plasticity model

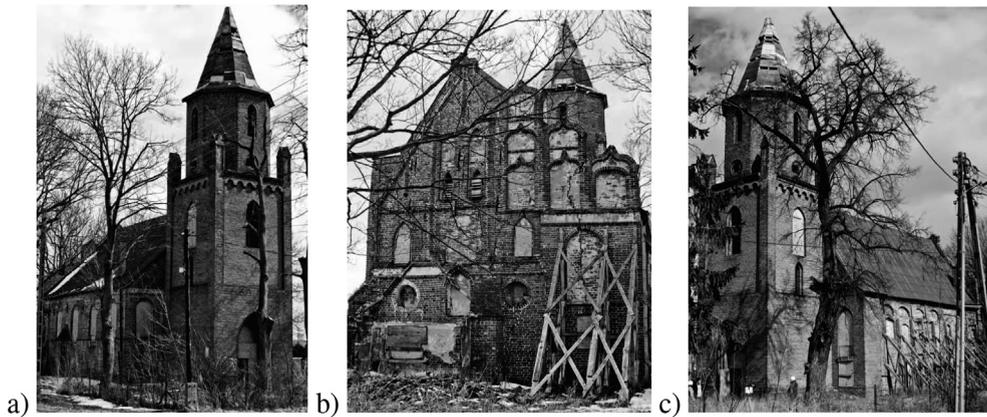
Fig. 2. Views of the church (a) north-west, (b) east, (c) west-south.

In the XIX century, two brick buttresses were built in the western corner of the south wall and in the east wall (see Fig. 4). In 2009, during the renovation, three columns of concrete were built into the southern inner wall (see Figs. 3 and 4). These three pillars are not founded on any foundation. The eastern wall is also comprised of two layers, and some vertical cracks of significant width are observed on it (see Figs. 2 and 15).

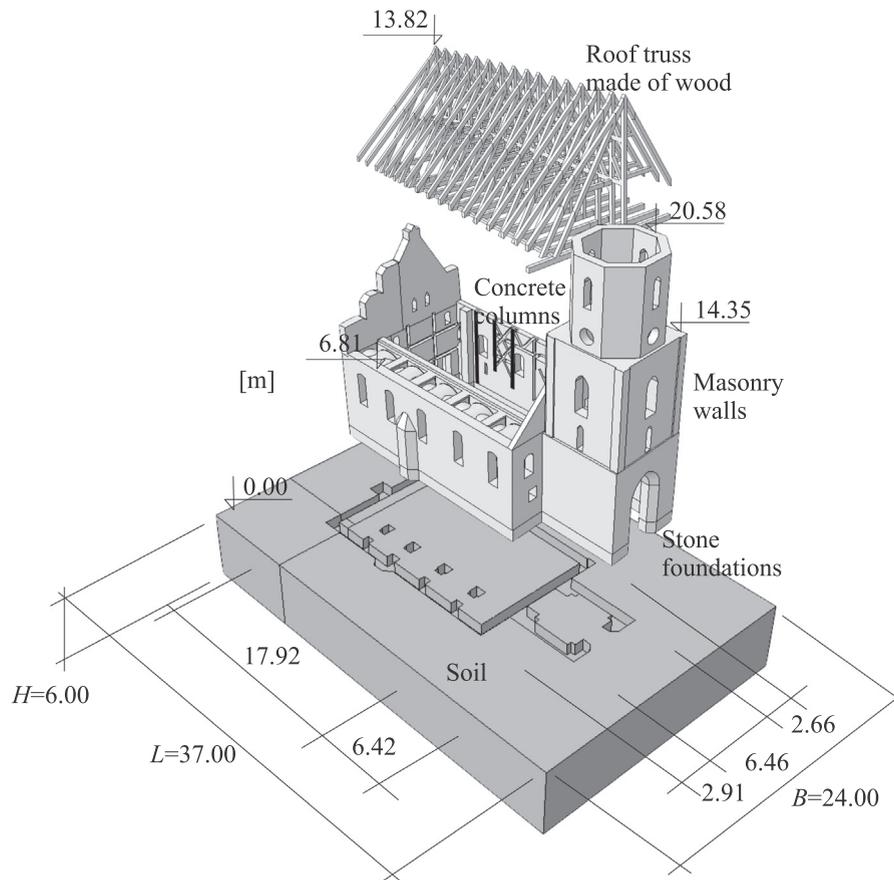
Fig. 3. Main parts and dimensions of the structure.

The analysed church is a brick nogged timber wall frame construction on a stone foundation of boulders. After 1323, the church was rebuilt several times. The main parts of structure and phases of the church reconstruction are shown in Figs. 3 and 4. In the first phase of redevelopment at the end of the fourteenth century, the church was reinforced by an outside solid brick wall. In the second phase, in the fifteenth century, the church was enlarged by an additional five chapels, which have been roofed vaulted using bricks. In the Baroque period after the year 1708, the windows were enlarged, and some doorways were bricked up. Finally, in the fourth phase, after 1819, a brick tower was built. At that time, the new owner tore down the walls between the main nave and chapels located on the north wall, creating a new second nave. The church was used for its intended purpose until 1945. Currently, the church is not in use, but it is included in the register of monuments.

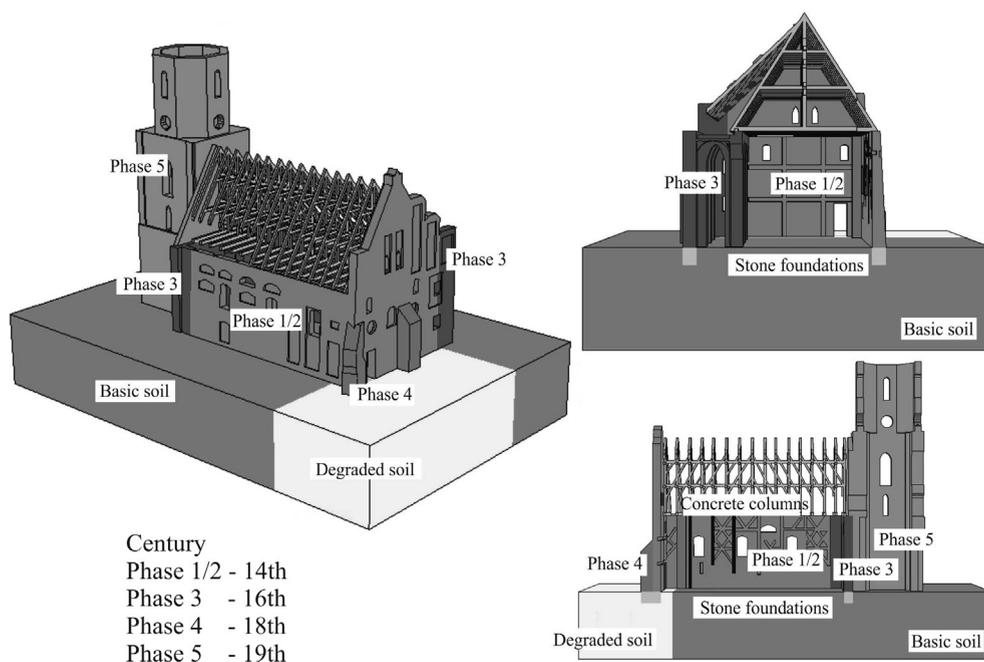
Fig. 4. Phases of the church reconstruction.

- The second but also very important cause of the masonry cracking is varied settlement of soil under the church structure (see Fig. 4). The numerical study results clearly indicate that the soil conditions, although seemingly good enough for supporting the structure, unfortunately are the cause of cracks in masonry. The geotechnical investigation carried out did not show problems with the bearing capacity of the soil merely because of the inadequate number of geotechnical test drillings (see Fig. 9). An additional geotechnical drilling should be conducted at the south-east corner of the church, where the soil seems to be weaker. The soil weakness can be confirmed by the reconstruction of the church in the 18th century (see Figs. 4 and 15 - phase 4) because the buttresses probably built in at that time were supposed to prevent the structure from collapsing. Moreover, a sacristy built later at the same corner made the situation even worse because it caused the overloading of the soil and the east masonry wall cracking (see Fig. 15).

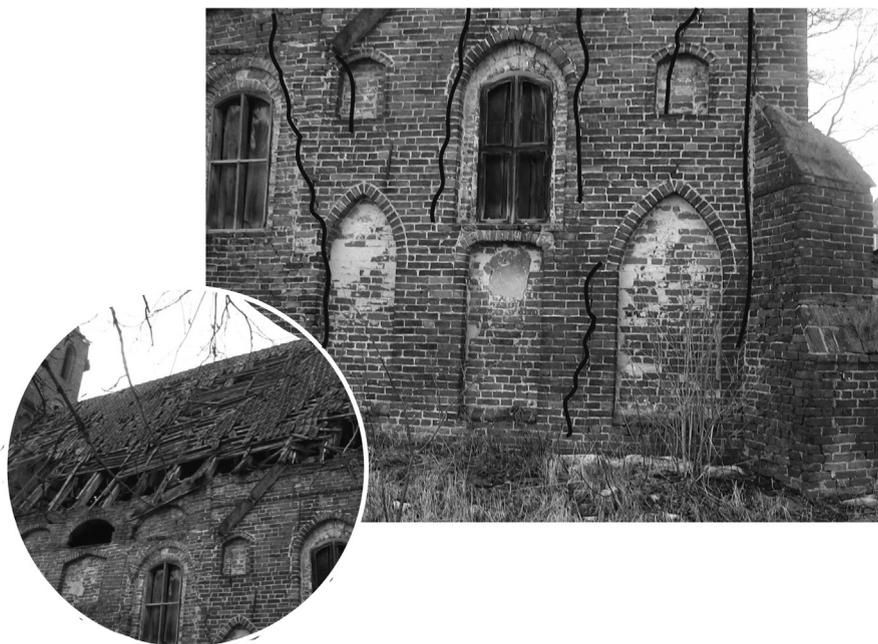
Fig. 5. View of the south wall and roof over the wall.

The roof of the church is made of wood (see Figs. 5–7). The main destroyed roof timber truss is considered in analysis here (see Fig. 7). The roof of the tower is omitted. The material of the truss is modelled in a simplified manner as elastic and isotropic even if wood is known as an anisotropic material. Because the church is a structure that was built centuries ago, the material may also have

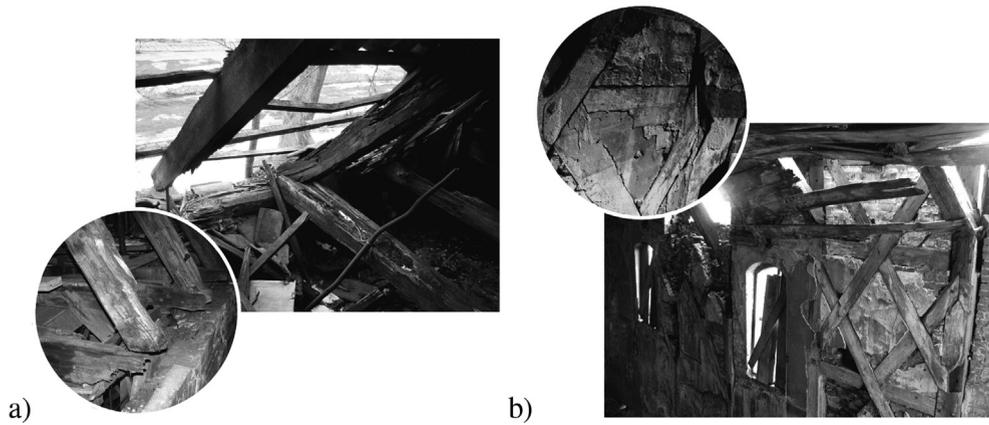
Fig. 6. Damage to (a) ceiling, rafter, wall beams and (b) timber wall frames (inner view of the south wall).

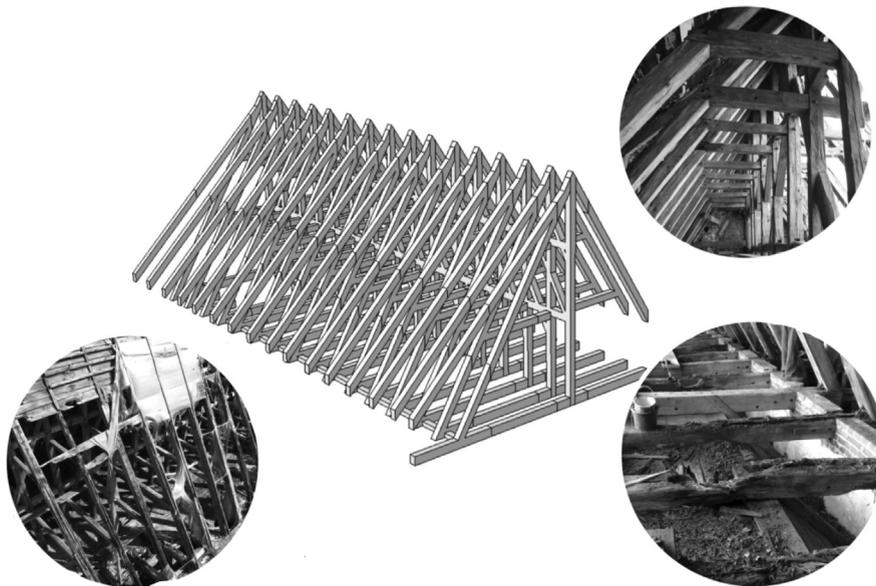
Fig. 7. Geometry of the timber roof: selected details.

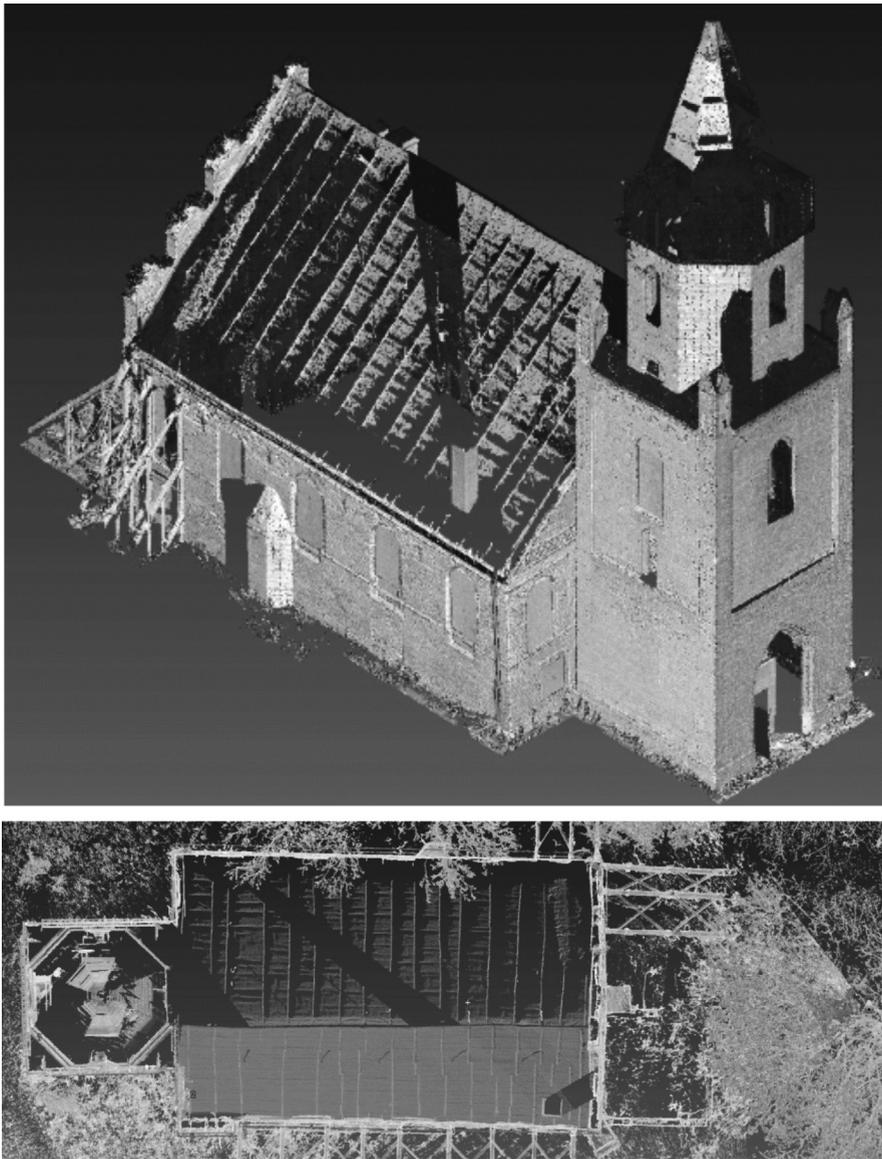
Fig. 8. View of the cloud of points.

The numerical models of the structures were created based on a standard architectural inventory with support from laser scanning (see Fig. 8). This technique and other similar techniques are not new and have been used for similar purposes, as presented in detail in [9,21]. A Leica ScanStation P20 3D laser scanner was used for the inventory. The data acquisition was based on the resolution

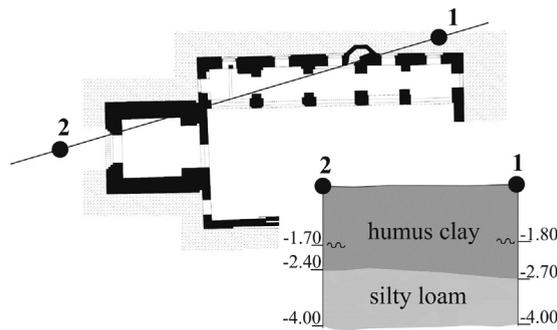
Fig. 9. Geotechnical research map.

The church is resting on the foundation approximately 1–1.5 meters below ground level (m bgl). As a part of field research, the locations of test points have been specified. The soil samples were retrieved from a depth of 4 m. Within the testing soil classification, water content, specific weight, cohesion, friction and soil consolidation properties were performed. On that basis, two main geotechnical layers were specified. The first layer of the soil under the church foundation is a humus clay that goes down to 2.7 m bgl and then up to 4 m bgl, where the second layer of dust clay is placed. Groundwater occurs below the foundation of the building (1.7–1.8 m bgl) in the form of filtration. The geotechnical investigation results indicate that the soil conditions are rather good for supporting the

structure [22] (see Fig. 9). In this paper, the support substrate on which the structure rests is treated in a simplified manner as a homogeneous and elastic material, without modelling the details of the support. The constrained modulus from oedometer testing is $E_{ode} = 29700 \text{ kPa}$ [22]. Assuming that the Poisson's ratio of the tested soil substrate is $\nu = 0.25$, we can determine the Young's modulus of the soil according to the formula $E = E_{ode} [(1 + \nu)(1 - 2\nu)] / (1 - \nu) = 24750 \text{ kPa}$ [23]. Furthermore, it is assumed that the average value of the soil mass is 1775 kg/m^3 .

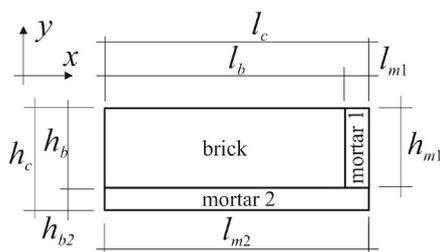
Fig. 10. Elementary cell in individual states.

The masonry church wall material modulus of elasticity was calculated using a homogenization algorithm described in papers [24,25]. In this method, an elementary cell is analyzed, where based on strain compatibility and stress balance equations of its components, the basic material properties of the entire element can be calculated. The cell is comprised of a brick and mortar attached along its two edges (see Fig. 10). The method assumes that the width and height of an elementary cell is greater than its thickness, which makes it possible to assume a plane stress state in the wall; the layout of bricks and joints in the wall is regular, and the stress gradient in the construction is small, with no concentrations.

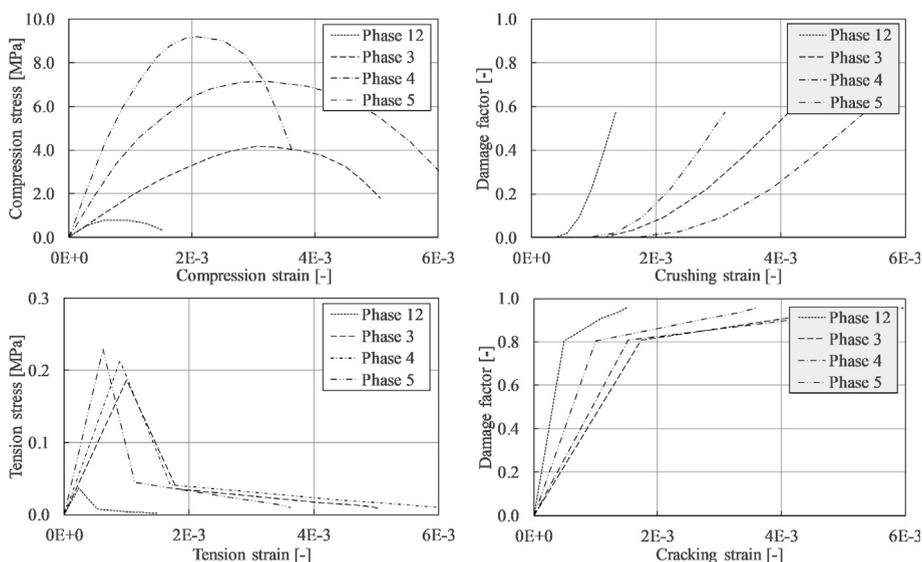
Fig. 11. Masonry properties: phase 1/2 (14th century), phase 3 (16th century), phase 4 (18th century), phase 5 (19th century).

1/2 and 3, 3% for material in phase 4 and 2.5% for material in phase 5). The values of the individual parameters are shown in Figs. 11 and 12.

Considering the material behaviour of the specific parts of the structure, the soil (basic and degraded), stone foundations and timber roof are modelled as linearly elastic (see Table 3), whereas the masonry walls (see Table 3 and Fig. 11) and concrete columns (see Fig. 12) are modelled as continuum plastic with damage and stiffness degradation in the sense of continuum damage mechanics. Plasticity-based damage constitutive modelling is widely used to describe the nonlinear properties of masonry structures and concrete. Such a model was first proposed for concrete analysis [37–39] and reinforced concrete (RC) structures [40] but also can be used to represent other brittle material behaviours such as for ceramic masonry structures [41,18,42]. The applied material model is described extensively in [36]. It assumes that the main two failure mechanisms are tensile cracking and compressive crushing of the masonry or concrete. The evolution of the yield (or failure) surface is controlled by two hardening variables $\tilde{\varepsilon}_t^{pl}$, which is a tensile equivalent plastic strain, and $\tilde{\varepsilon}_c^{pl}$, which is a compressive plastic strain. Both refer to failure mechanisms under tension and compression loading. It assumes that uniaxial tensile and compressive response of the brittle-like material is characterized by damage plasticity, as shown in Figs. 11 and 12.

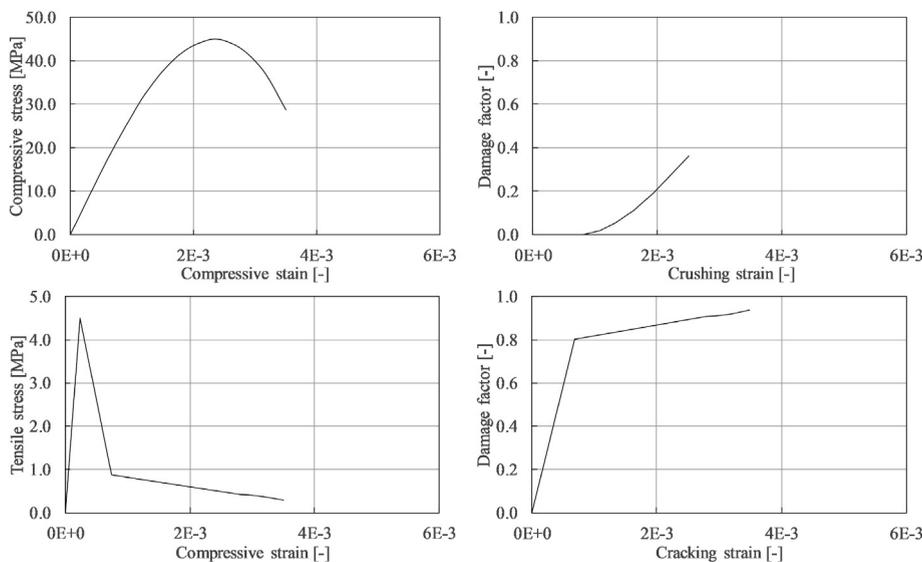
Fig. 12. Concrete properties.

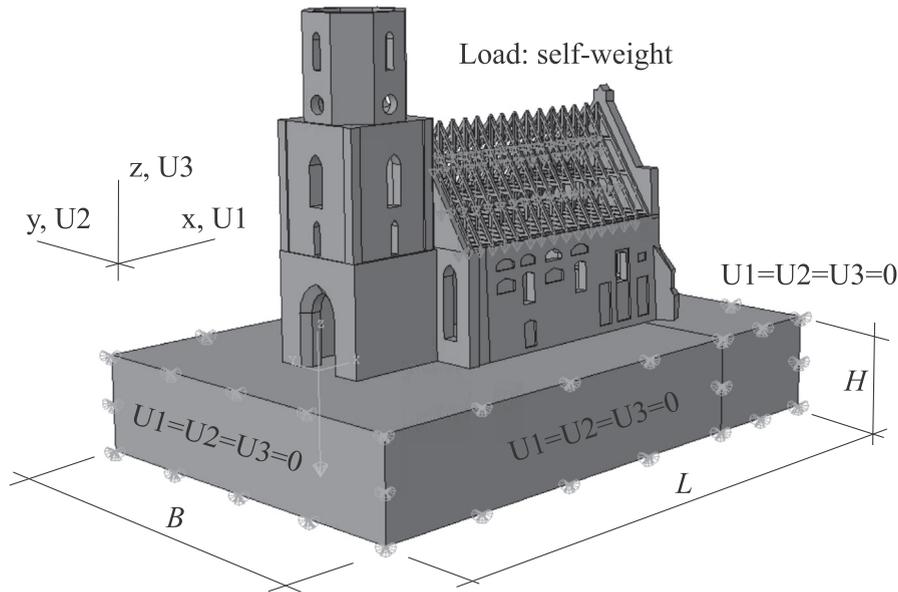
Fig. 13. FEM model: load and boundary conditions.

The whole numerical model (see Fig. 13) is built of 4-node linear tetrahedral volumetric finite elements with one integration point and three degrees of freedom in each node-type C3D4 [35]. The total number of finite elements in all the analysis cases equals approximately 3.5 million. The FE mesh density was determined in a parametric study based on convergence analysis of the cracked form. The numerical model is loaded only by its self-weight. The geometrically nonlinear analysis was performed using a dynamic explicit procedure [36], as it is computationally efficient for the analysis of large models with relatively short dynamic response times and for the analysis of extremely discontinuous events or processes. The dynamic explicit analysis can also be used to perform a quasi-static analysis. In the proposed numerical solution (quasi-static technique), the load is applied smoothly; consequently, slow deformation triggers a low strain rate. This type of analysis allows for using a consistent, large-deformation theory. In view of the above, the proposed method of analysis is highly effective for studying the damage and degradation of masonry structures. Due to this approach, one can track very carefully the propagation of gradually occurring damage (like cracking and crushing) under an increasing load value, regardless of the type of loads. The ABAQUS package apparently offers several other methods performing dynamic analysis of nonlinear problems, such as implicit dynamic analysis. However, implicit dynamic analysis is not as effective as the explicit approach. The authors' experience shows that while modelling large complex nonlinear problems, like damage of masonry structures, a solution convergence problem often emerges at the time of structural degradation start while applying implicit dynamic analysis.

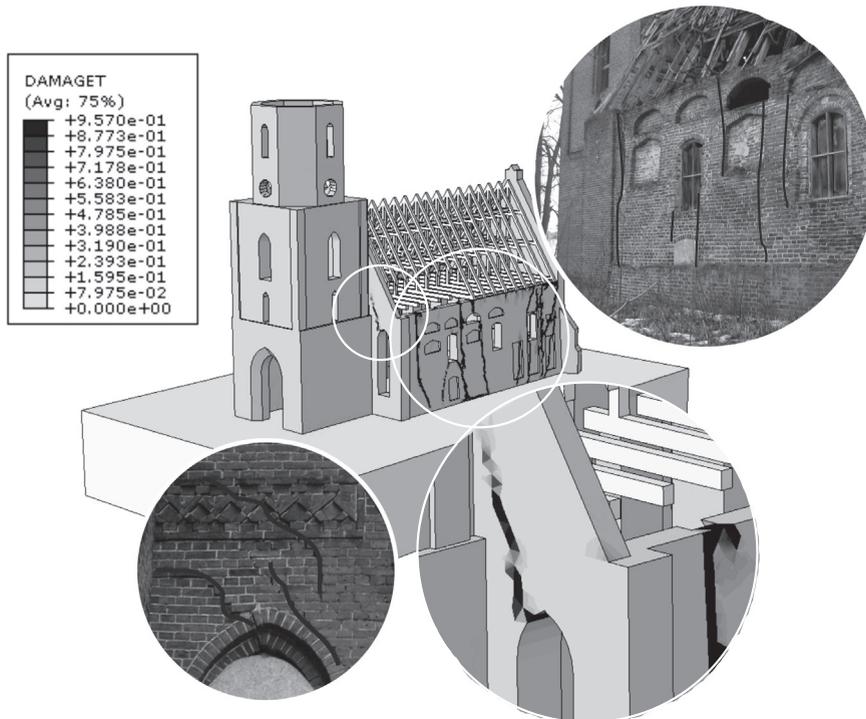
Fig. 14. Selected details of main cracks on the west-south walls compared with FEM solutions expressed by tension damage factor DAMAGET.

The main results of the numerical analysis are shown in Figs. 14–16. All the main cracks of the real structure of the church are reflected by the numerical results. Fig. 14 shows the main cracks of the west-south walls in the real structure and the resulting

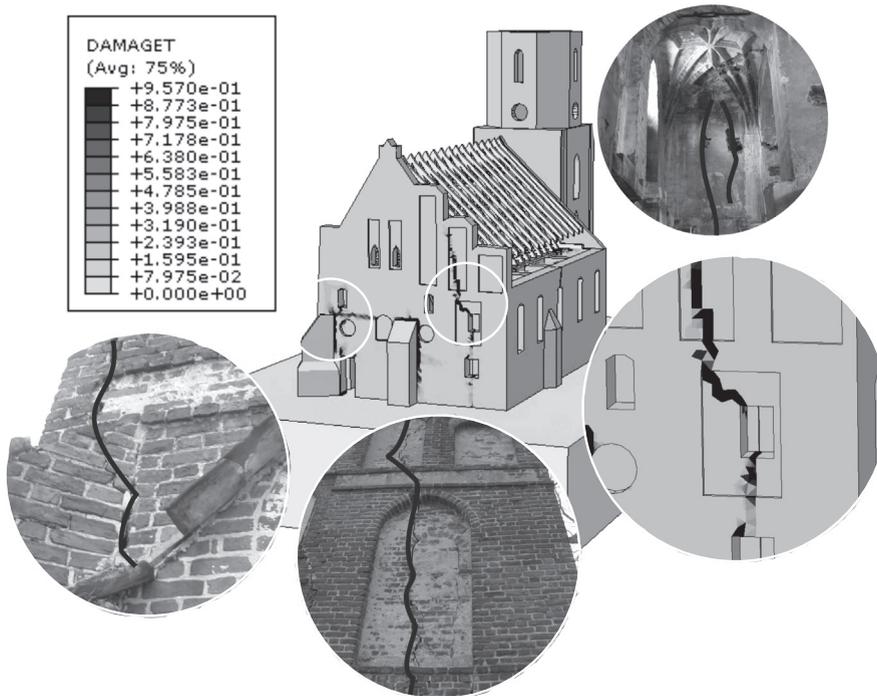
Fig. 15. Selected details of main cracks on the east wall compared with FEM solutions expressed by tension damage factor DAMAGET.

damage obtained from the numerical analysis. Similarly, the main damage to the east wall and the damage to the inner nave arch are presented together with the appropriate numerical results of the mechanical analysis in the Figs. 15 and 16.

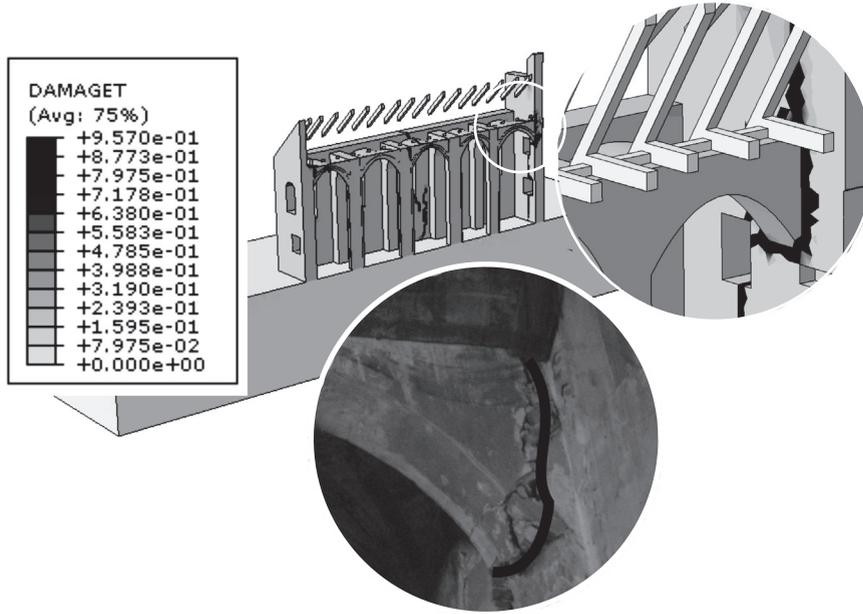
Fig. 16. Selected detail of main cracks on the arch of the inner nave compared with FEM solutions expressed by tension damage factor DAMAGET.

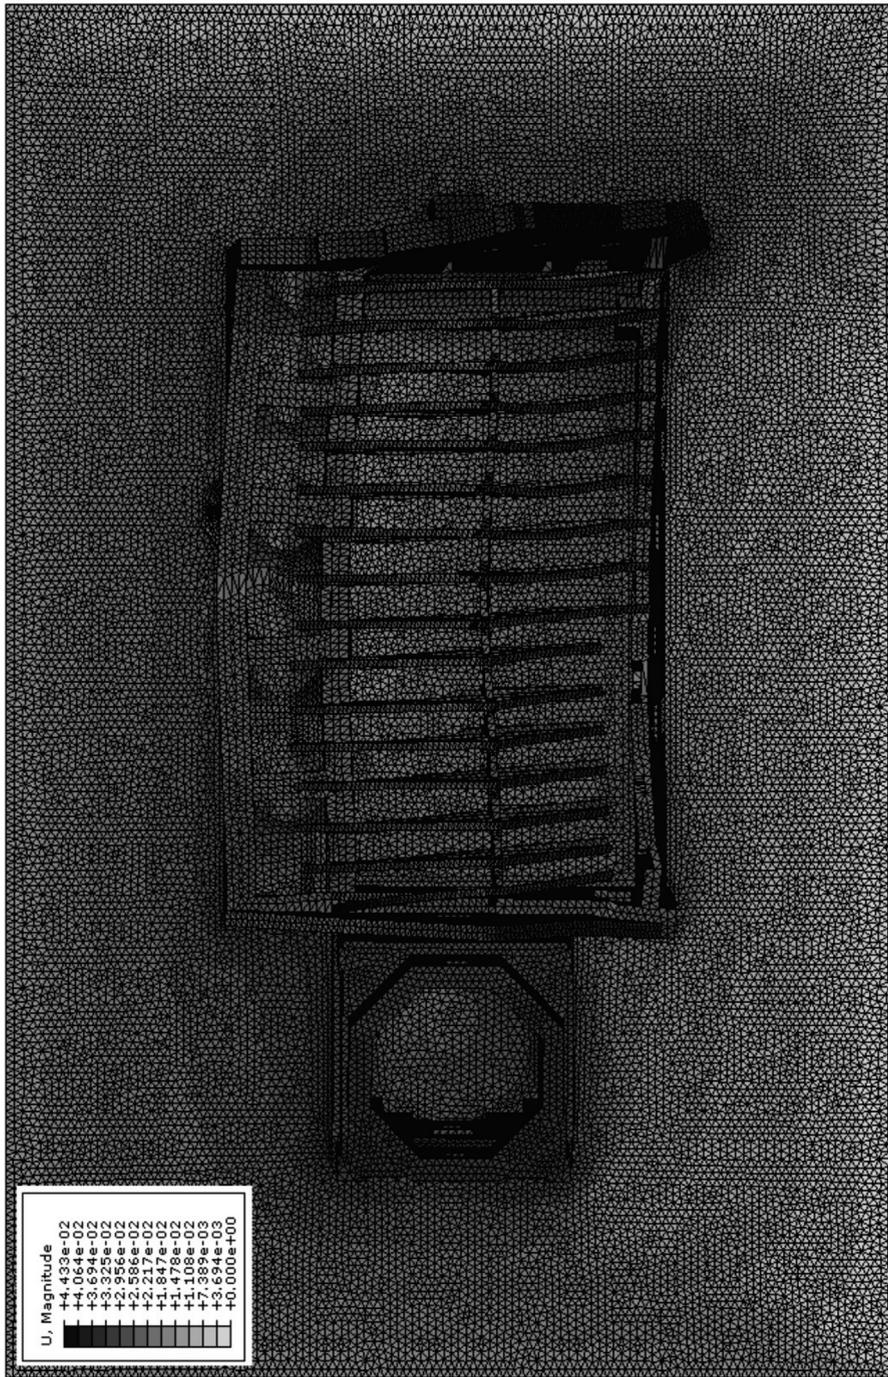
Fig. 17. Numerical solution - deformations [m] according to soil volume at $H = 6$ m ($L = 37$ m, $B = 24$ m).

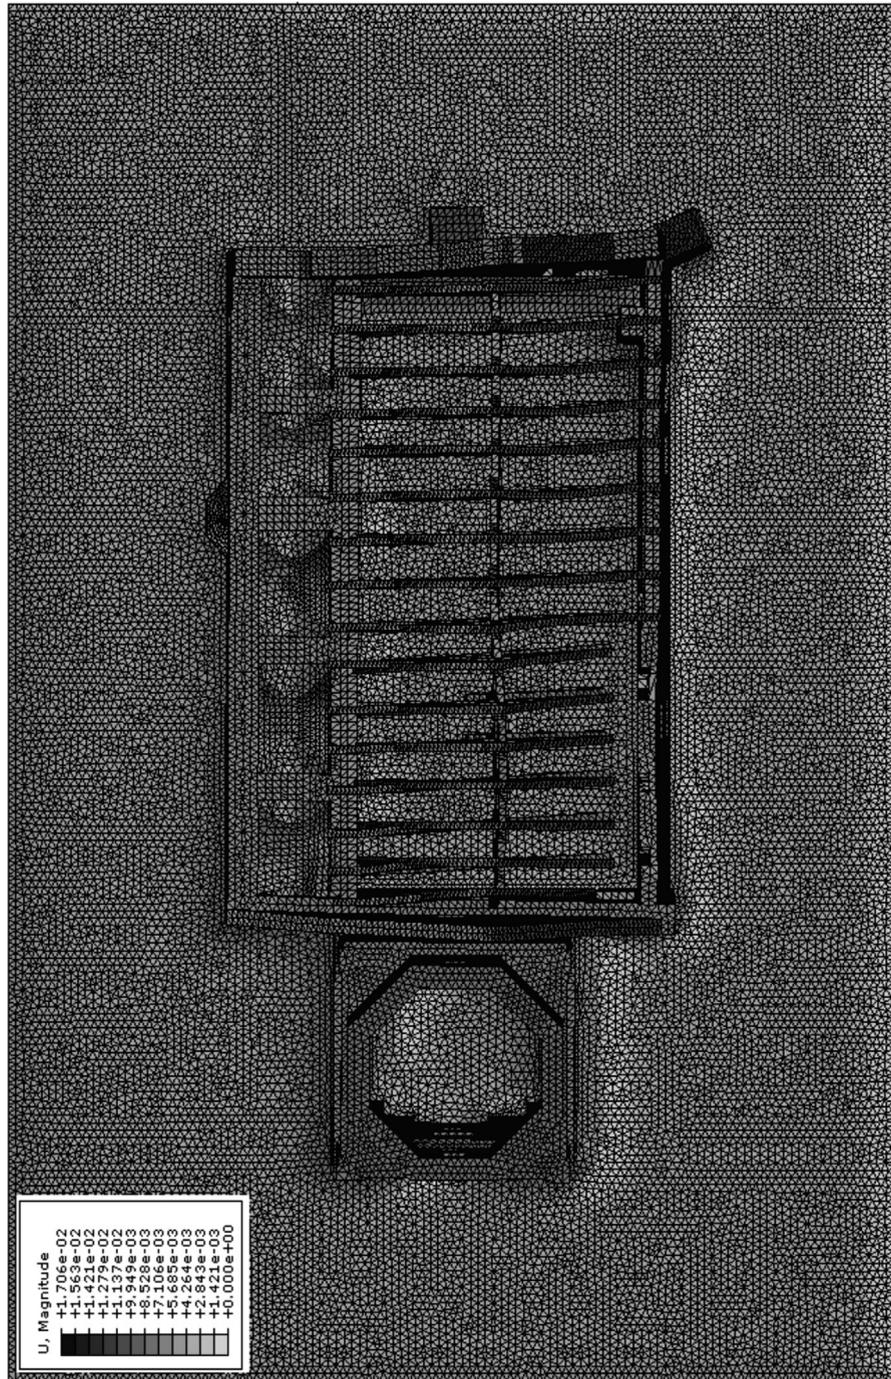
Fig. 18. Numerical solution – deformations [m] according to soil volume at $H = 1.5$ m ($L = 37$ m, $B = 24$ m).

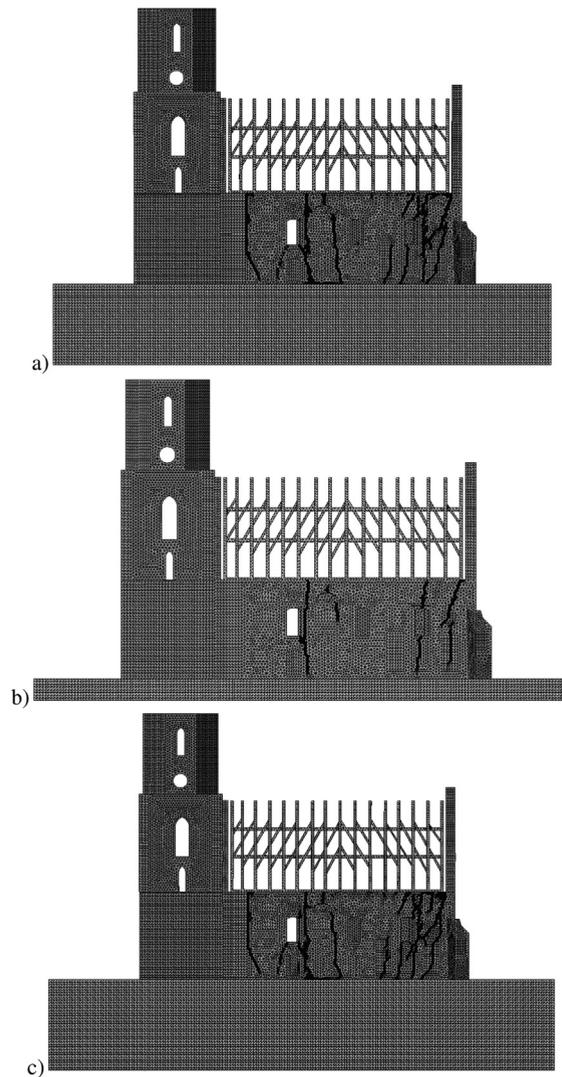
Fig. 19. Numerical solutions, view of the south wall – damage factor DAMAGET due to: (a) the soil volume at $H = 6$ m ($L = 37$ m, $B = 24$ m), (b) the soil volume at $H = 1.5$ m ($L = 37$ m, $B = 24$ m) and (c) the soil volume at $H = 7$ m ($L = 39$ m, $B = 26$ m).

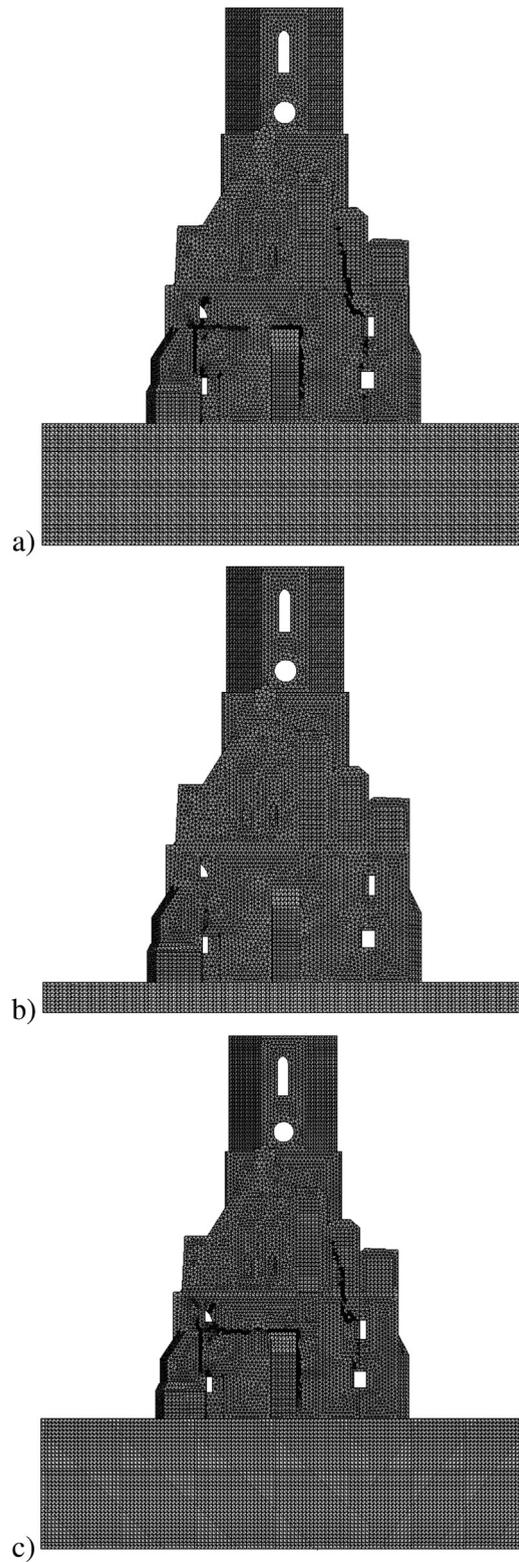
Fig. 20. Numerical solution, view of the east wall - damage factor DAMAGET for: (a) the soil volume at $H = 6$ m ($L = 37$ m, $B = 24$ m), (b) the soil volume at $H = 1.5$ m ($L = 37$ m, $B = 24$ m) and (c) the soil volume at $H = 7$ m ($L = 39$ m, $B = 26$ m).
