# High frequency impulse ground penetrating radar application in assessment of interlayer connections

**Abstract.** Ground Penetrating Radar (GPR) technique is commonly used in the nondestructive evaluation of pavement structures. In particular, this method is used to estimate thicknesses of pavement layers as well as it can be utilized in advanced studies of pavement structures. The device presented in this paper comprise the high frequency impulse antennas that allow for investigating the interlayer zones in terms of their electromagnetic properties (e.g. dielectric constant). In some cases these electromagnetic responses can be suitable in the assessment of layer bonding in the pavement structure. This paper discusses the assessment of the quality of asphalt pavement interlayer bonding with the use of high frequency GPR techniques. The preliminary laboratory measurements were performed using an impulse antenna in the zero-offset configuration combined with the large-scale models simulating an idealized horizontal delamination. These measurements allowed to estimate the antenna sensitivity to detect interlayer connection under dry and wet conditions. Analysis of collected result

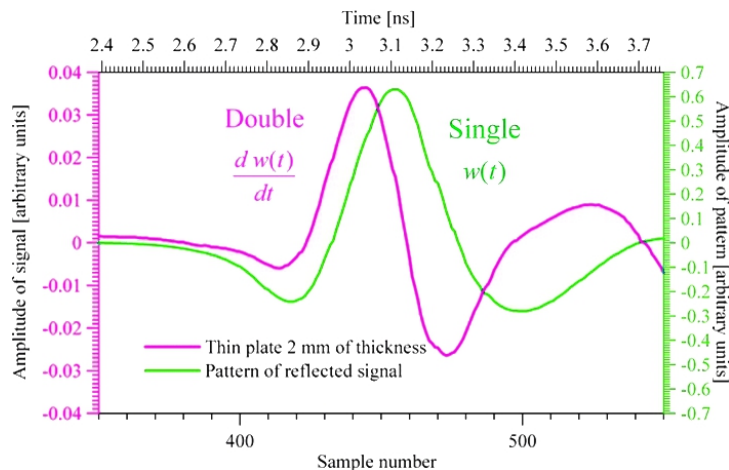
**Fig. 1.** Comparison of the head package shapes of the single  $w(t)$  and the double reflection  $dw(t)/dt$  measured on laboratory model of the crevice simulated by thin glass plate [9]

identifying the type of reflection, i.e. a single reflection  $w(t)$  or double reflection  $dw(t)/dt$ , with one leading extreme or two adjacent leading extremes of inverse signs, respectively (Fig. 1). The simple single reflection is generated by the commonly known type of the planar boundary between a two homogeneous layers having mutual contrast of impedance. Depending on the sign of contrast the single reflection can be positive, as it is in case of boundary between successive mediums of low and high permittivity, or negative, as between mediums of high and low permittivity. When a crevice is very wide (in comparison with wavelength) the resulting signals are single type with positive or negative sign. When crevice becomes thinner and thinner the signal becomes similar to the derivative of the incident signal, its amplitude becomes proportional to the decreasing crevice thickness and then it is called the double reflection. The presence of strong positive double reflection marks the existence of serious damage at the joints of asphalt layers, e.g. delamination fissures filled with water. Strong negative double reflections may be the sign of sever dry delaminations, connections strongly sprayed with binder or cracks filled with foreign material of low permittivity.

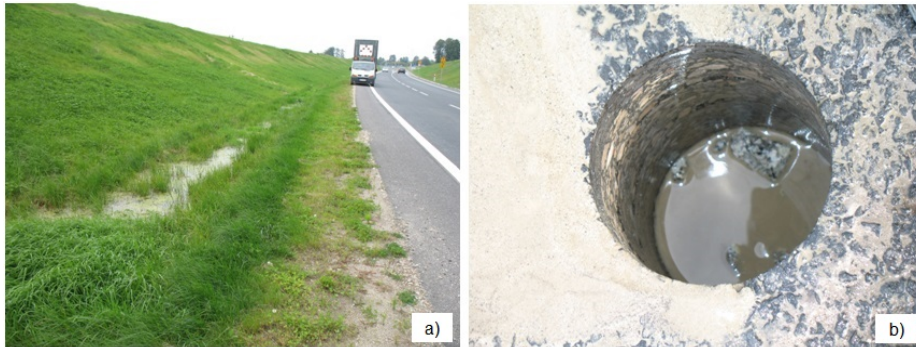
**Fig. 3.** a) section of road on which the drainage system is not functional; b) core extraction spot cleaned of dirt and water, spontaneously filling with water coming up from below.

The strongest extensive reflections are present in Case C, in which hydrological problems are dramatically demonstrated at the roadside (Fig. 3a), and water infiltrated into the borehole from below (Fig. 3b).
