High-Temperature Tensile Behaviour of GTAW Joints of P92 Steel and Alloy 617 for Two Different Fillers

Abstract: This study explores the high-temperature (HT) tensile rupture characteristics of a dissimilar gas-tungsten-arc-welded (GTAW) joint between P92 steel and Alloy 617, fabricated using ER62S-B9 and ERNiCrCoMo-1 fillers. The high-temperature tensile tests were performed at elevated temperatures of 550 °C and 650 °C. An optical microscope (OM) and a field emission scanning electron microscope (FESEM) were utilized to characterize the joint. The high-temperature test results indicated that the specimen failed at the P92 base metal/intercritical heat-affected zone (ICHAZ) rather than the weld metal for the ERNiCrCoMo-1(IN617) filler. This finding confirmed the suitability of the joint for use in the Indian advanced ultra-supercritical (A-USC) program. The fracture surface morphology and presence of precipitates were analysed using an SEM equipped with energy dispersive spectroscopy (EDS). The appearance of the dimples and voids confirmed that both welded fillers underwent ductile–dominant fracture. EDS analysis revealed the presence of Cr-rich $M_{23}C_6$ phases, which was conf

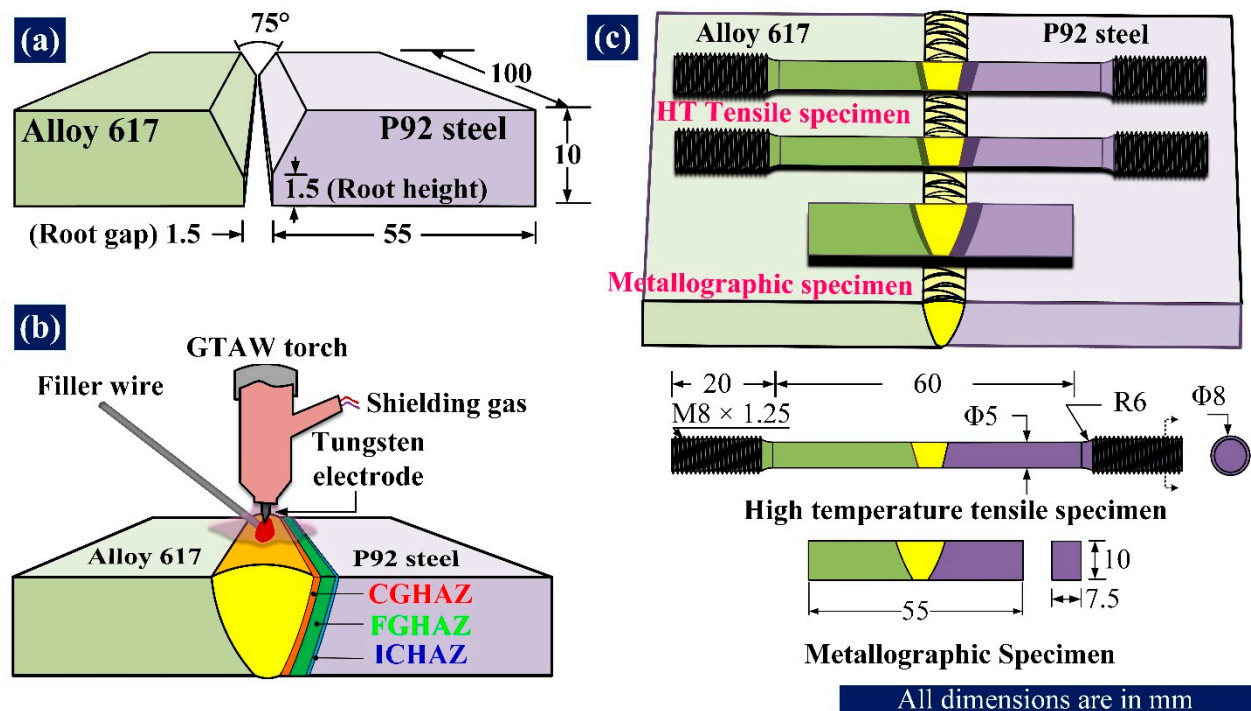
Figure 1. Schematic of (a) V-groove, (b) GTAW joint, (c) Welded plate and extracted samples with dimensions.

For this study, two 10 mm thick plates of P92 steel and Alloy 617 were welded together using the multi-pass gas tungsten arc welding (GTAW) process. The plates were cut and machined into dimensions of 100 mm \times 55 mm \times 10 mm. One side of the plates was machined as per the conventional V-groove of bevel angle 37.5° with a root face of 1.5 mm. All required dimensions related to the groove are illustrated in Figure 1a. Two joints were made: one joint with the P92 filler (ER62S-B9), and the other joint with the

ERNiCrCoMo-1 filler. The chemical compositions of plates and fillers are mentioned in previously published articles [22,23]. Each joint was completed in five passes, including the root pass. The root pass was completed with a welding current of 110 A and voltage of 12 V with a travel speed of 80 mm/min. For the remaining four passes, the welding current and voltage were 120–125 A and 12–14 V, respectively, with a travel speed of approximately 50–60 mm/min [22,23]. The argon gas was used for shielding purposes with a flow rate of 15 L/min. The P92 side HAZs include the region of the coarse grain heat-affected zone (CGHAZ), fine grain heat-affected zone (FGHAZ), and intercritical heat-affected zone (ICHAZ), all of which are shown in Figure 1b. To study the metallurgical and mechanical properties of the weldments, transverse samples were extracted from the plates (Figure 1c) using wire-cut electrical discharge machining (EDM). The metallurgical samples underwent grinding and polishing with sandpaper of grit sizes varying from 180 to 2000. To achieve a mirror surface finish, the sandpaper-grinded samples were further polished with alumina powder. Polished samples were then etched with Vilella's reagent for 60 s to reveal the microstructure of the P92 steel BM and P92 weld. The electrolytic etching was performed in a 10% oxalic acid solution to reveal the microstructure of Alloy 617 BM and the IN617-weld. The etched samples were analysed with an optical light microscope (model DMC4500 Leica) and scanning electron microscopes (model Apreo-2S ThermoScientific). The dimensions of the HT tensile test specimen and metallurgical specimen are displayed in Figure 1c. The HT tensile tests were performed at 550 °C and 650 °C, respectively, at a constant cross-head speed of 1 mm/min. The tensile tests were carried out on the universal testing machine 'Shimadzu AG-X-100KN'. The microhardness of the HT tensile samples was determined on a Vickers hardness tester (model AVHD-1000XY Banbros) along with the sample's longitudinal axis by applying a load of 500 g for a duration of 10 s. The indent was taken at every 0.5 mm gap. For the sake of convenience in this study, the P92-weld samples tested at 550 °C and 650 °C are represented as P92-weld-550 °C and P92-weld-650 °C, respectively. The IN617-weld samples tested at 550 °C and 650 °C are represented as IN617-weld-550 °C and IN617-weld-650 °C, respectively.

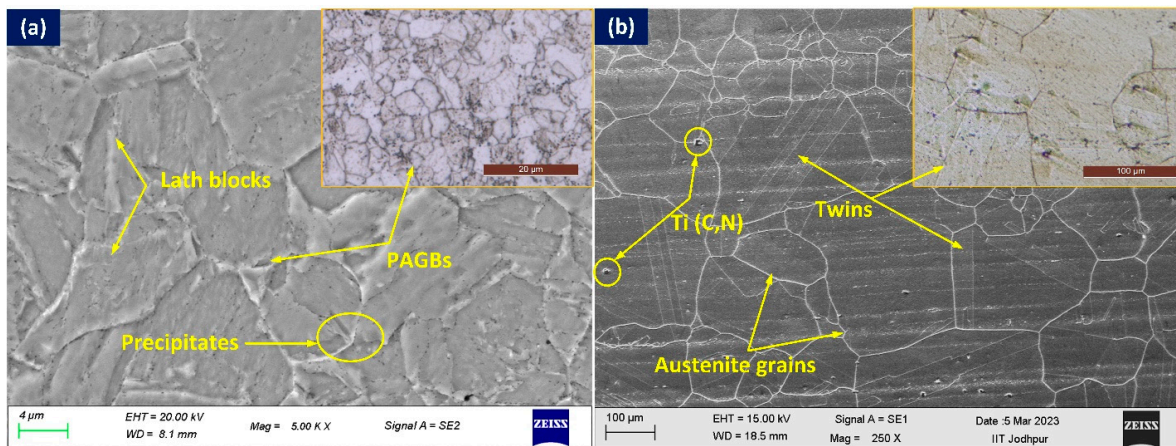
Figure 2. SEM and optical microstructure of (a) P92 steel BM and (b) Alloy 617 BM.

The microstructure of P92 steel BM is depicted in Figure 2a. The tempered martensitic microstructure consists of lath blocks, lath packets, packet boundaries, and prior austenite grain boundaries (PAGBs). The microstructure is strengthened through the presence of Cr, Mo, and W-rich coarse $M_{23}C_6$ precipitates, as well as V and Nb-rich fine MX (X: C, N) precipitates [24,25]. The microstructure of Alloy 617 BM consists of a solid solution that strengthens the matrix of austenite grain (Figure 2b) along with twins and carbides of Cr and Mo ($M_{23}C_6$), Mo-rich (M_6C), and Ti-rich (MX (X: C, N)) [24,25].

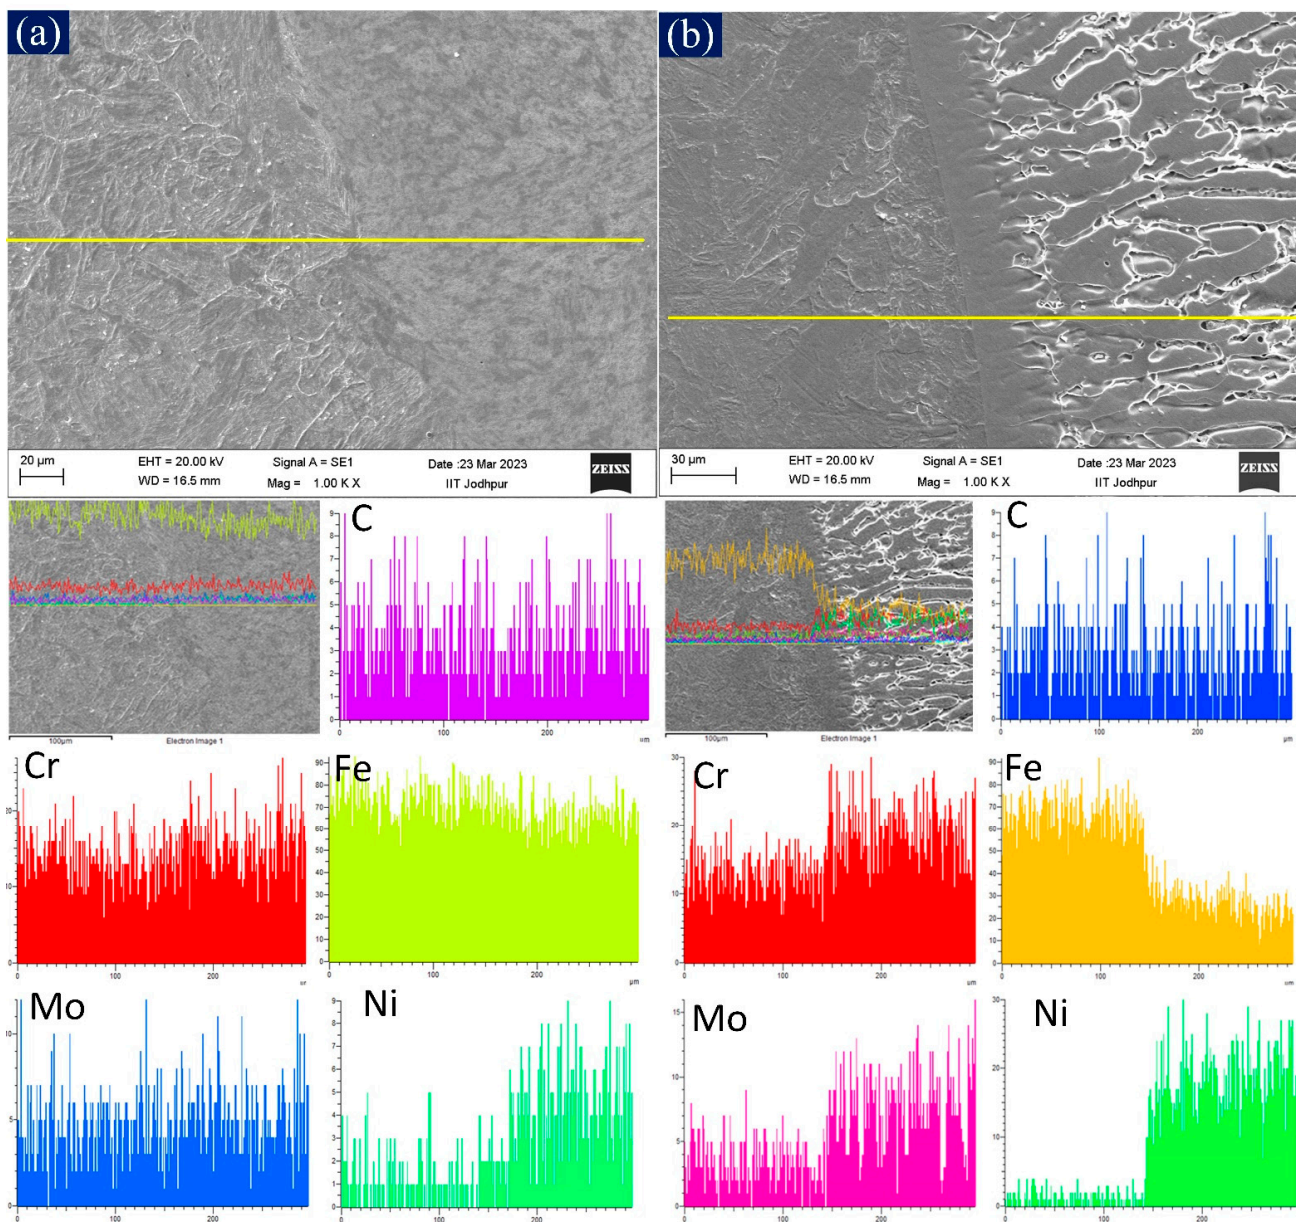
Figure 4. EDS line map across the interface of (a) P92-weld and P92 BM (b) IN617-weld and P92 BM.

The EDS line map was carried out on as-welded samples across the interface of WM and P92 to determine the diffusion of elements from the WM to P92-steel (Figure 4a,b). No significant diffusion was observed for the P92 filler because it has a similar composition to that of the P92 base material (Figure 4a). This confirms that the hardness variation was due to the change in the microstructure of the HAZ of P92, not from the elemental alteration due to diffusion of the elements from the WM to P92-HAZ. However, a significant element

variation is seen at the interface of the weld and P92 BM for the ERNiCrCoMo-1 filler (Figure 4b). The major variation is seen for Cr, Mo, Fe, and Ni. The line map confirms the diffusion of Fe from the P92 base matrix to the weld, as well as the diffusion of Cr, Ni, and Mo from the weld to the P92 base matrix. A similar observation has also been made in our previous study from the P92 filler [22] and the IN617 filler [23] welded joint.
