# HYDRAULIC ANALYSIS OF CAUSES OF WASHOUT OF GDYNIA-ORŁOWO SEA-SHORE DURING THE FLOOD IN THE KACZA RIVER ESTUARY

Michał Szydłowski

Gdańsk University of Technology, Faculty of Civil and Environmental Engineering, Poland

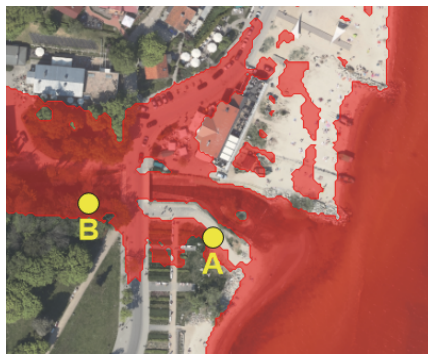
Fig. 6. Maximum depths [m] and range of flooded area in the region of Kacza river estuary and Gdynia- Orłowo beach together with depicted measurement points of maximum water level ordinates after the flood in July 2016 (A, B) (images prepared by this author on the basis of orthophotomap from municipal geodesic resources of Gdynia, Gdynia Municipal Council licence No. PND.6642.1.1697.2018\_2262\_N, without scale)

The differences in the calculated range of flooded area near the Orłowska street bridge and the beach are shown for particular simulation variants in Fig. 6. As can be seen, in successive variants the flooded area range increases and the zones of potential washing -out the sea shore belt and beach spread. Worth mentioning, that the flooded areas indicated in the last graph of Fig. 6 correspond to the location of the washout areas observed after the flood, shown in Fig. 1 (No. 1, 2 and 3). Simultaneously, neither in variant 1 nor 2 the flow streams north from the visible building and those on the southern side over the right bank of the river close to its estuary, were reproduced. This way the hypothesis has been proved on the decisive role of the reduced flow passage capacity of the cross-section under the Orłowska street bridge in forming the freshet run-off in the area of Kacza river estuary and its impact on the flood damages resulting in the washout of the sea-shore belt in Gdynia –Orłowo .
