# Influence of a Lighting Column in the Working Width of a W-Beam Barrier on TB51 Crash Test

**Abstract:** Road equipment, such as, e.g., road safety barriers and lighting columns, are subject to certification according to the EN1317 standard to be allowed for use on European roads. In engineering practice, due to the terrain conditions, there are cases where other road equipment is installed within the working width of road safety barriers. Such situations are not considered during the certification process. Hence, the aim of this study is to analyze the effect of a lighting column installed within the working width of the barrier on the results of the TB51 crash test. The full-scale crash test and numerical simulation of this event were conducted. In the full-scale crash test, as well as in the simulation, the lighting column prevented the barrier's post from properly disconnecting from the guardrail, which resulted in the barrier failing to restrain and redirect the 13-t bus. The simulation was quantitatively compared to the experiment, where the correlation coefficient of ASI curves equaled 84%. The THIV curves differed significantly between the experiment and the simulation,

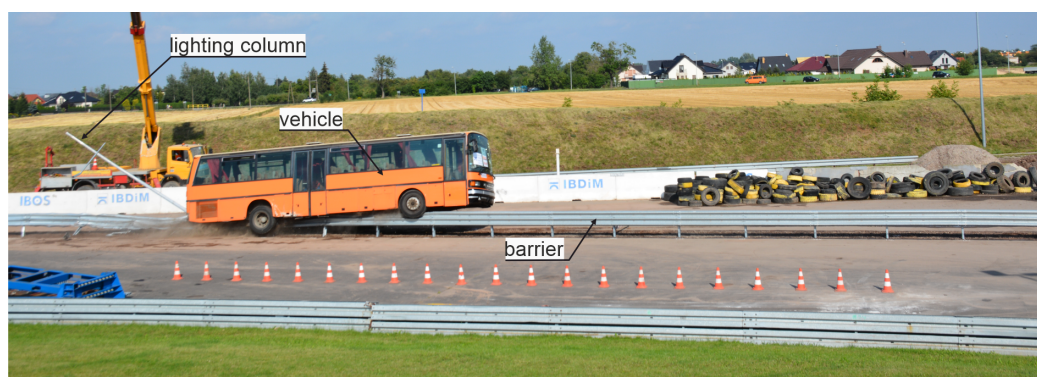
**Figure 1.** Exemplanary view of the bus during the analyzed crash test.

This study analyzes the effect of the installation of a lighting column in the working width of a W-beam RSB on the results of the TB51 crash test, as in Figure 1. This research is important as it will shed light onto the mechanisms and interactions that occur in the barrier–column–vehicle system during an accident. This will allow the verification of whether two road safety devices that are safe separately will also work together to achieve an appropriate level of safety. The TB51 crash test was selected as it involves a 13-tonne bus, which can inflict serious damage to the barrier during the impact. Moreover, this particular impact can have extremely tragic consequences, as there may be many fatalities and seriously injured persons. The W-beam barrier was chosen as it is one of the most frequently used types of barriers on roads in the EU. That barrier successfully passed full-scale crash tests according to EN 1317 [14]; hence, it has appropriate certificates for use on European roads. Similarly, the lighting column was positively tested in accordance with the EN 12767 standard [32]. However, the tests for both systems were conducted separately. Hence, the research aimed to evaluate the safety of the combination of those two road safety systems: the W-beam barrier and the lighting column. The other objectives of this study were as follows:

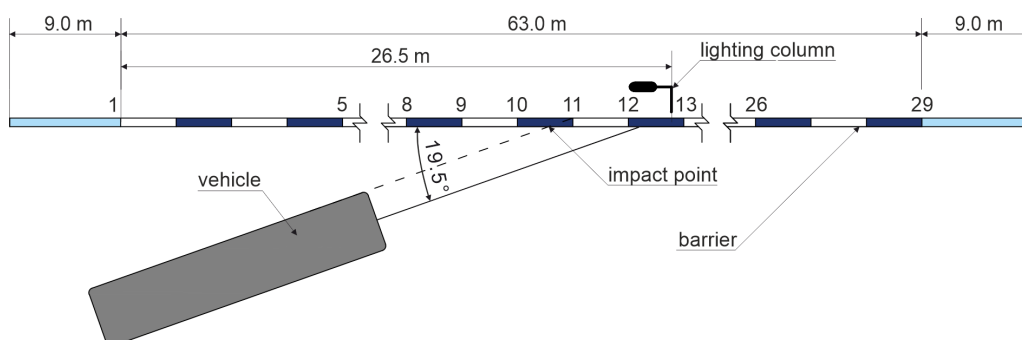
The full-scale crash test was conducted on 10 August 2017 at the testing grounds of the Research Institute for Protective Systems (IBOS) [33]. The experiment was carried out by the Research Institute for Roads and Bridges (IBDiM) [34]. This institute is certified by the Polish Center for Accreditation to, among others, perform crash tests according to the EN1317 standard [14]. The setup of the test is presented in Figure 2. The total length of the system was 81 m, where there was 63 m of straight section and 9 m at each end of the barrier.

**Figure 2.** Scheme of the test setup.

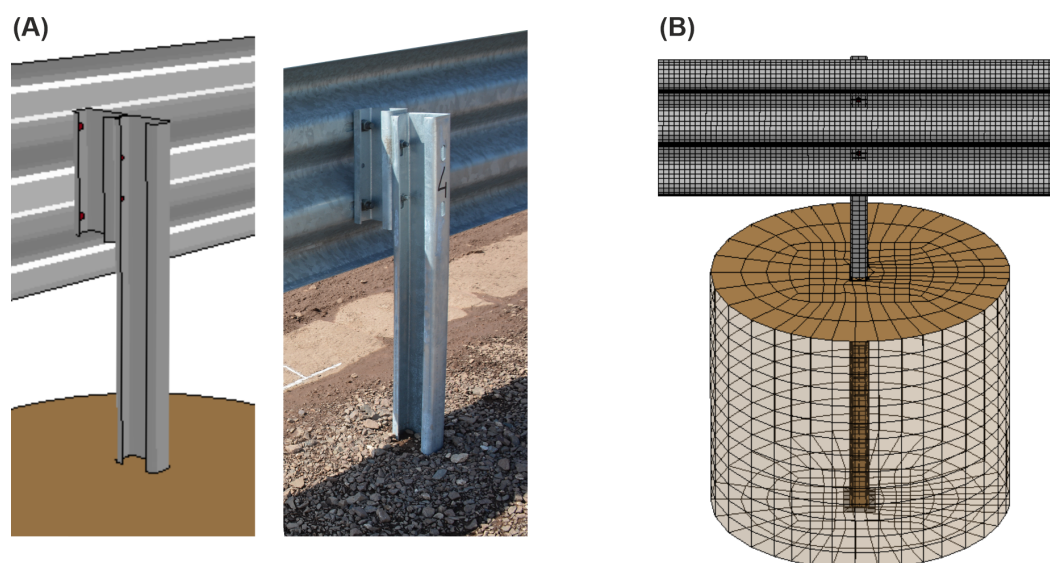
The model of RSB consisted of 271,018 nodes and 259,336 mainly quadrilateral FEs. The comparison between the selected part of the numerical model and the actual barrier is shown in Figure 5A. In Figure 5B, there is a view on the detail of the finite element discretization of the surroundings of the barrier's post. Figure 6A,B show the numerical simulation setup and include descriptions of the objects involved. In Figure 6C, there is also a discretization detail of the barrier's segment.

**Figure 5.** (A) Comparison between the actual post of the road safety barrier and the corresponding numerical model; (B) detail of FE discretization of a guardrail, a post, and the ground.

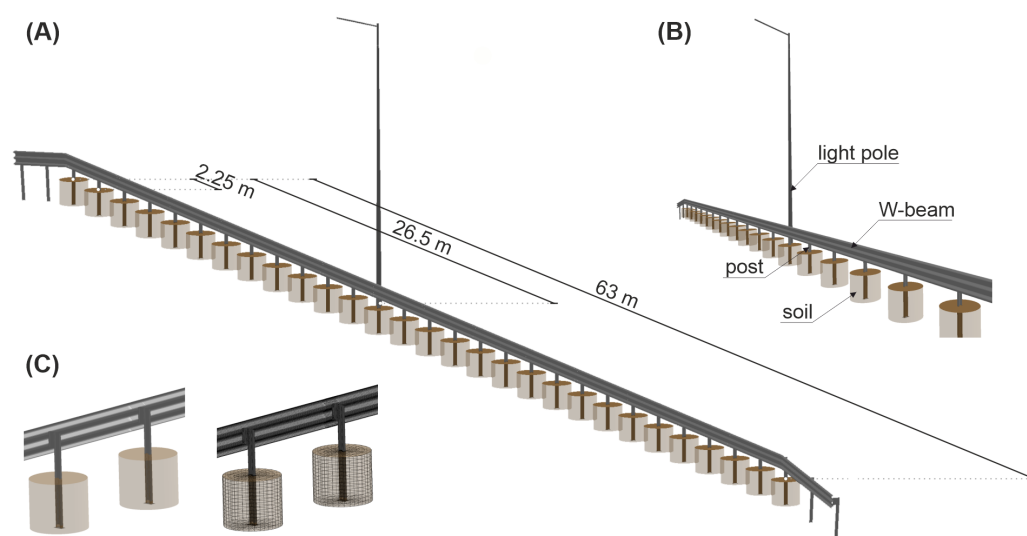
The lighting column model was created based on the column used in the experiment. The column in the test setup is shown in Figure 6A,B. The numerical model consisted of 3715 nodes comprising 3706 FEs. The elements of the column were modeled using four-node reduced integration shell elements. They had assigned a constitutive model of a piecewise linear plastic material law with material characteristics corresponding to S235 steel. The size of the elements was in the range from 20 to 50 mm, depending on the height. The mass and geometry were assigned according to the report from the experiment.

**Figure 6.** General views of the road safety barrier and the lighting pole with (A) specific dimensions, (B) a description of specific elements, and (C) a discretization detail of the barrier's segment.

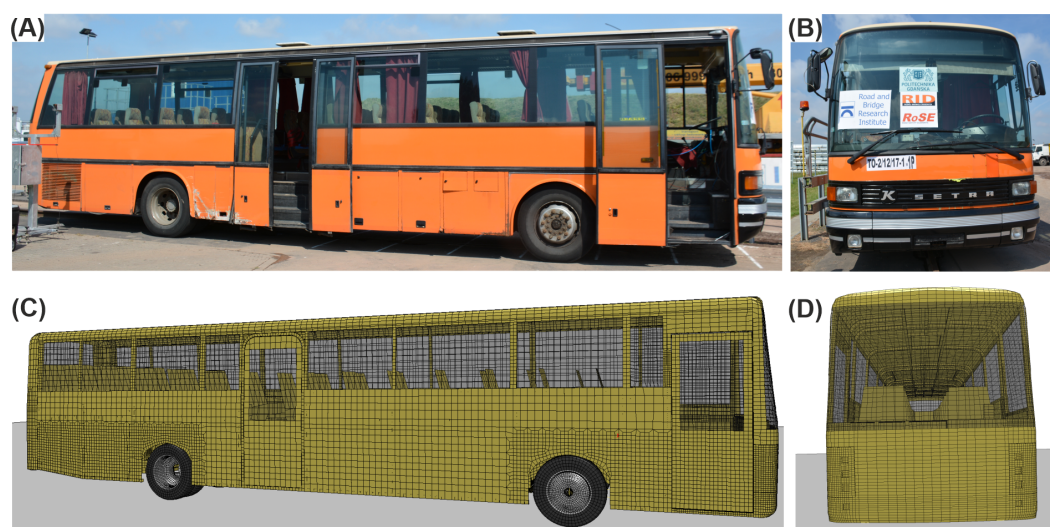
**Figure 7.** Comparison between the bus used in the experiment and the corresponding numerical model, with (A) a side view of the bus, (B) a front view of the bus, and (C) a side view and (D) a front view of the numerical model.

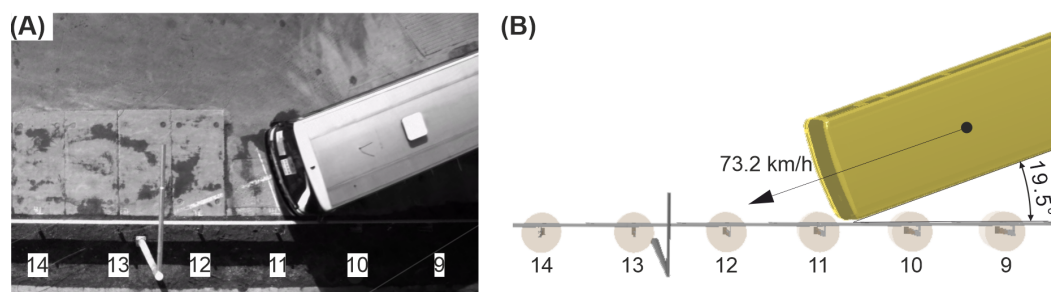
in the experiment; hence, the bus in the simulation hit the barrier 10 cm before Post 11. A comparison of the impact conditions between the experiment and the simulation is also presented in Figure 9.

**Figure 9.** Impact conditions of the vehicle in (A) the full-scale crash test and in (B) the simulation.

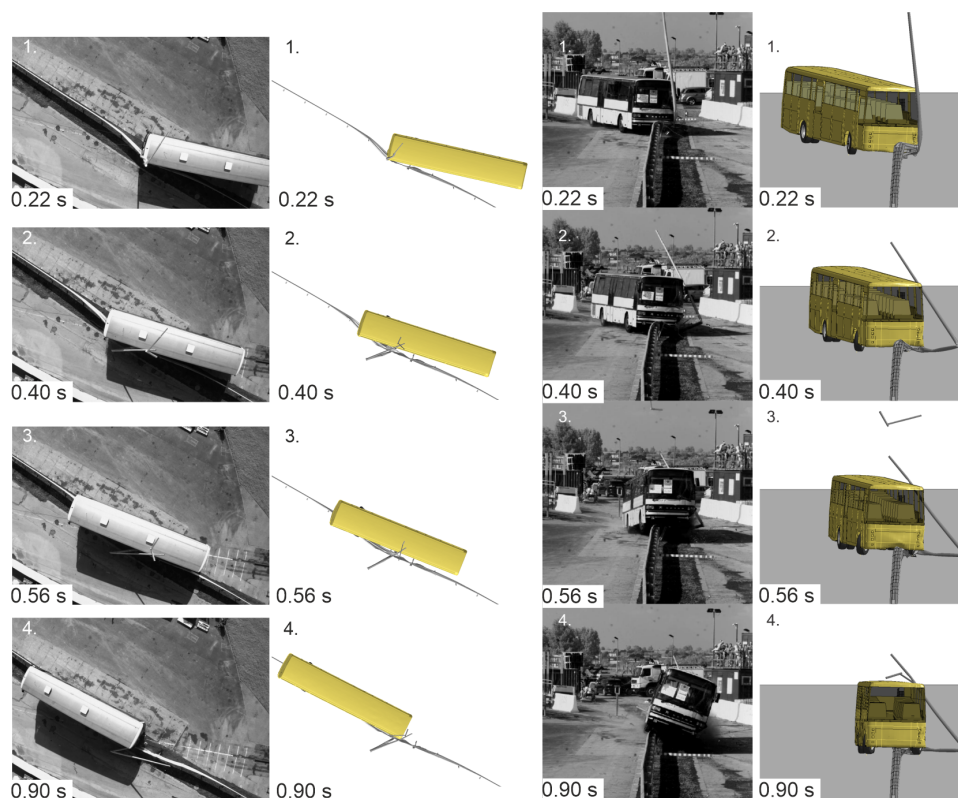
The results of the numerical simulation were compared with the corresponding experiment. A visual representation of the vehicle trajectories for both cases is presented in Figure 10. During the initial phase, the bus in the simulation and the experiment followed a similar path. Differences were observed in the latter parts of the test. The vehicle in the experiment hit the barrier and swung to its other side, as in Figure 10(2). As seen, the left side of the vehicle crossed the face of the barrier, and eventually, the whole bus followed and fully crossed over to the other side of the protective system (see Figure 10(4)). The wheels on the right side of the bus then caught the barrier, resulting in the bus rollover. A difference in the vehicle course was observed in the simulation where the center of the vehicle's chassis did not cross the face of the barrier. Hence, as a consequence, the vehicle hung on the barrier, as seen in Figure 10(3). The simulation ended with the bus's undercarriage hanging on the protective barrier, as in Figure 10(4). Nevertheless, in both, the experiment and the simulation, the analyzed road safety barrier did not stop the vehicle from crossing over the traffic lane.

**Figure 10.** Vehicle trajectories of the full-scale crash test and the numerical simulation.

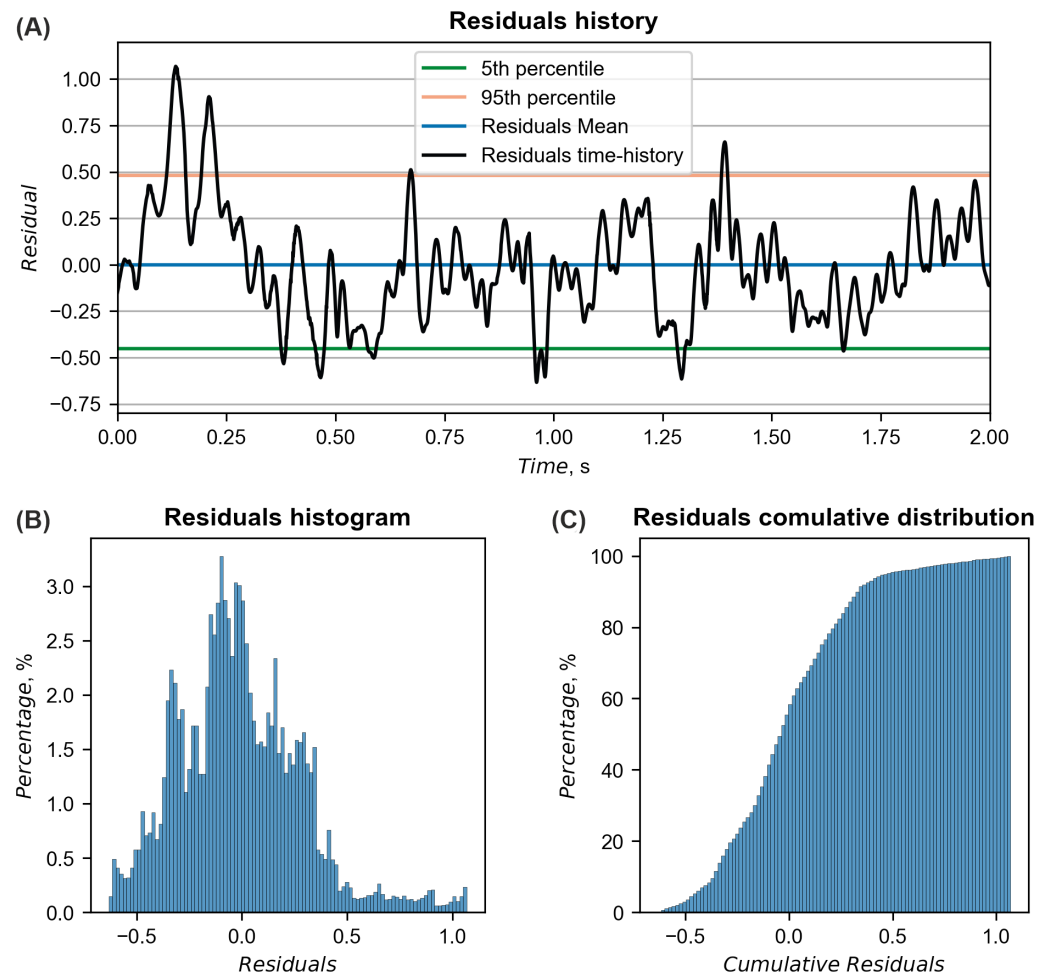
**Figure 12.** Residuals (A) history, (B) histogram, and (C) cumulative distribution of ASI curves.

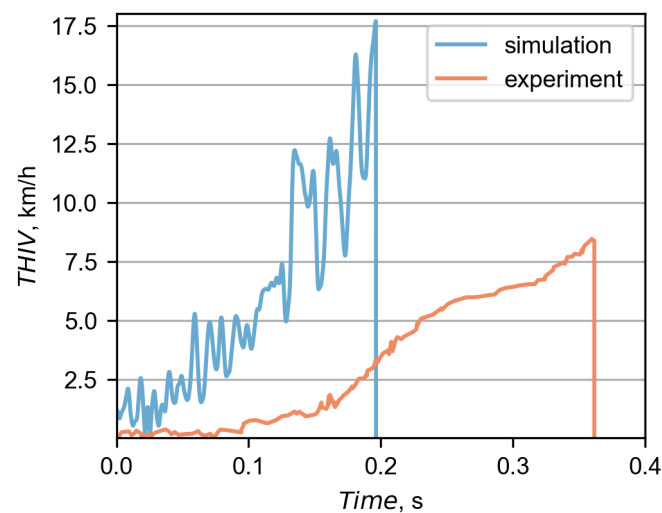
In Figure 13, there is a comparison between the experimental and the simulation THIV curves. For both cases, the THIV was based on accelerations from the driver seat. However, as seen in Figure 13, there are significant differences between those curves. Discrepancies are mainly due to the different rate at which the vehicle changed its direction after hitting the barrier. This is because the THIV index directly depends on the yaw velocity. In both cases, the barrier initiated the redirection of the bus. However, in the simulation, the redirection occurred faster and was more abrupt. In the experiment, the bus maintained its initial moving direction for longer. Additionally, the discrepancy may be due to the fact that in the simulation, the bus hanged on the barrier, and in the experiment, the bus completely ran over to the other side of the barrier.

**Figure 13.** The comparison between the THIV calculated at the driver seat in the simulation and the experiment.

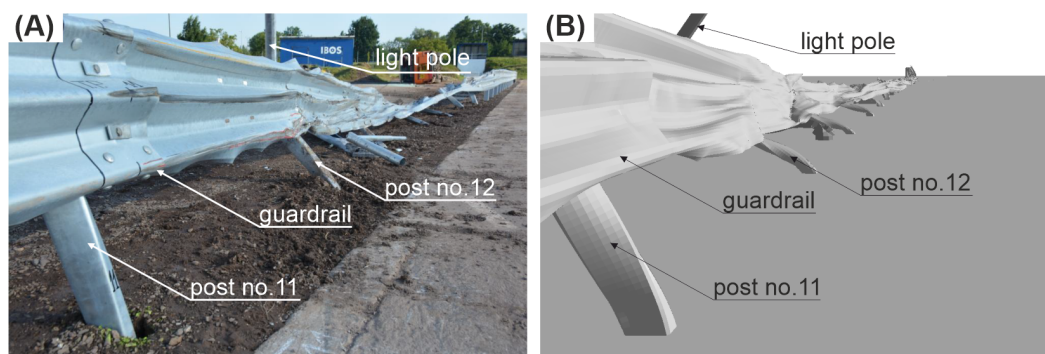
As a result of the impact in the full-scale crash test, the system was damaged between Posts 11 and 19. For the simulation, the damage was between Posts 10 and 25. The guardrail was locally torn in the experiment at Posts 12, 15, 16, and 18. For the simulation, the guardrail was severely damaged at Posts 12, 15, 18, 19, and 20. In the full-scale

crash test, Posts 11, 12, and 17 were bent, the posts between 13 to 16 were bent to the ground, and the posts from 1 to 11 were only twisted. For the simulation case, Posts 10, 11, 12, and 24 were bent, Posts 13 to 23 were bent to the ground, and the posts from 1 to 9 and No. 25 were only twisted. The lighting column for both the experiment and the simulation was damaged near the foundation and was broken at one third of its height.

A view of the damage of the system can be seen in Figure 14.

**Figure 14.** View of the damaged barrier. (A) Experiment; (B) simulation.

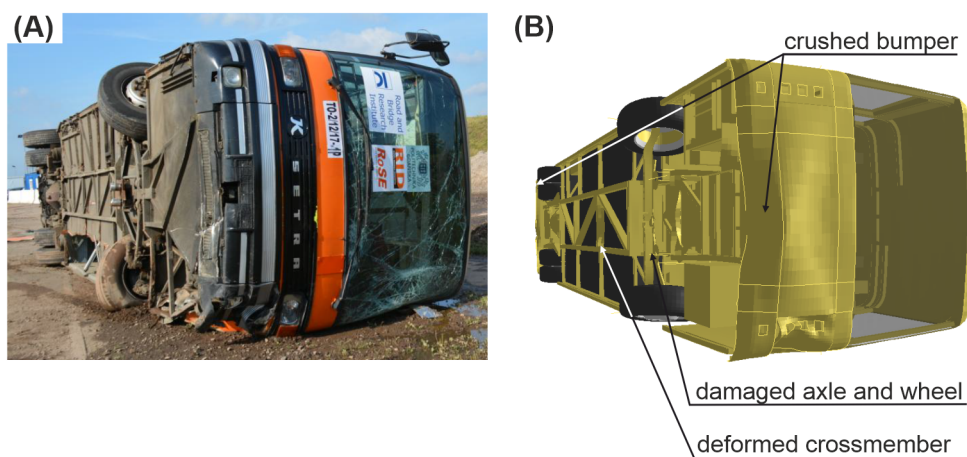
In the experiment, the rear window of the vehicle was broken, the front windshield was severely cracked, and the front bumper was crushed. Moreover, the left-front wheel of the vehicle was broken. The left side of the vehicle was damaged due to the contact with the guardrail. In the simulation, the left side of the vehicle was also damaged. Additionally, the front and rear bumpers were crushed due to the impact. Moreover, the cross-member of the chassis frame was damaged and the front axle was bent near the left-front wheel.

A comparison of vehicle's damage between the full-scale crash test and simulation is presented in Figure 15.

**Figure 15.** View of the damaged vehicle. (A) Experiment; (B) simulation.

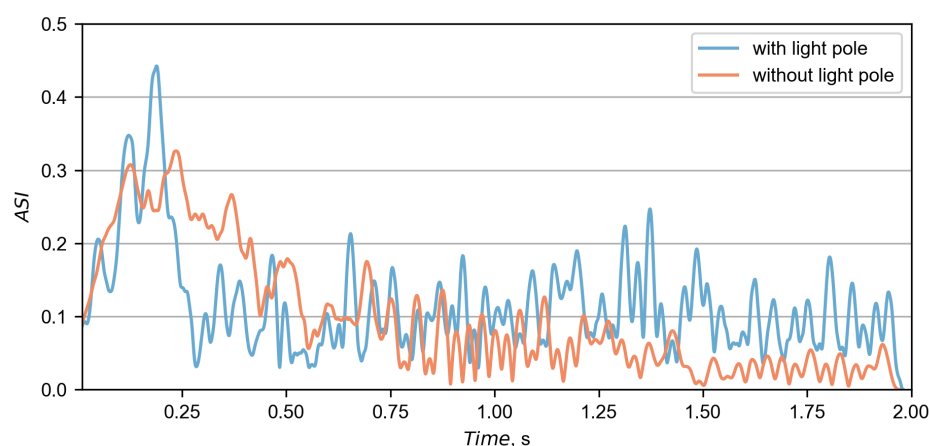
The results of the ASI and THIV for both simulations were calculated based on accelerations from the driver seat. Their corresponding curves are presented in Figures 17 and 18. In Case No. 2, the maximum ASI equaled 0.33 and was 25% lower than in Case No. 1. The time of the maximum ASI in Case No. 2 was at 0.235 s after the impact, which was 0.046 s later than in Case No. 1. The maximum THIV in Case No. 2 was 16.06 km/h at the time of 0.196 s, which is 9% less and 0.006 s earlier, compared to the other case.

**Figure 17.** The comparison between the ASI calculated at the driver seat in both simulations.

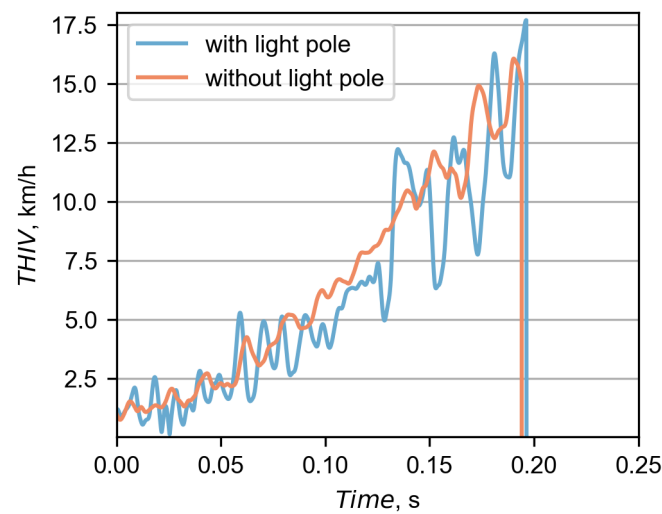
**Figure 18.** The comparison between the THIV calculated at the driver seat in both simulations.

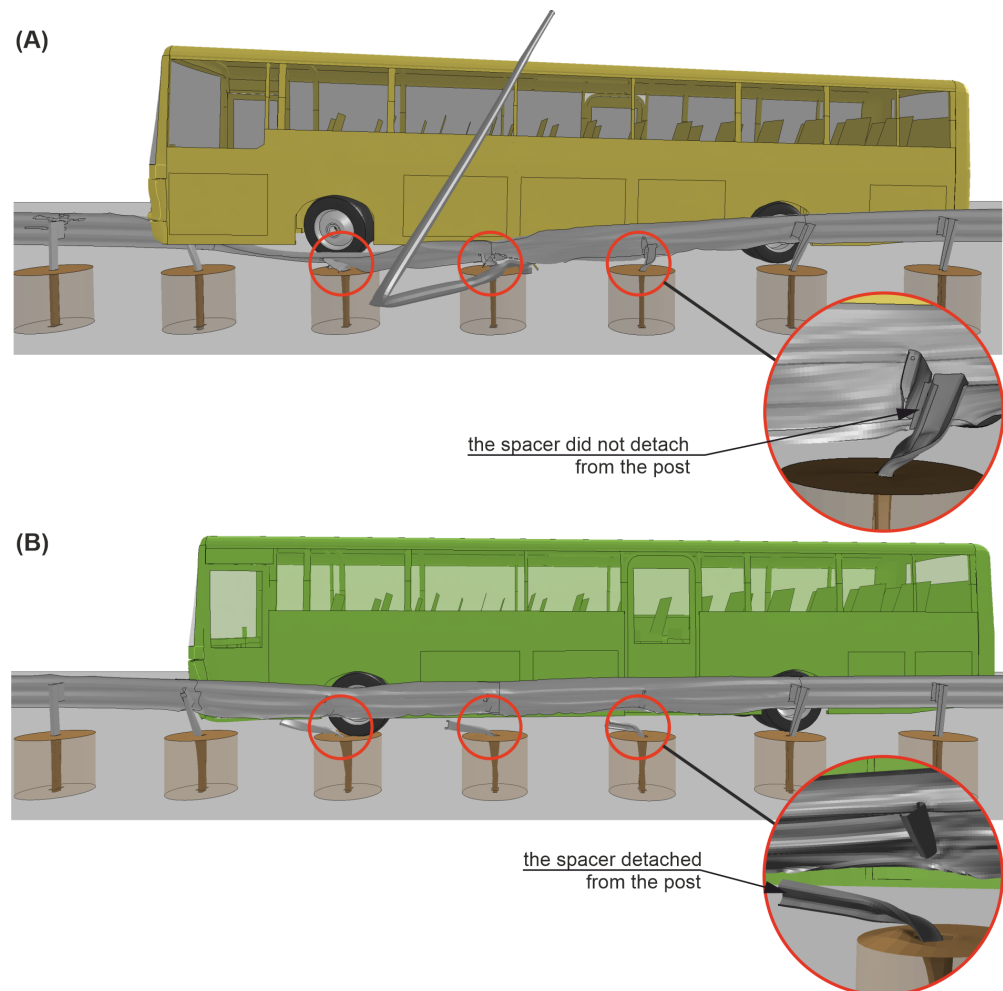
In Figures 19 and 20, there is a comparison between Case No. 1 and Case No. 2 at crucial moments in the simulation. It was observed that Post Nos. 11, 12, and 13 in Case No. 1 (see Figure 19A) did not detach from the guardrail, in contrast to the ones in Case No. 2 (see Figure 19B). This difference seems to be crucial from the point of view of the correct operation of the system. The experiment additionally confirmed the simulation results, where also no detachment of the posts from the system was observed. The comparison of the damaged barrier in the experiment and corresponding simulation is presented in Figure 21.

**Figure 19.** Side views of the H2/W4/B road safety barrier during simulations (time = 0.5 s) for (A) Case No. 1 and (B) Case No. 2. Note that the surface and soil cylinders are set transparent for clarity.

0.63–0.85	The left-front wheel of the vehicle crossed to the other side of the barrier, and the vehicle chassis landed on the top of the guardrail. The system underneath the bus almost completely laid down on the ground (see Figures 16(4.A) and 19A).	The bus was moving parallel to the line of the barrier. Post No. 12, 13, and 14 were disconnected from the system (see Figures 16(4.B) and 19B).

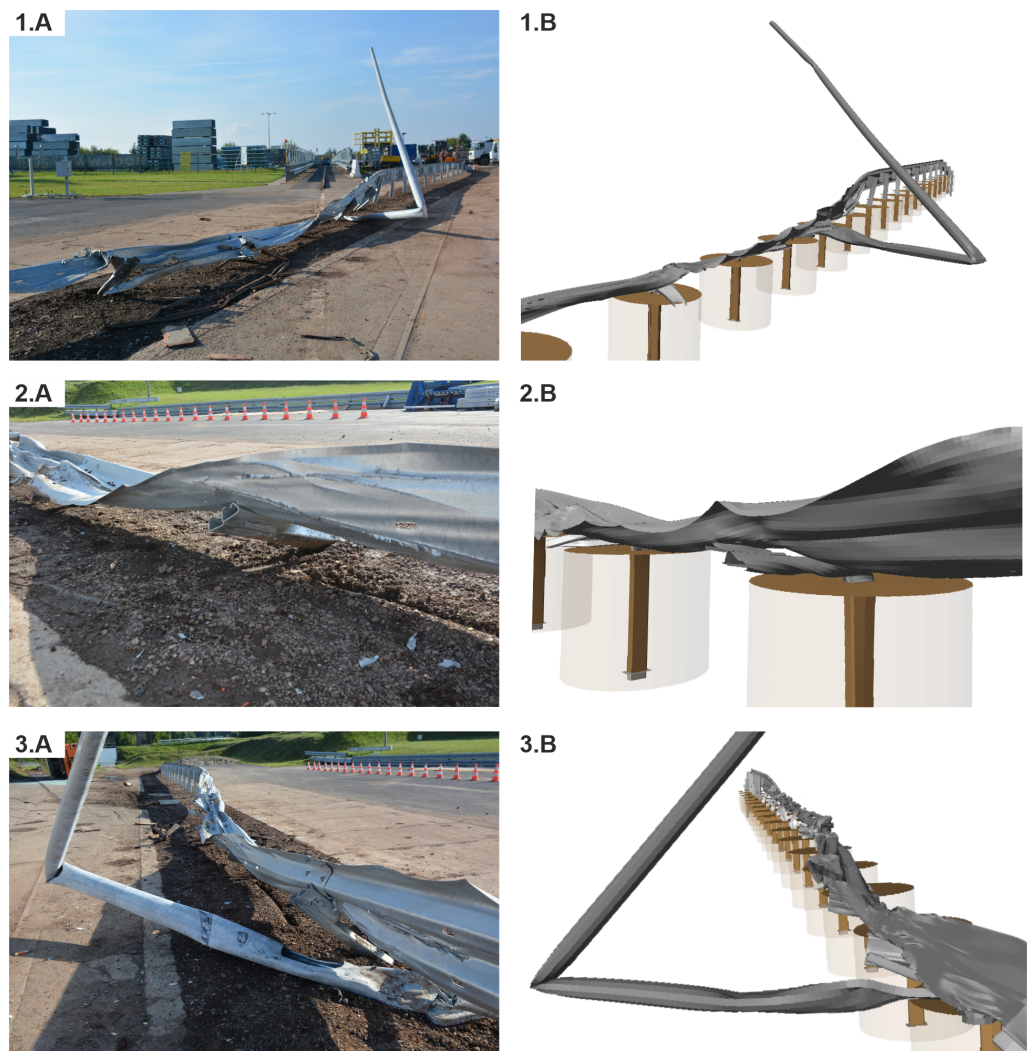
**Figure 21.** Views of the damaged H2/W4/A road safety barrier in (A) the experiment and in (B) the simulation. Note that the surface and soil cylinders are set transparent for clarity.
