Influence of Lubrication Water Contamination by Solid Particles of Mineral Origin on Marine Strut Propeller Shafts Bearings of Ships

Gdansk University of Technology, Faculty of Mechanical Engineering and Ship Technology, Poland

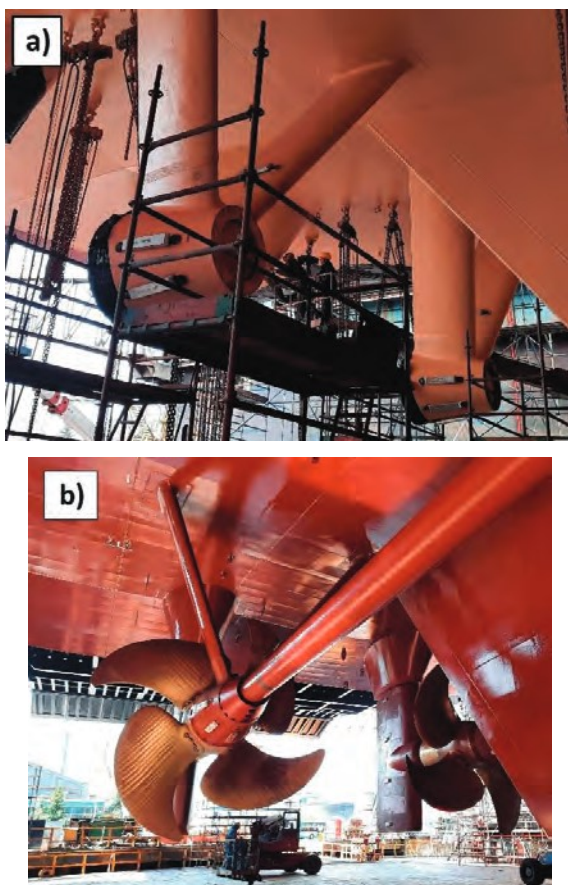
Fig. 1. Strut propeller shaft bearings for passenger and car ferries: (a) a propeller shaft strut before installation of the propeller shaft; (b) two shafts with propellers after final assembly

gives rise to certain problems. In the past, water-lubricated bearings installed inside the struts were commonly used, and the failure of these propulsion systems caused some shipowners to demand the use of oil-lubricated strut bearings. To make this possible, the shaft support was connected to the hull by a pipe called a stern tube, consisting of a jacket protecting the shaft, filled with circulating lubricating oil. This solution is relatively complicated and sensitive, due to the need for a complex sealing system to ensure the tightness of the lubrication system. These are not 100% environmentally safe solutions, as there is a risk of seal damage and oil leakage into the sea. To extend the durability of the seal, some permanent operational leakage of oil into the water is often allowed (up to two litres per day from a properly functioning system). It is also common that seawater enters the lubricating oil, which may degrade the properties of the lubricant. In the case of some environmentally friendly oils (i.e. the so-called EAL), water ingress may cause the formation of chemical compounds such as acids that can degrade rubber seals, among other components. The desire to reduce the cost of components at the construction and operation stages and to avoid the risk of contamination of lubricating oil from seawater has caused some shipowners to willingly use water-lubricated bearings (Fig. 1b). A cantilever bearing has a relatively simple structure, since it is lubricated by the surrounding water.

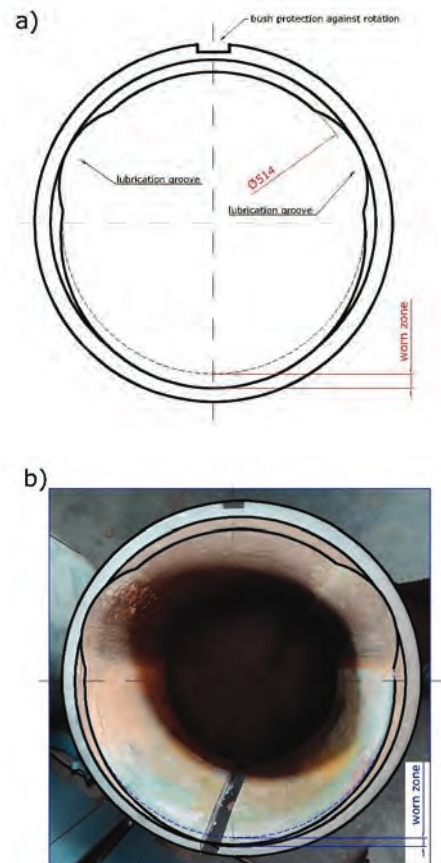
Fig. 2. A ship tail shaft strut bearing bush after dismantling from the passenger and car ferry shown above: (a) simplified drawing of the bushing; (b) photo of a dismantled, worn bushing (the worn area is marked; a slice of the bush was cut and removed by shipyard workers to make disassembly easier)

However, this solution also has some significant disadvantages. An unprotected propeller shaft is exposed to corrosion, and must be carefully protected. The bearing is lubricated with water, which is not filtered, meaning that it may contain various impurities, including hard solid particles of mineral origin, which are particularly dangerous. This was the case for the shaft shown in Fig. 1. After only two years of operation, the wear of the bushings was so deep that it was necessary to replace the bearings and regenerate the journals of both propeller shafts (Fig. 2).

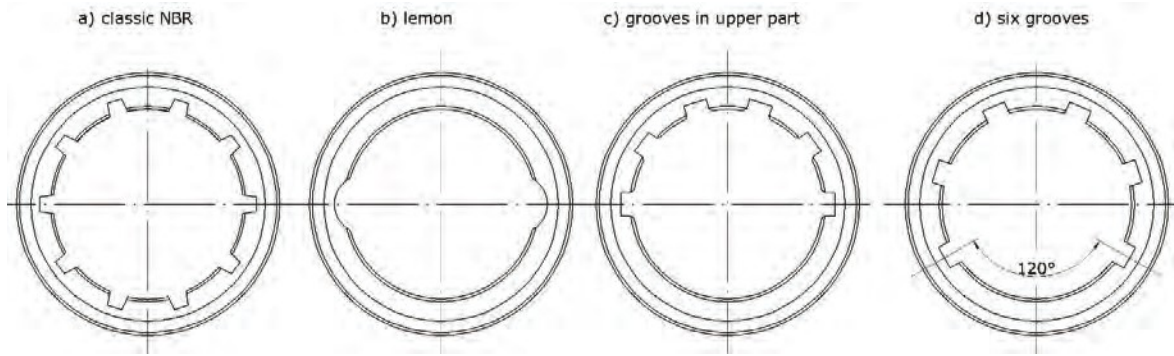
Fig. 3. Four popular bush geometries used in shipbuilding

This research focused on a group of typical materials prepared for use in shipbuilding (Table 1) with four typical, popular geometries (Fig. 3). It is worth noting that the solution with grooves around the entire circumference (Fig. 3a) is considered to be a classic design, and is still being produced, although attention is now being paid to hydrodynamic phenomena, which is why bushings in which the loaded part has no lubrication grooves at all are becoming increasingly popular (Fig. 3b, c). A compromise can be found in the form of a geometry with wider grooves (Fig. 3d), and it is sometimes possible to find the opinion that a wider arrangement of lubrication grooves favours the flashing out of impurities from the friction zone, and that limiting the sliding surface to 120° of circumference does not limit the hydrodynamic potential of such a solution. All the bushings tested here were manufactured and provided by global manufacturers, and were made extremely carefully. The bearing clearance was selected each in each case in accordance with the manufacturer's recommendations and experience. Each of the materials tested here has also been accepted for use in shipbuilding by at least one of the well-known classification societies, and is in practical use in shipbuilding.

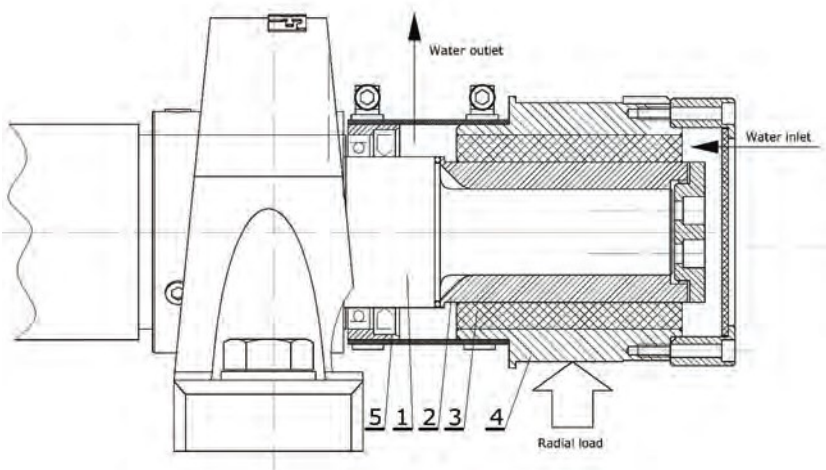
Fig. 4. Key parts of the test rig: tested bearing with seal module; 1 - main shaft, 2 - shaft sleeve, 3 - tested bush, 4 - bush housing, 5 - sealing ring guided by a ball bearing

The experiment was conducted using a specially designed test stand (Fig. 4) with a replaceable stainless steel shaft journal. The bearing assembly was sealed with a specially designed seal module (5). By guiding the sealing ring through the rolling bearing, it was possible to ensure tightness despite the progressive wear of the sliding couple and the gradually increasing displacement of the shaft and bushing axis. The lubricant was water contaminated with solid particles, which was kept in a tank with a conical bottom. To prevent the process of gravity causing sedimentation of the water contaminants, the mixture of water and contaminants was constantly stirred. The

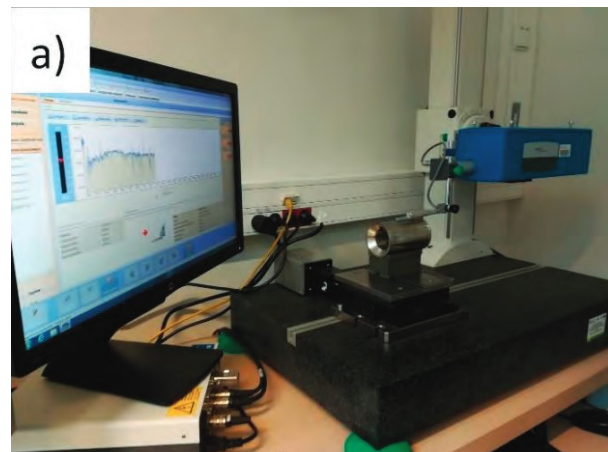
Fig. 7. (a) Profilometer measurements of the shaft journal surface profile; (b) method used to calculate the wear field based on the roughness profile.

In order to investigate the wear of the sliding pair, it was necessary to measure the wear of the shaft journal and bushings. The shaft journal wear was determined by analysing the measurement results with a profilographometer, which allowed us to calculate the consumption area and then the volume (Fig. 7).

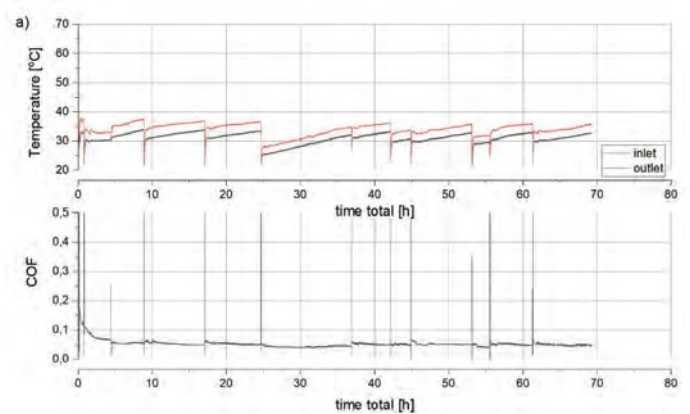
Fig. 9. Temperature of the water at the inlet and outlet sides of the bearing, and coefficient of friction (COF) for a classic bearing with a rubber bush with grooves around the entire circumference, under clean water lubrication (bearing 1a*)

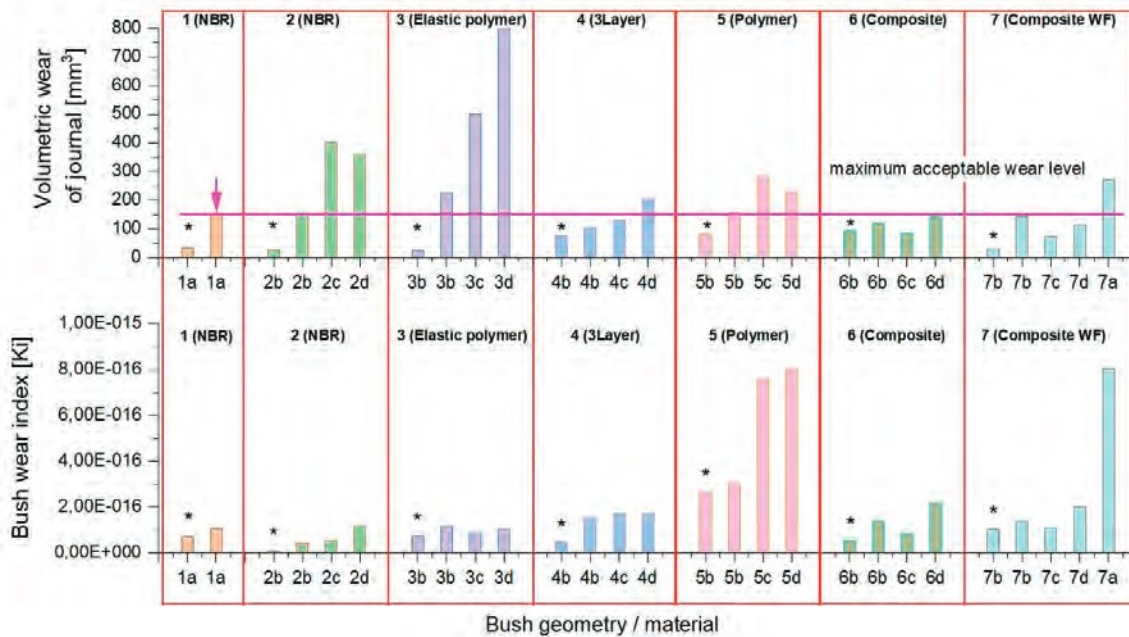
Fig. 11. Summary of wear results for shaft journals and bearing bushes, for varying sliding couples and geometries (* indicates tests performed with clean water)

The reference line showing the maximum acceptable wear level is marked on the volumetric journal wear comparison chart above. This is conventionally used to show the level of wear recorded for the classic solution, i.e. a bearing with a rubber bushing with through lubrication grooves on the

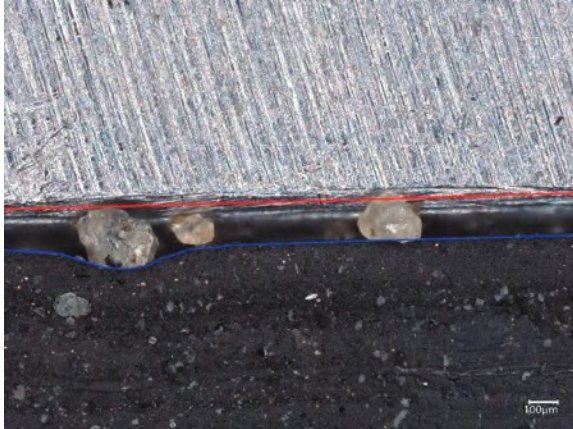
Fig. 12. Contact surface of the steel-NBR pair, with solid particles of mineral origin between them, showing the local deformation of the flexible NBR.

It was found that the forces exerted on the particle were not large enough to crush it, and that it rolled between the shaft journal and the bushing. The local deformation of the bush is shown in the microscopic photo below of a specially prepared model (Fig. 12). This concept helps to explain why on elastic bearing bushes only large scratches probably made by larger hard particle are easy to notice (fig. 13, 2b and 4b). For harder bushes process of crushing a particles results intensive wear especially when hydrodynamic properties are poor because of lubrication grooves located in lower half of the bearing bush (fig. 13, 6d and 7a).

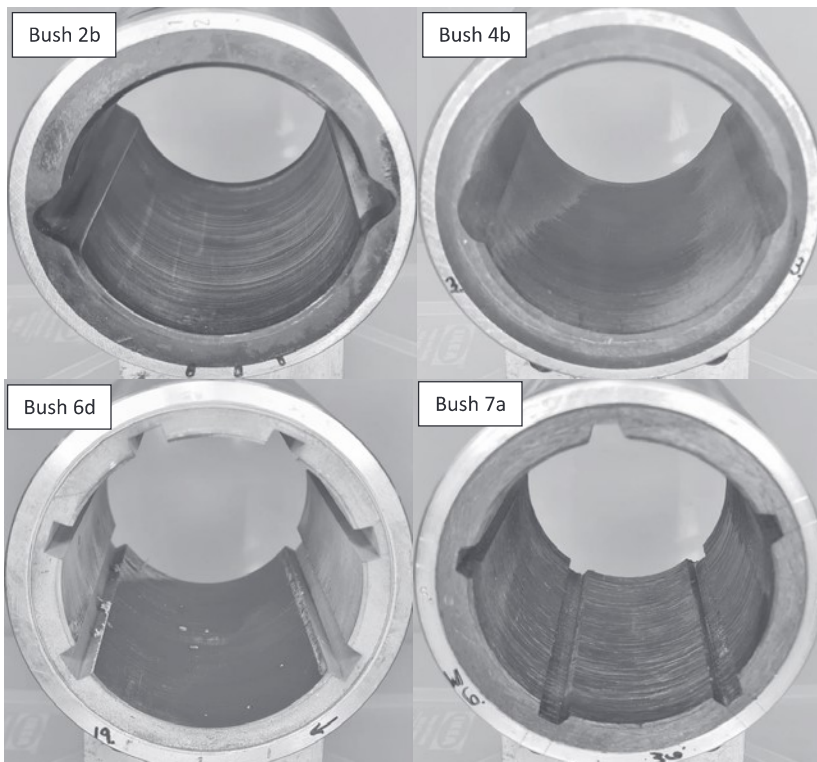
Fig. 13. Selected group of tested bearing bushes; 2b- NBR with scratches on surface, 4b- 3 layer bush with smoothed surface and visible contact zone, 6d - polymer bush with wear zone between grooves, 7a- composite with deep worn zone - visible contact zone (dark)
