INFLUENCE OF PROCESS OF STRAIGHTENING SHIP HULL STRUCTURE MADE OF 316L STAINLESS STEEL ON CORROSION RESISTANCE AND MECHANICAL PROPERTIES

ABSTRACT

Keywords: 316L steel, flame straightening, corrosion resistance, mechanical properties

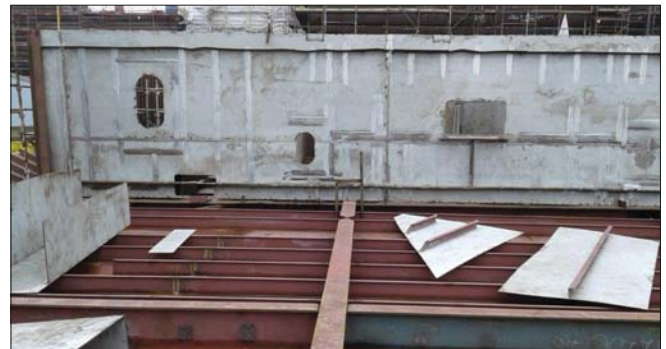
Fig. 1. RSW cargo tank under construction in shipyard

Tests were carried out on 316 L steel plates after the flame heating process. The steel plates were austenitic steel, which, due to its corrosion resistance and high plasticity properties, has a wide spectrum of uses. It is commonly used even under cryogenic conditions. In shipbuilding industry it is used to make, among others, LNG gas tanks in a liquid state (operating temperature of about -155°C), piping and to lay RSW (refrigerated seawater) holds (for transporting fish in water at a temperature close to 0°C) of fishing vessels (see Fig. 1).

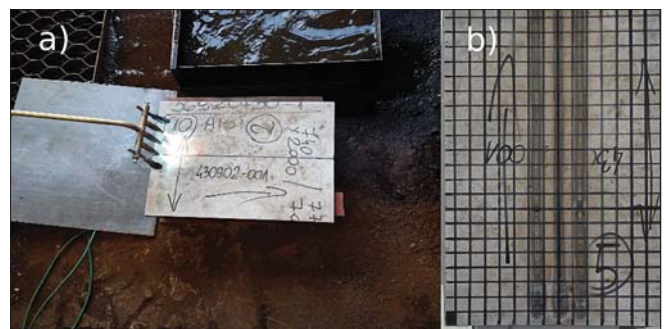
Fig. 2. Test plate during straightening process (a) and surface after process (b)

Eight test plates were provided for testing: two reference ones made of material not subjected to flame straightening (reference material), three straightened and naturally cooled ones, and three straightened and water-cooled ones (All panels had dimensions of 300×450 mm and a thickness of 10 mm. Straightening was carried out using triple flame burners. Figure 2 shows the plate during straightening. The straightening direction was perpendicular to the rolling direction.
