Mechanical and Microstructural Characterization of TIG Welded Dissimilar Joints between 304L Austenitic Stainless Steel and Incoloy 800HT Nickel Alloy

Abstract: In this article, the mechanical properties and microstructure of 304L austenitic stainless steel/Incoloy 800HT nickel alloy dissimilar welded joints are investigated. The joints were made of 21.3 mm × 7.47 mm tubes using the TIG process with the use of S Ni 6082 nickel filler metal. No welding imperfections were found and high strength properties of joints were obtained, meeting the assumed acceptance criteria of the product's standards. The tensile strength of the welded joints was higher than for the joined materials (Incoloy 800HT). Macro- and microscopic metallographic tests revealed the correct morphology of the joints and the appropriate structures in their critical zones. However, differences were found in the morphologies of the zones between the weld and the base materials. In fusion boundary from the side of the Incoloy 800HT alloy, no clear outline of the fusion line was observed (type A fusion boundary), while increased grain size and an epitaxial structure were observed. In turn, in the zone: weld–304L steel,

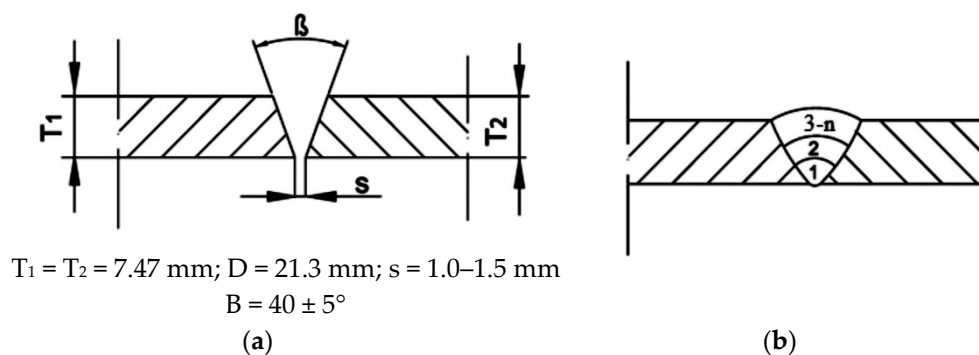
Figure 1. Scheme of (a) edge preparation for welding, (b) welding sequence.

For structural and operation reasons, the need to make welded joints of 304L austenitic stainless steel and Incoloy 800HT tubes appeared. Before welding, the tubes were beveled according to the scheme in Figure 1a. The proposed geometry of the welding groove enables full penetration and minimizes welding deformations by reducing the bevel angle, which is important because of the required dimensional tolerance of the tube system. Figure 1b shows the welding sequence.

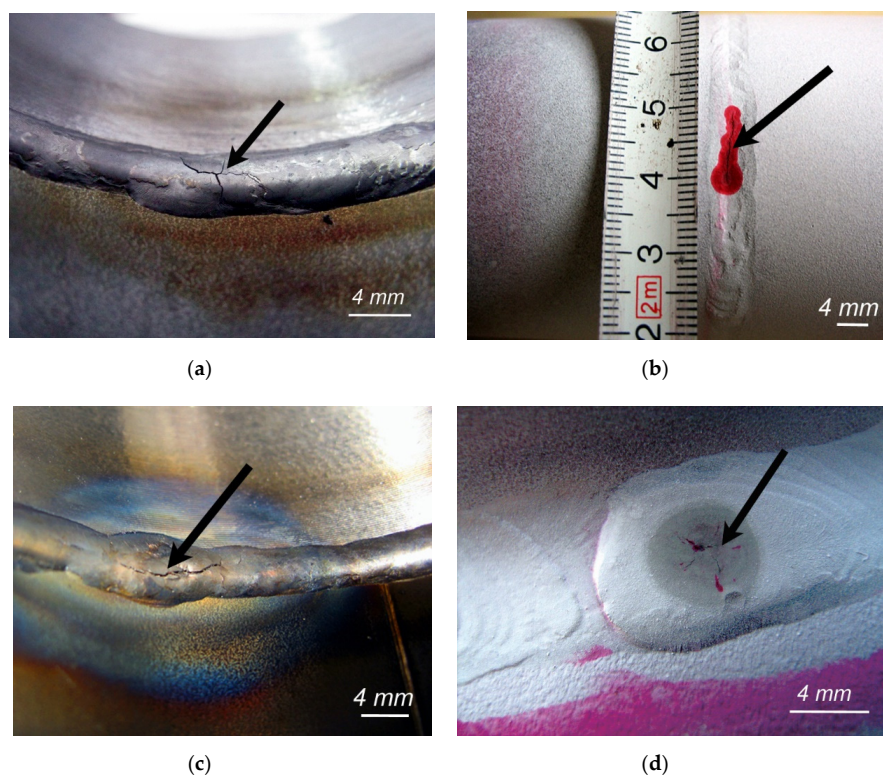
Figure 2. Examples of welding imperfections identified after the preliminary welding tests (a) and (c) crack from the root; (b) and (d) cracks from the face. The arrows mark the cracks.

The identified cracks occurred from the root side (Figure 2a,c) and the face side (Figure 2b,d) of the weld. Their shape is characteristic for hot cracks, i.e., they extend along the axis of the weld (Figure 2a,b) and propagate out from the center of the weld at its end (Figure 2d). The analysis of the welding process showed that the welding technique characteristic for austenitic stainless steels was one of the causes of the formation of this type of imperfection. It was changed through the use of straight beads, the distribution of liquid metal by mixing with a filler, making joints with an excess weld metal and filling the end crater with reinforcement. In addition, after each bead, the oxidized filler tip was cut off to eliminate the introduction of oxides into the liquid metal pool, which was not done for preliminary joints. This limited the appearance of liquid and brittle film from the segregation of impurities, which is one of the causes of crack formation [13]. The applied changes also led us to verify the welding parameters, which resulted in a decrease in the heat input. Those modifications brought positive results and allowed us to accept welding parameters. Test joints were made according to the parameters shown in Table 4. Five specimens were made: two were subjected to tensile tests, two to bending tests and one for other structural tests and microhardness measurements.

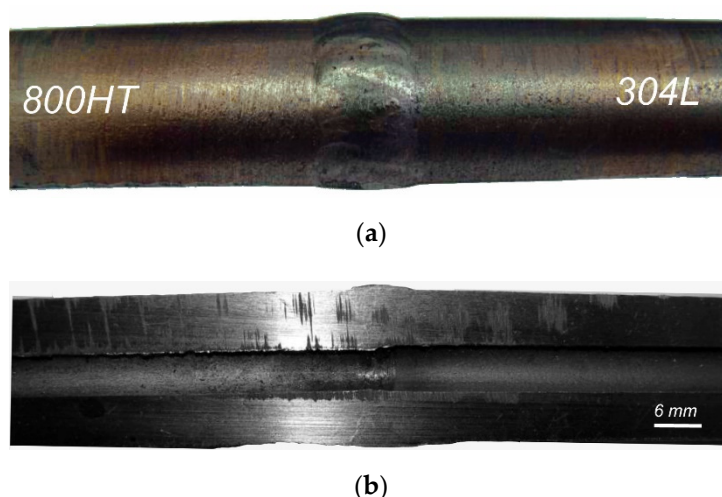
Figure 3. Example of a specimens (a) view from the face; (b) cross-section.

Figure 3a shows the view of the face of the weld. A characteristic feature of this area for the material group being studied is low fluidity (high density) of the liquid metal pool. The consequence of this is the inability to obtain a characteristic clear, smooth face as in the case of the welding of austenitic stainless steels. All joints had the same weld face appearance. Figure 3b shows the cross section of the joint. As can be seen, the wall thickness of the tube is large relative to the outer diameter of the tube, which results in a small inner diameter. Thus, it is very important to shape and protect the root using forming gas. This requires the right flow rate to achieve laminar flow of the shielding gas. In the present case, sufficient values are 6–8 l/min. In addition to the proper formation of the root, this protected the surface against oxidation, which, when it occurs, may lead to the loss of corrosion resistance. After verification of the joints made on the basis of NDT and positive test results, they were subjected to destructive tests according to the presented research plan.

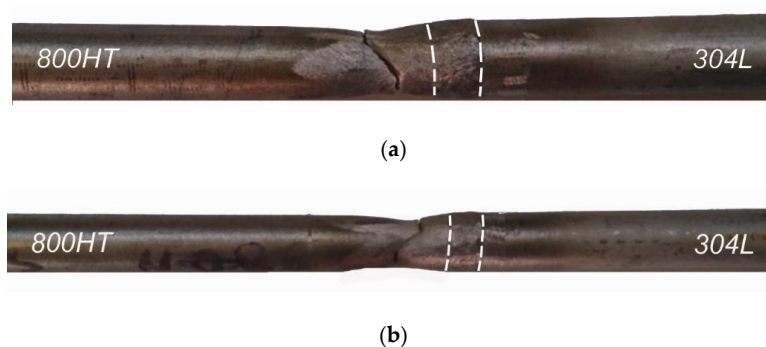
Figure 4. Specimens after transverse tensile test (a) specimen A; (b) specimen B. Dashed lines mark welds.

Transverse tensile tests were carried out for two specimens, A and B (extended entire welded tube joint). Figure 4 presents the view of specimens after the tests. According to ASTM B 407, the minimum tensile strength of the Incoloy 800HT alloy is 450 MPa, and according to SA 312, the minimum tensile strength of the 304L austenitic stainless steel is 485 MPa. The acceptance criterion was the minimum tensile strength of the base material with a lower tensile strength, in this case Incoloy 800HT. The results of the test are presented in Table 5.

Despite the fact that the hardness distribution (Figure 18) indicates a reduction in the hardness in HAZ of austenitic steel, both samples were fractured in Incoloy 800HT base material (Figure 4). This is not a typical result, but has already been reported in the literature for dissimilar joints of nickel alloy and austenitic stainless steel [39].

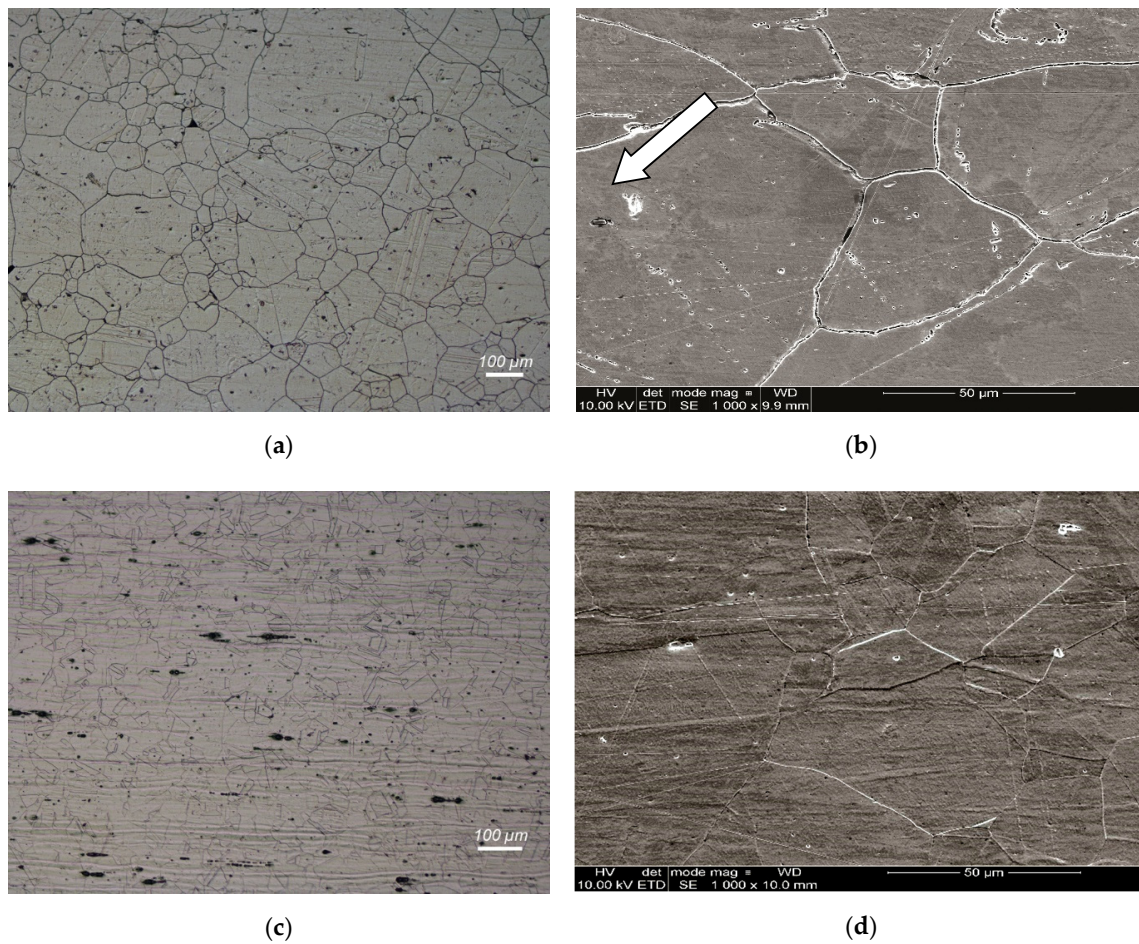
Figure 7. Metallographic structure of (a) Incoloy 800HT nickel alloy—optical microscopy; (b) Incoloy 800HT nickel alloy—electron microscopy; (c) 304L austenitic stainless steel—optical microscopy; (d) 304L austenitic stainless steel—electron microscopy.

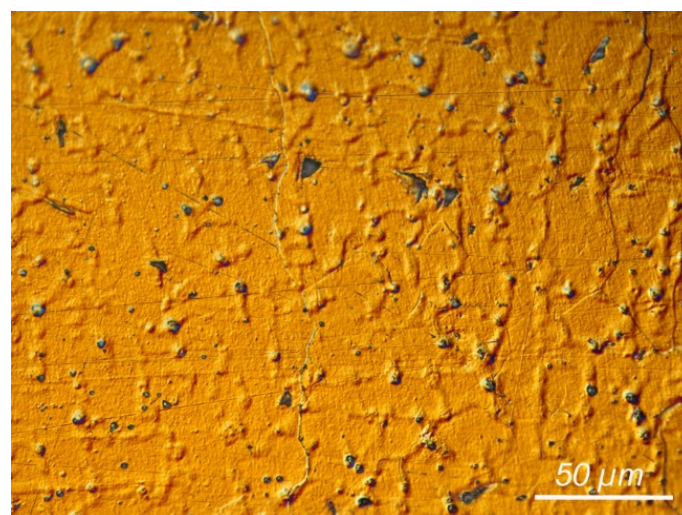
Figure 8. Metallographic structure in the middle part of weld metal.

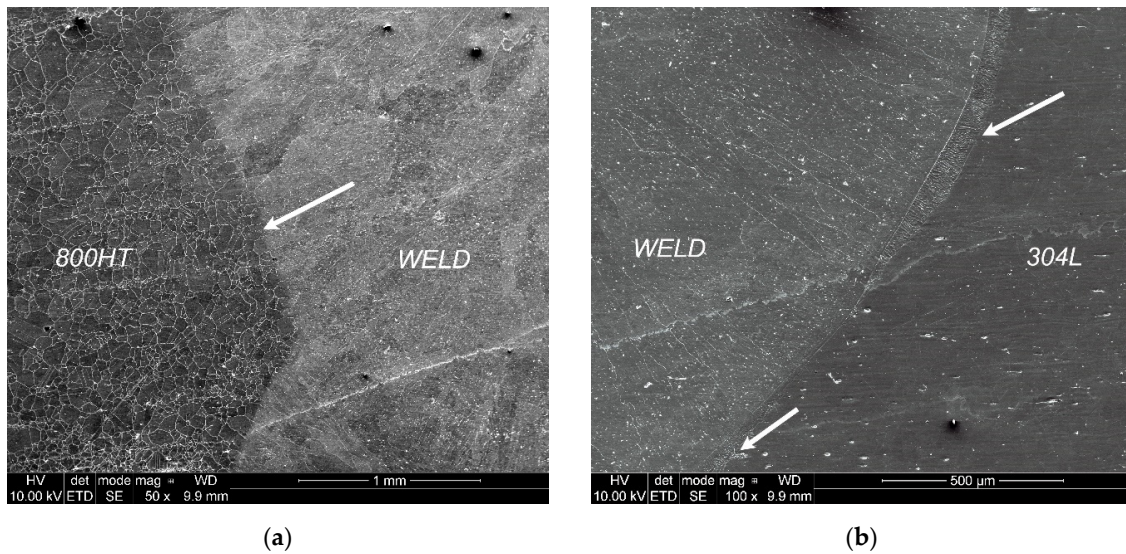
Figure 9. SEM micrograph showing interface between (a) weld–fusion line and Incoloy 800HT nickel alloy (type A fusion boundary) and (b) weld–fusion line and 304L austenitic stainless steel (type B fusion boundary).

Changing the arrangement of dendrites into columnar and their increase occurred in zones adjacent to the base material. Figure 9a,b show a view of the joint areas: Incoloy 800HT–fusion line–weld and weld–fusion line–304L stainless steel (white bands visible also in Figure 6). There are significant differences between the morphology of the fusion line and the HAZ for both materials (indicated by arrows), which is in accordance with the available literature [38]. From the Incoloy 800HT side, there is no clearly defined HAZ (type A fusion boundary); only at larger magnifications, a smooth transition of the weld metal into the base material can be observed (Figure 10). The morphology of the area between 304L stainless steel and the weld is different (type B fusion boundary). The areas of the smooth transition of weld to base material were observed, but there were also the zones of different morphologies (marked by the arrow in Figure 9b) which may indicate structural changes in this area. In order to analyze them, microscopic examinations (Figures 10 and 11) were performed with higher magnification and the application of DIC (Nomarski contrast).

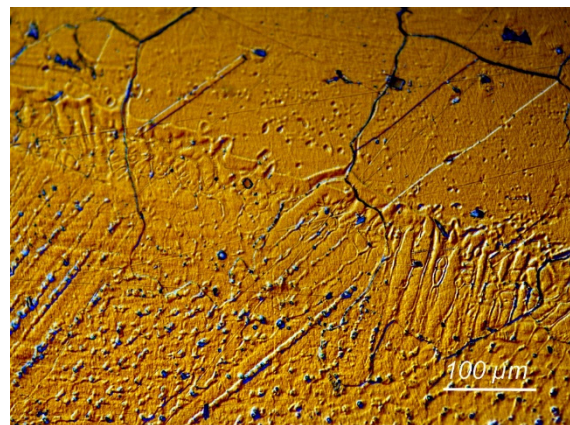
Figure 10. Micrograph showing interface between weld–fusion line and Incoloy 800HT nickel alloy (Nomarski contrast).

In the transition zone between the weld and Incoloy 800HT (Figure 10), columnar dendrites appearing towards the base material are visible. This may be due to the lower thermal conductivity of the Incoloy 800HT alloy (11.5 W/mK) compared to 304L stainless steel (14.0–16.3 W/mK). This leads to a slight dissipation of heat introduced during welding and the formation of the observed dendrite arrangement. Such changes were also observed by other researchers in welded joints of nickel alloys with austenitic stainless steel [38,44]. In the direction of the base material, melting of its grains and the epitaxial crystallization area, a transition of the dendritic structure of the weld in the crystallographic direction of the base material was observed. In the fusion zone, the grain shape of the primary structure (base material) can be observed. This type of crystallization is associated with relatively low thermal conductivity, low heat dissipation and a high density of the liquid metal. In the case of transition zone: weld–304L stainless steel, this structure was not observed. However, areas with significant changes in morphology were identified, as revealed using the Nomarski contrast (Figure 11). Clearly defined spaces on the fusion line show the occurrence of high-temperature δ ferrite. Their intensity is associated with the higher thermal conductivity coefficient of 304L compared to the Incoloy 800HT and the welding position (H-L045), which generates varied heat distribution along the fusion line. Hence, the δ ferrite-rich zones do not occur along the entire length. The analyzed areas, despite structural and morphological differences, did not reveal imperfections in the form of microcracks or the formation of eutectics, which can be the result of introducing oxides or organic contaminations into the welding pool. No chromium carbide precipitations—that could lead to intergranular corrosion—were observed, which could result from the heat input during welding in the H-L045 position.

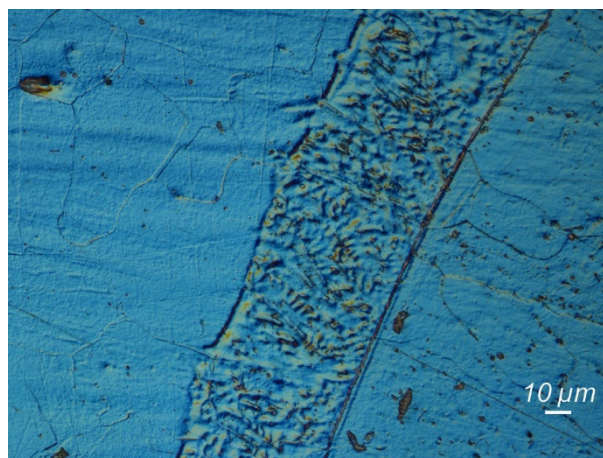
Figure 11. Micrograph showing interface between weld–fusion line and 304L austenitic stainless steel (Nomarski contrast).

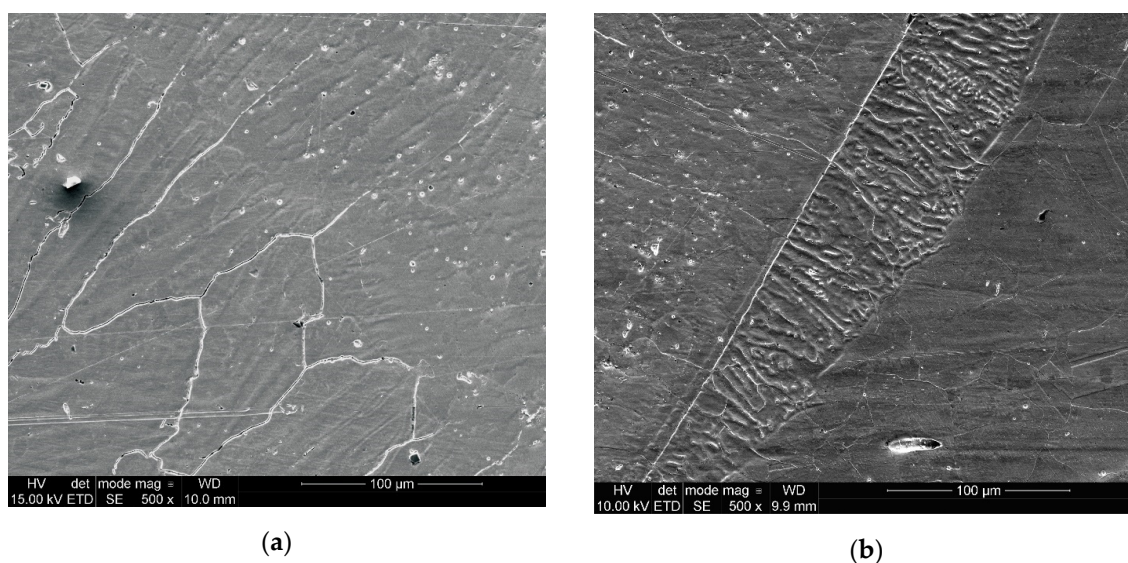
Figure 12. SEM micrograph showing interface between (a) weld–fusion line and Incoloy 800HT nickel alloy and (b) weld–fusion line and 304L austenitic stainless steel.

The next stage of the research was to determine the distribution of elements in transition zones. Figure 12 shows the areas subjected to this analysis, and Figures 13 and 14 show the results of the test.

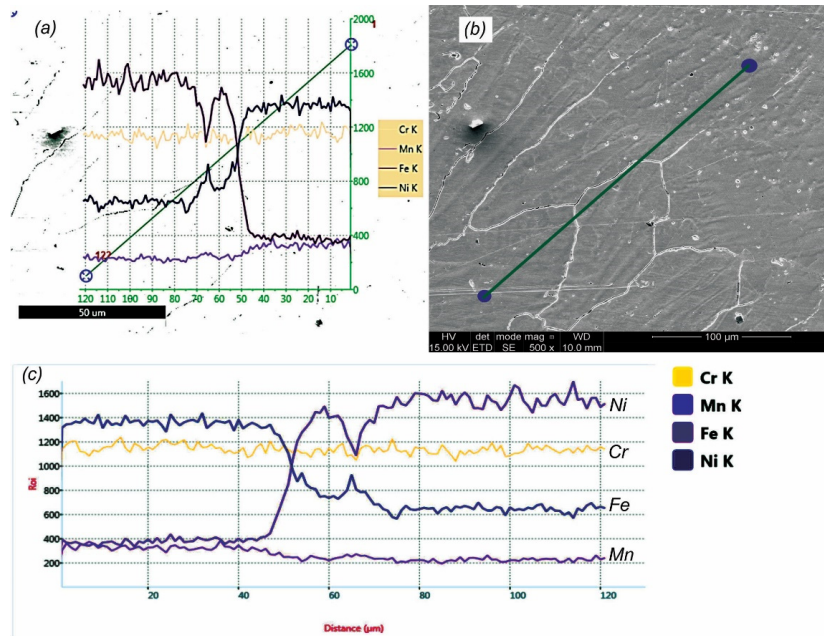
Figure 13. Results of EDS linear analysis for the zone: Incoloy 800HT nickel alloy (a) distribution of elements against the background of the structure with the measuring line marked; (b) microstructure of the weld area–HAZ–Incoloy 800HT nickel alloy with the line according to which the elements were measured; (c) linear distribution of elements.

In the transition zone on Incoloy 800HT, the proper change in the content of elements was found during an analysis of the linear distribution of the chemical elements. The change in chemical composition presented in Figure 13 indicates that the iron and nickel content in the fusion line changes significantly, which is an expected feature. The iron content increases after crossing the fusion line, and the nickel content decreases and corresponds to the content in the base material. No changes in chromium content were observed, suggesting no chromium carbide precipitates in this area. The manganese content decreased after crossing the fusion line. The contents of other elements were at the expected, correct levels. An analysis of the EDS linear distribution of the second transition zone, i.e., for 304L stainless steel, showed similar characteristics. Elemental distribution changes after crossing the fusion line were

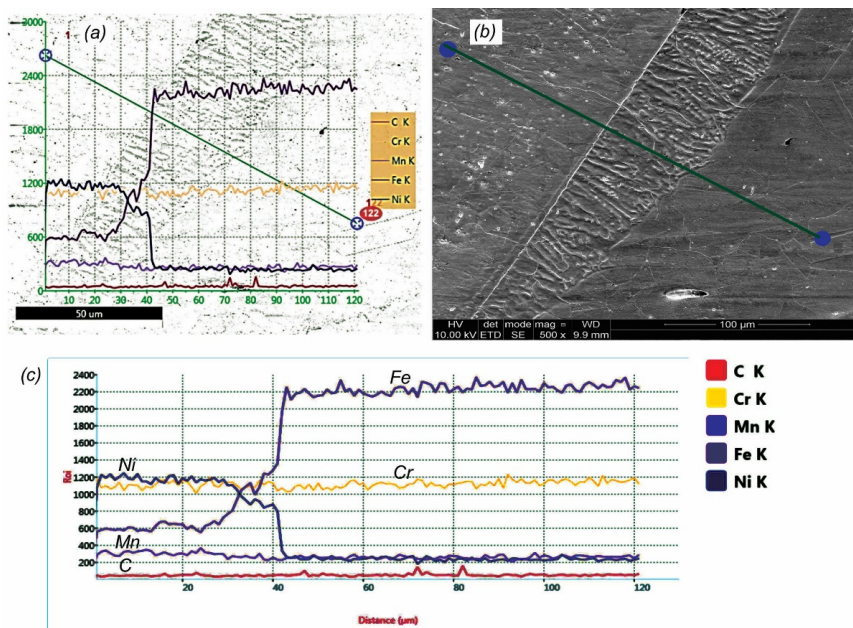
Figure 14. Results of EDS linear analysis for the zone: 304L austenitic stainless steel (a) distribution of elements against the background of the structure with the measuring line marked; (b) microstructure of the weld area–HAZ–304L austenitic stainless steel with the line according to which the elements were measured; (c) linear distribution of elements.

observed (Figure 14), and were the greatest for nickel and iron. These diffusive changes are slight compared to the transition zone of Incoloy 800HT. The presented research results suggest that no intermetallic phases were precipitated. The appropriate welding heat input and the use of straight beads (high cooling rate) allowed the reinforcing elements to remain in the solid solution. It also resulted in high strength, as revealed by mechanical tests.

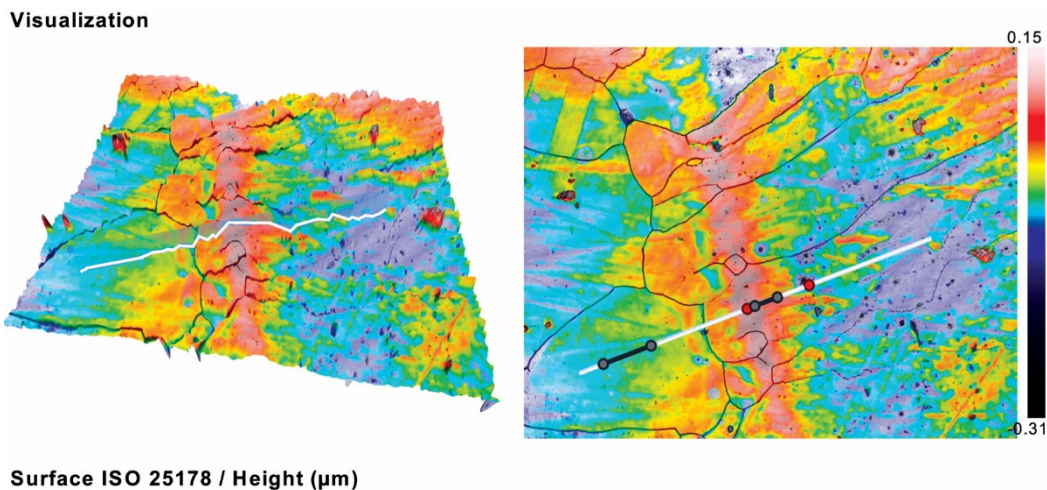
Figure 15. Test results of profile analysis for the zone of Incoloy 800HT nickel alloy. The analysis was performed along the white line.

The surface topography on both sides of the investigated joint showed the existence of transition zones between the base materials and the weld. These zones were associated with the influence of heat in the transition zone during the welding process. However, they have a different nature. In the case of Incoloy 800HT, a marked uniform hill of approximately $120\ \mu\text{m}$ (maximum $150\ \mu\text{m}$) above the average surface was visible. In the second case, in the transition valley, single peaks of about $400\ \mu\text{m}$ existed. The roughness of the specimens was evaluated by applying mean parameters such as root mean square height (S_q) and arithmetical mean height (S_a). Both of them demonstrate the general texture of the surfaces under investigation. Individual maximum and minimum height values do not affect both of these parameters (the differences were in the range of 15–20%). The maximum height (S_z) was $0.46\ \mu\text{m}$

for Incoloy 800HT and 50× magnification and 1.32 μm for 304L stainless steel and 150× magnification. For the Incoloy 800HT specimen, the valley depths were predominant, and maximum pit depth (S_v) values reached 0.28 μm , i.e., approximately two times higher than the corresponding maximum peak height (S_p). In the second case, the surface was characterized by equaled distribution among peak heights and valley depths (S_p and S_v parameters were about 0.66 μm). The analyzed surfaces were in the form of a plateau with a concentration of the material near the profile tops which was represented by negative skewness S_{sk} (−0.36 for Incoloy 800HT alloy and −0.18 for 304L steel). A kurtosis (S_{ku}) value higher than three for Incoloy 800HT (4.19) indicates the presence of a sharp structure of the profile. In the case of 304L steel, the structure was smoother (the S_{ku} value was 2.83).

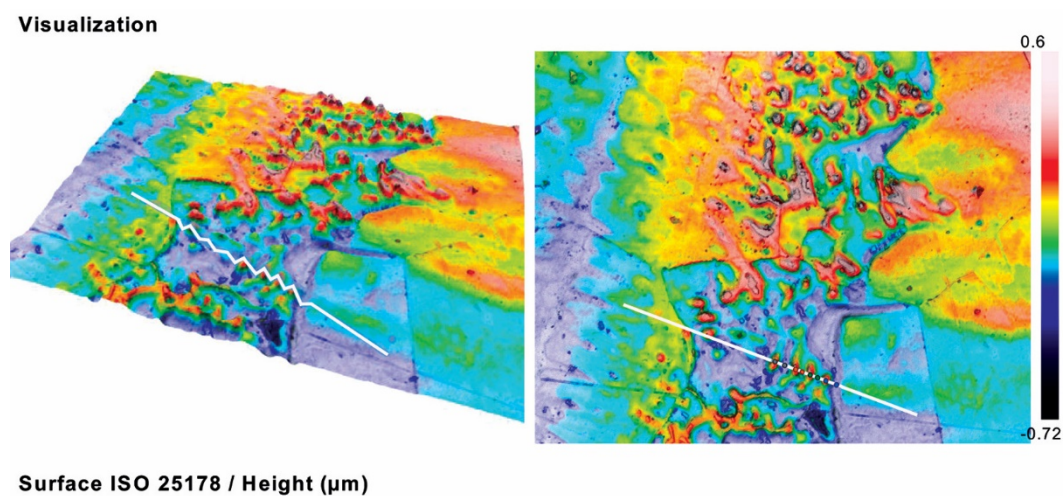
Figure 16. Test results of profile analysis for the zone of 304L austenitic stainless steel. The analysis was performed along the white line.

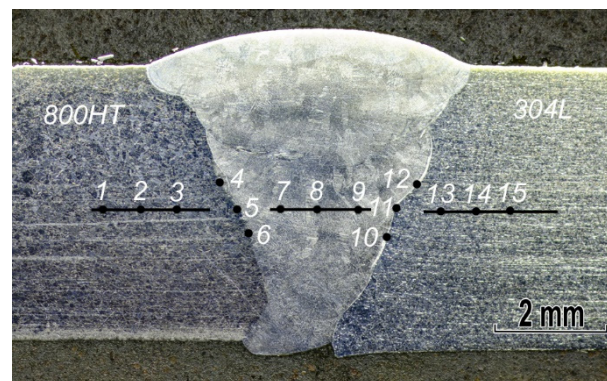
Figure 17. The arrangement of measurement points on the specimen for microhardness measurements.

Microhardness measurements were made in base materials, weld and heat affected zones (paying special attention to transition zones) according to the arrangement of measurement points shown in Figure 17. Figure 18 shows the results of the measurements.

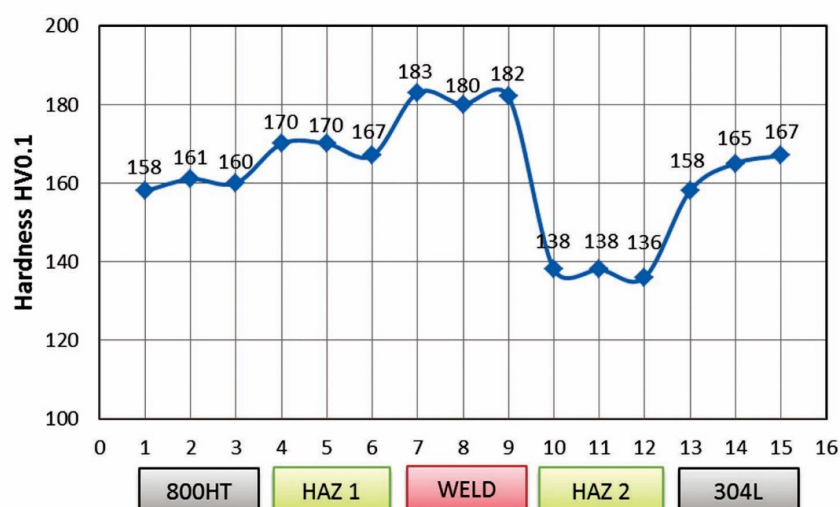
Figure 18. Microhardness distribution across the welded joint.

According to literature data, the microhardness for Incoloy 800HT nickel alloy is in the range of 120–250 HV0.1 [10,29,36]. In the considered case, this value was 158–161 HV0.1, which corresponds to the indicated range. In the heat affected zone (HAZ1), these values are slightly higher (average 169 HV), which indicates the appropriate heat input and cooling rate. The average HV0.1 value for weld metal is around 182 HV0.1. Such an increase can be explained by changes in the dendrite arrangement in the weld. The hardness for 304L steel reaches typical values for this grade [45]. However, a decrease in the HAZ2 area (average value 137 HV0.1) was observed, which results from the structure changes that were presented in microscopic studies (δ ferrite). The obtained results are characteristic of dissimilar nickel alloy and austenitic stainless steel welded joints, as also demonstrated by other authors [10,29,36,45].
