## Mechanism of hydrogen enhanced-cracking of high-strength steel welded joints

J. Ćwiek\*, A. Zieliński

Faculty of Mechanical Engineering, Gdańsk University of Technology,  
ul. Narutowicza 11/12, 80-952 Gdańsk, Poland

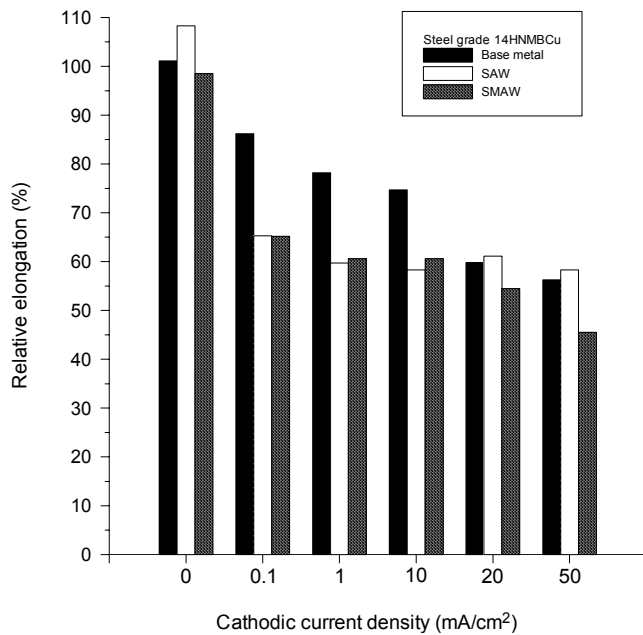
Fig. 1. Relative elongation versus cathodic current density for 14HNMBCu steel and its welded joints

Elongation and reduction in area were chosen as measures of hydrogen embrittlement. Then, relative parameters determined as

the ratio of the appropriate value measured in air to that measured in artificial sea-water were calculated and presented as bar charts (Fig. 1-2).

Observed decrease of relative values of elongation, and reduction in area with the increase of current density exhibits a certain minimum. Further increase of current density does not cause higher degradation. The loss of elongation was as high as 10% for base metal, and 35% for welded joints. Reduction in area decreased of 40% for base metal, and 55-75% in the case of SMAW and SAW welded joints respectively.

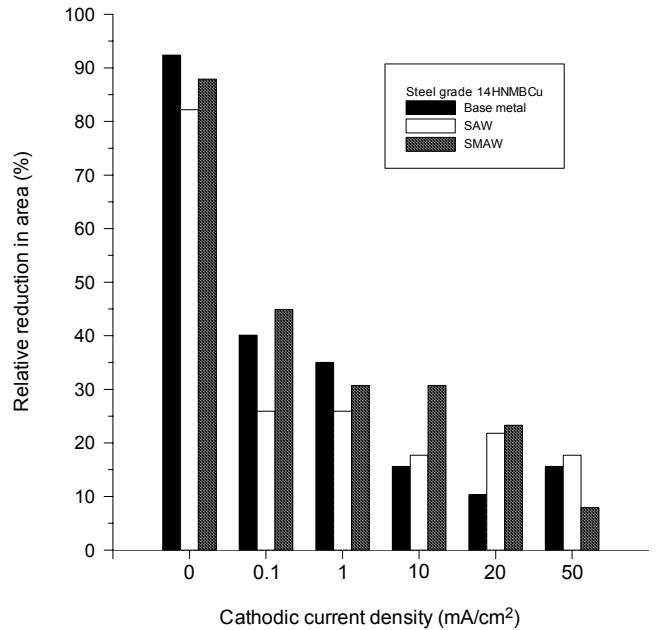
Fig. 2. Relative reduction in area versus cathodic current density for 14HNMBCu steel and its welded joints

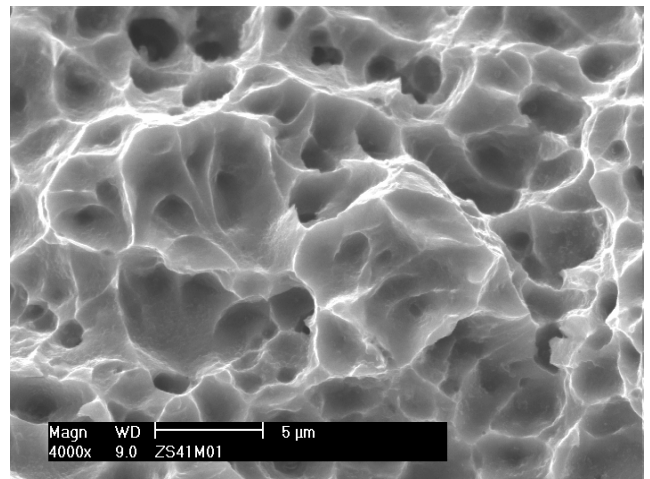
Fig. 3. SEM image of the fracture surfaces of welded joint (SMAW) of 14HNMBCu steel. SSRT test in seawater  $i = 0.1 \text{ mA/cm}^2$

Fracture surfaces of failed samples were investigated with the use of the scanning electron microscope (SEM) to determine mode of fracture. Examples of fractographic observations are shown in Fig. 3-4.

Failure of samples with welded joints occurred always in weld metal, where strength was lower comparing to base metal. The reduction of ductility by hydrogen was accompanied by a change in fracture mode. For samples tested in air crack growth occurred in a ductile mode with microvoid coalescence and quasi-cleavage fracture. For samples tested in sea-water transgranular brittle mode with quasi-cleavage and cleavage fracture was observed. At higher cathodic current densities the presence of hydrogen induced microcracks and flakes appeared (Fig. 4).

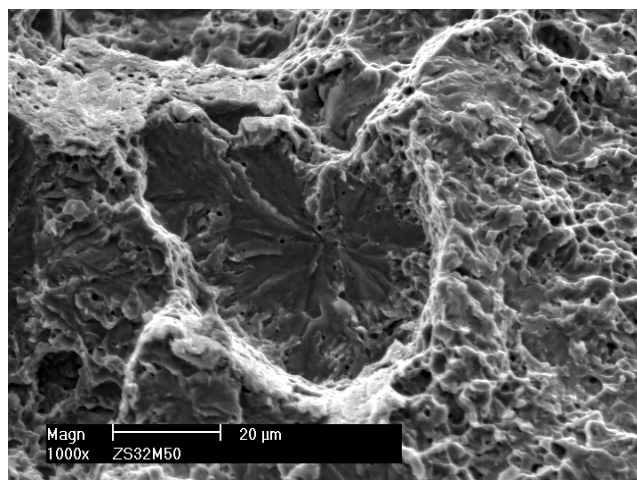
Fig. 4. SEM image of the fracture surfaces of welded joint (SAW) of 14HNMBCu steel. SSRT test in seawater  $i = 50 \text{ mA/cm}^2$
