Mechanism of hydrogen enhanced-cracking of high-strength steel welded joints

J. Ćwiek*, A. Zieliński

Faculty of Mechanical Engineering, Gdańsk University of Technology,
ul. Narutowicza 11/12, 80-952 Gdańsk, Poland

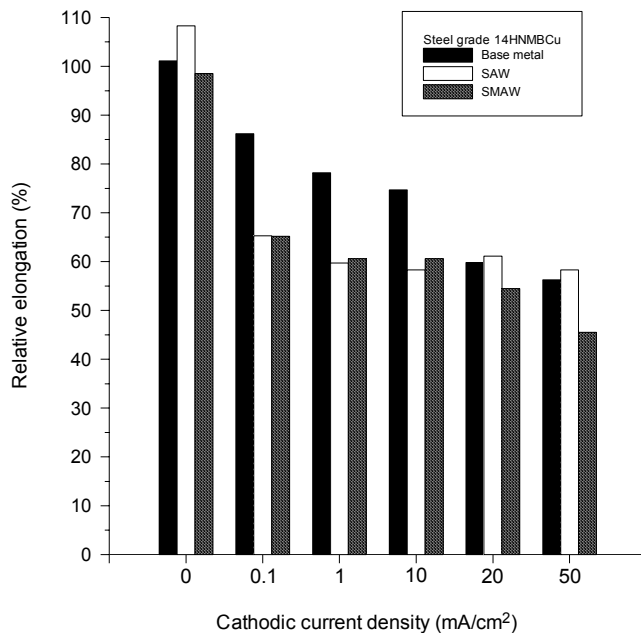
Fig. 1. Relative elongation versus cathodic current density for 14HNMBCu steel and its welded joints

Elongation and reduction in area were chosen as measures of hydrogen embrittlement. Then, relative parameters determined as

the ratio of the appropriate value measured in air to that measured in artificial sea-water were calculated and presented as bar charts (Fig. 1-2).

Observed decrease of relative values of elongation, and reduction in area with the increase of current density exhibits a certain minimum. Further increase of current density does not cause higher degradation. The loss of elongation was as high as 10% for base metal, and 35% for welded joints. Reduction in area decreased of 40% for base metal, and 55-75% in the case of SMAW and SAW welded joints respectively.

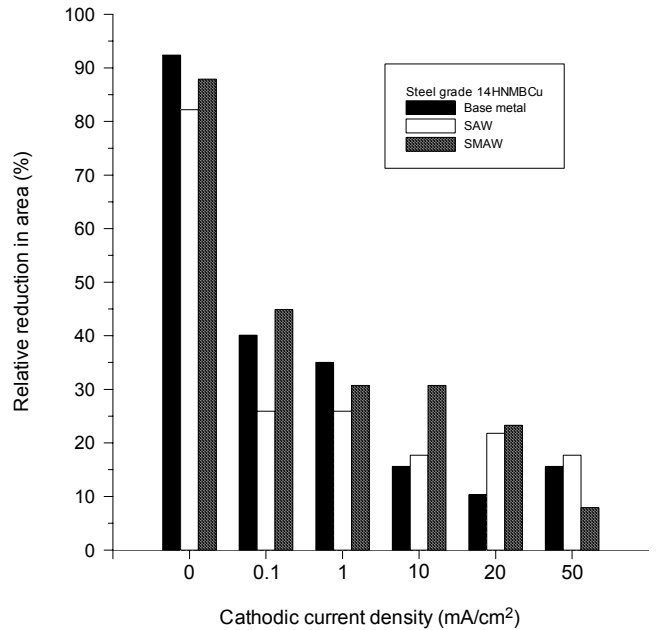
Fig. 2. Relative reduction in area versus cathodic current density for 14HNMBCu steel and its welded joints

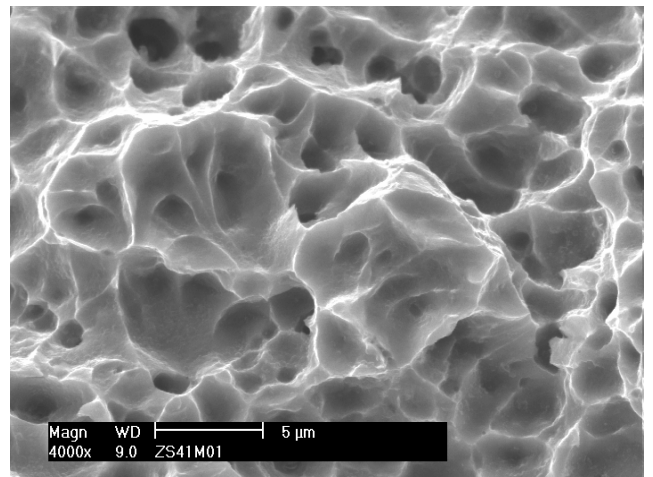
Fig. 3. SEM image of the fracture surfaces of welded joint (SMAW) of 14HNMBCu steel. SSRT test in seawater $i = 0.1 \text{ mA/cm}^2$

Fracture surfaces of failed samples were investigated with the use of the scanning electron microscope (SEM) to determine mode of fracture. Examples of fractographic observations are shown in Fig. 3-4.

Failure of samples with welded joints occurred always in weld metal, where strength was lower comparing to base metal. The reduction of ductility by hydrogen was accompanied by a change in fracture mode. For samples tested in air crack growth occurred in a ductile mode with microvoid coalescence and quasi-cleavage fracture. For samples tested in sea-water transgranular brittle mode with quasi-cleavage and cleavage fracture was observed. At higher cathodic current densities the presence of hydrogen induced microcracks and flakes appeared (Fig. 4).

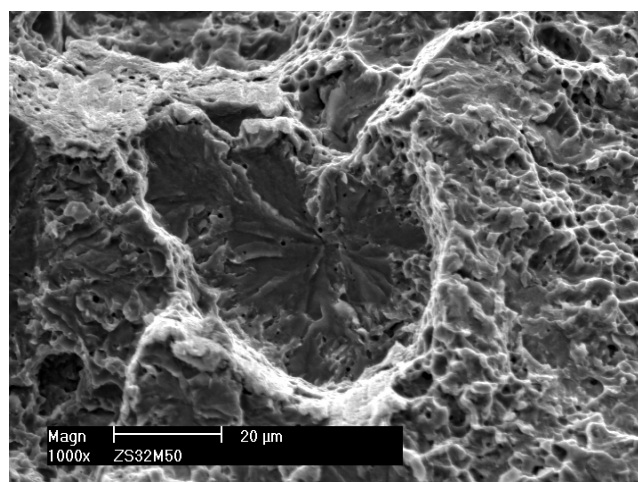
Fig. 4. SEM image of the fracture surfaces of welded joint (SAW) of 14HNMBCu steel. SSRT test in seawater $i = 50 \text{ mA/cm}^2$
