Non-Destructive Assessment of Masonry Pillars using Ultrasonic Tomography

Abstract: In this paper, a condition assessment of masonry pillars is presented. Non-destructive tests were performed on an intact pillar as well as three pillars with internal inclusions in the form of a hole, a steel bar grouted by gypsum mortar, and a steel bar grouted by cement mortar. The inspection utilized ultrasonic stress waves and the reconstruction of the velocity distribution was performed by means of computed tomography. The results showed the possibilities of tomographic imaging in characterizing the internal structure of pillars. Particular attention was paid to the assessment of the adhesive connection between a steel reinforcing bar, embedded inside pillars, and the surrounding pillar body.

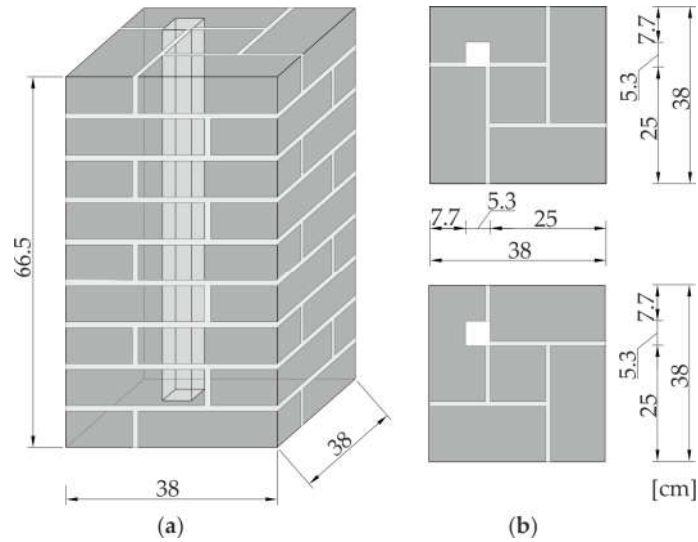
Figure 2. Geometry of the tested pillars: (a) 3D view; (b) plane view of even and odd layers.

A masonry pillar was used as a testing object. The pillar was manufactured using solid bricks, with dimensions of 25 cm × 12 cm × 6.5 cm. Joints between bricks were 1 cm thick and were filled with gauged (cement-lime) mortar. Nine brick layers were used to build the specimen. The model had a length of 66.5 cm and cross-section dimensions of 38 cm × 38 cm. The geometry of the pillar and a view of the even and odd layers are shown in Figure 2.

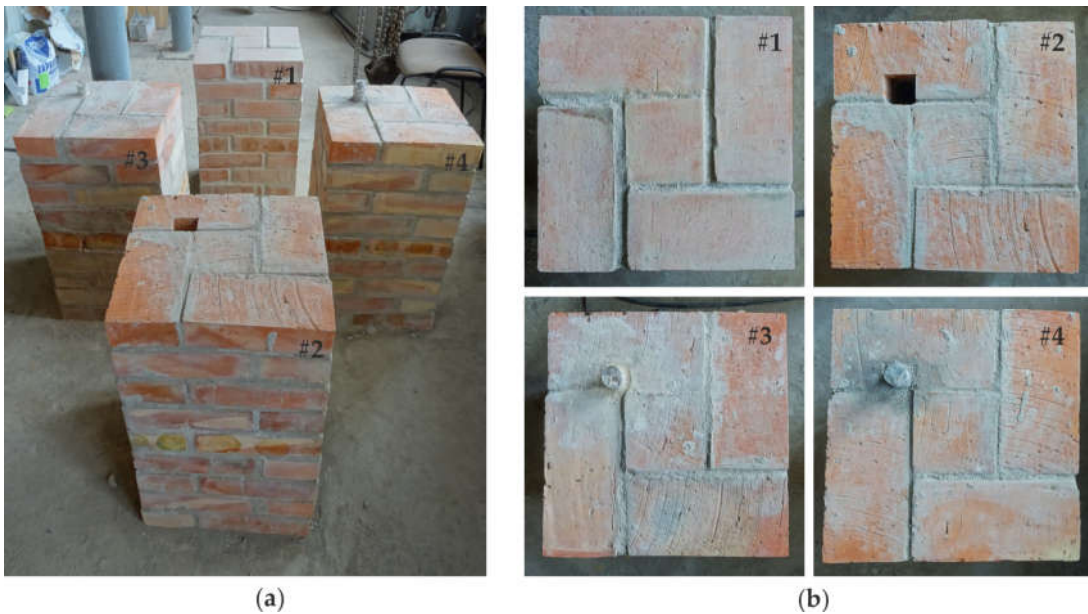
Figure 3. Photographs of laboratory models of the brick pillars: (a) overall view; (b) plane views of specimens #1 to #4.

The test specimens included one pristine pillar and three pillars with inclusions (Figure 3). The first pillar (#1) was prepared as a reference model. Pillars #2, #3 and #4 had a square hole through the entire height of the specimen. The hole, with dimensions of 5.3 cm × 5.3 cm, was situated at a distance of 7.7 cm from the pillar edges (Figure 2b). The hole in pillar #2 remained empty, while in the case of pillars #3 and #4, an anchor was mounted in it. The threaded steel bar had a diameter of 32 cm, and was grouted using two types of mortar. In pillar #3, the anchor was mounted using gypsum mortar to represent a weak bond, while in the case of pillar #4, cement mortar was used to represent a strong bond.

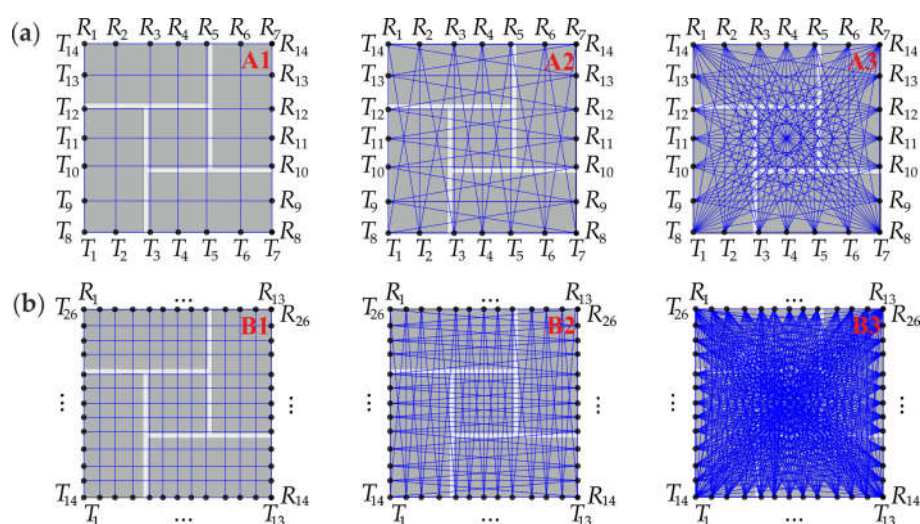
Figure 6. Configuration of paths: (a) configuration #A (#A1, #A2 and #A3); (b) configuration #B (#B1, #B2 and #B3).

The acquired experimental and numerical signals were processed to obtain tomography images. At first, the cross-section of the pillar was divided into 49 pixels, in the case of configuration #A, and 169 pixels, in the case of configuration #B. Data analysis was conducted in three stages, with different arrangements of paths (Figure 6). In the first stage, paths were assumed only between opposite transmitting/receiving points. There were 14 paths in configuration #A.1 and 26 paths in configuration #B.1. In the second stage, from each transmitting point, two or three paths were considered, giving 38 paths in configuration #A.2 and 74 paths in configuration #B.2. The third stage took into account seven paths from each transmitting point. As a result, 98 paths were traced in configuration #A.3 and 338 paths in configuration #B.3.
