# Non-Destructive Testing of a Sport Tribune under Synchronized Crowd-Induced Excitation Using Vibration Analysis

**Abstract:** This paper presents the concept of repairing the stand of a motorbike speedway stadium. The synchronized dancing of fans cheering during a meeting brought the stand into excessive resonance. The main goal of this research was to propose a method for the structural tuning of stadium stands. Non-destructive testing by vibration methods was conducted on a selected stand segment, the structure of which recurred on the remaining stadium segments. Through experiments, we determined the vibration forms throughout the stand, taking into account the dynamic impact of fans. Numerical analyses were performed on the 3-D finite element method (FEM) stadium model to identify the dynamic jump load function. The results obtained on the basis of sensitivity tests using the finite element method allowed the tuning of the stadium structure to successfully meet the requirements of the serviceability limit state.

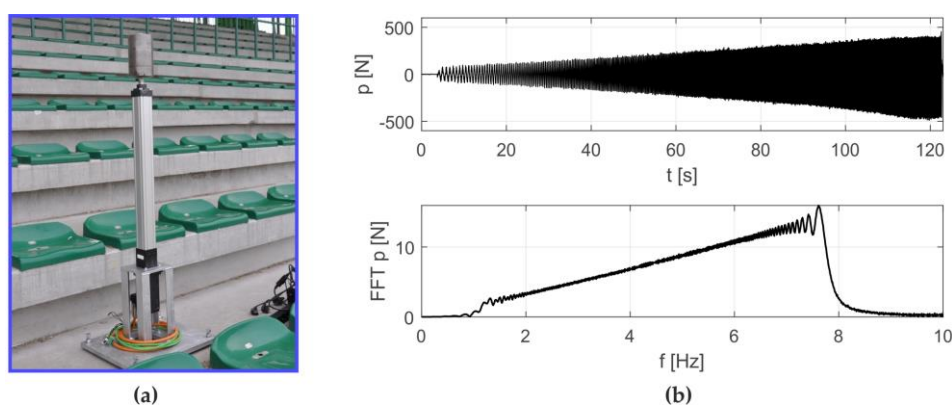
**Figure 5.** Experimental setup: (a) electromechanical actuator, (b) excitation signal in the time and frequency domains.

In the first stage, the experimental modal analysis was conducted. The harmonic load was excited by means of the electromechanical actuator shown in Figure 5a. The excitation signal, created by an arbitrary signal generator, was a sweep sine of a smoothly adjustable frequency from 1 Hz to 8 Hz (Figure 5b).

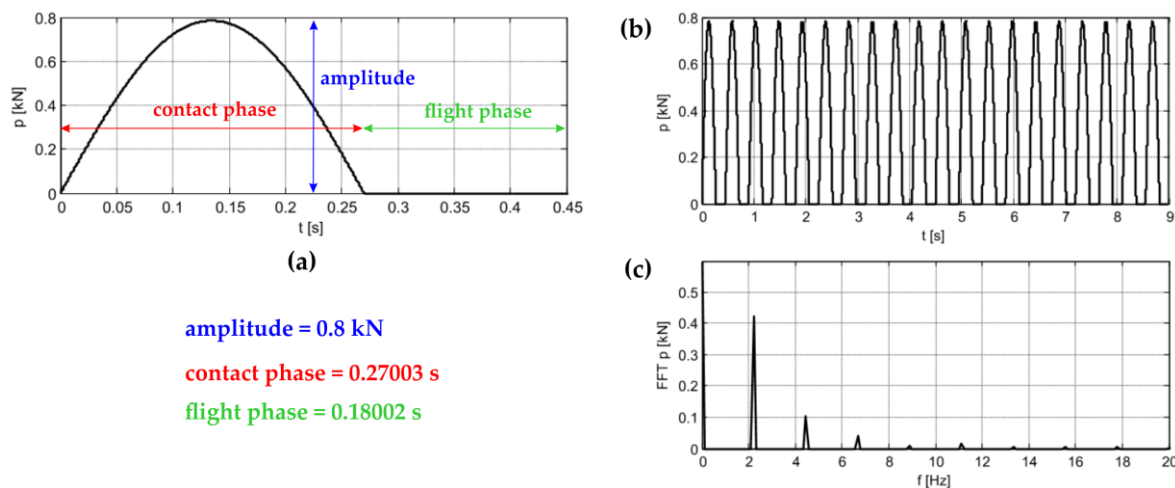
**Figure 14.** Labado function: (a) one jump, (b) 20 jumps, (c) Fourier transformation of the Labado function.

The dynamic impact function during the jumping was described by means of an impulse shaped in half of the sinus function period form. The loading cycle for the Labado dance includes the flight phase and the contact phase. On the basis of the measurement results, the duration of the periodic force full period was identified as 0.45005 s, which is composed of: the phase of load contact with the plate equal to 0.27003 s and the flight phase equal to 0.18002 s. The shape of a single dance cycle is shown in Figure 14a. The in situ tests indicated the jump frequency to be 2.2 Hz. The amplitude of the load function was determined as the average value of the weight of fans participating in the experiment, and was equal to approximately 0.78 kN.

Figure 14b,c shows excitation over time during 20 rhythmic jumps and the corresponding Fourier transform. The Fourier transform graph proves that, in addition to the 2.2 Hz jump frequency, further harmonics are present in the spectrum. The occurrence of higher harmonics is characteristic of this periodic signal. Higher harmonic components are also present on transforms from the experimental data.

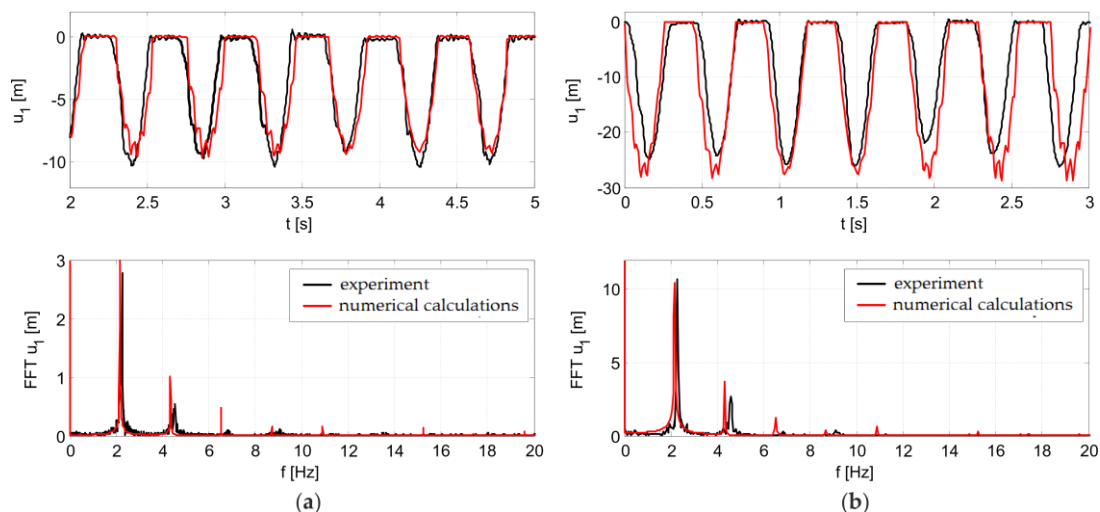
**Figure 16.** Numerical model validation results for jumps performed by: (a) one person, (b) three people.

Figure 16 presents a comparison of the numerical and experimental results in the form of displacement in time, registered at the middle of the span, and their Fourier transforms for the cases of one and three people jumping. In the flight phase, plate vibrations occurred at a frequency of 26 Hz for both the experimental and numerical results. Slight phase shifts between the experimental and numerical graphs can be observed. The reason for the shifts lies in the fact that the real jumps were not perfectly repetitive. A very good experiment consistency of the numerical simulations was obtained, which proves the correctness of the assumed load model for the Labado dance. The excitation frequency was approximately 2.2 Hz during both the experimental and numerical tests. Later in the article, the obtained Labado dance load model is used to simulate vibrations and structure tuning of the stand at the Swiss Krono Arena speedway stadium.

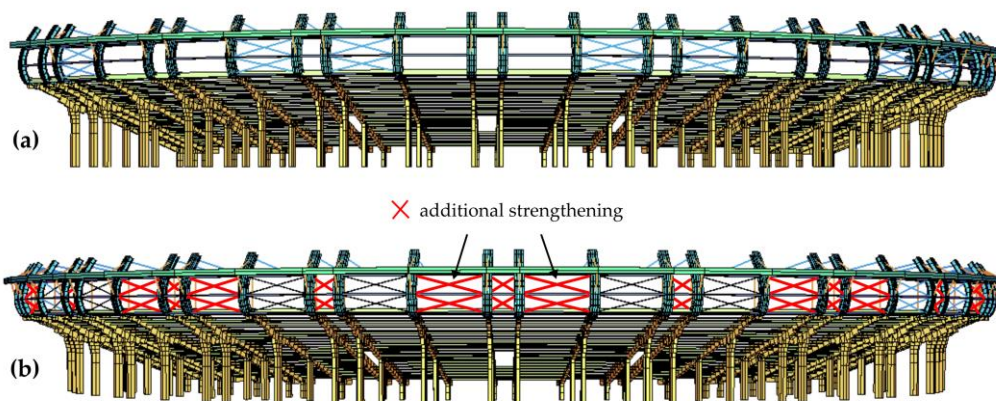
Figure 22. Additional wall bracings (a) before structural tuning, (b) after structural tuning.

An original method of stand structural tuning was proposed in response to the excess of the serviceability limit state. This method assumed the implementation of wall bracings stiffening the steel roofing columns, as well as roof bracings on the wooden roof structure (Figures 22 and 23). The main goal of the concept of bracing of all columns and roof girders was to significantly limit the free end of the wooden roof vibration amplitudes, and hence reduce the concrete cantilever displacements. The bracing cross-sections were the same as those of the bracings already installed in the stand structure. The bracings were made from Macalloy bar rods with a yield point of 520 MPa and tensile strength of 690 MPa.

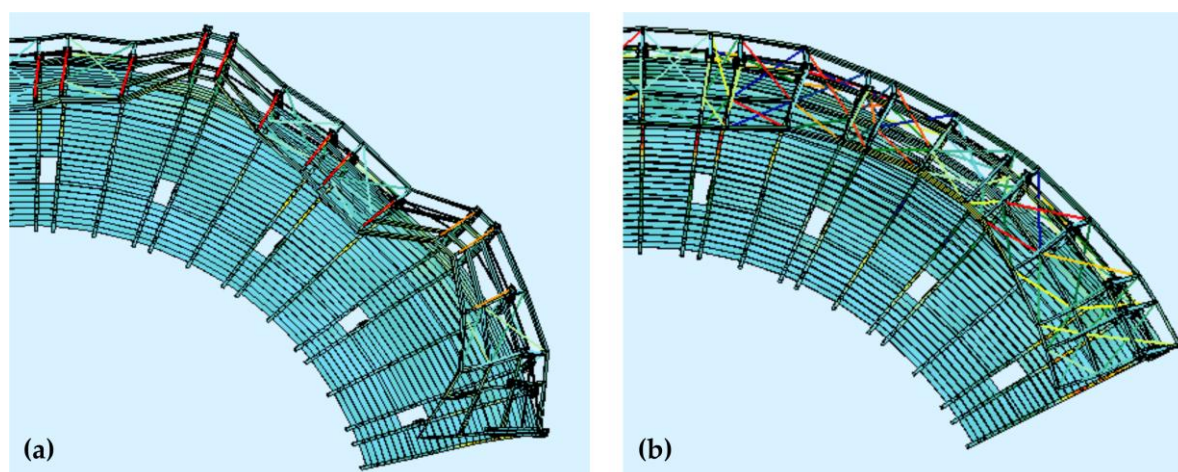
**Figure 27.** Top view of the stand's roof loaded with synchronous jumps of people showing the vibration amplitudes (a) before structural tuning, (b) after structural tuning.

Figure 27 shows the visualization of vibrations induced by synchronized dancing of the crowd in the stands, located in rows 22–25 throughout the stadium. The applied dynamic load was a periodic function consisting of a contact phase (sinusoidal impulse) and a flight phase (no load). The load function of a jumping crowd is typically not included in standard regulations. The integration of motion equations was carried out using the Newmark–Wilson method. Figure 27a shows a plane view of the relations of the object degrees of freedom vibration amplitudes in the case when the roof and vertical bracings were fixed in accordance with the design, i.e., every two fields. Figure 27b presents the nature of vibrations for bracings installed in each roofing field. The bracings installation resulted in the roof structure stiffening and in the change of its vibrational spatial character. The calculated amplitude of vibrations from the fans' synchronized dance on the whole structure in rows 22–25 was equal to 3.6 mm at the end of the concrete cantilever, and 5 mm at the free end of the roof. The strengthening method caused a slight reduction in the vibrations of the concrete cantilevers and a significant reduction in the vibration amplitudes of the free end of the roof. A requirement for the correct bracing performance during vibrations was the presence of an initially prestressing force. However, the reduction of concrete cantilevers vibration amplitudes was problematic, because they took over the main part of the dynamic forces generated by fans dancing directly on them.

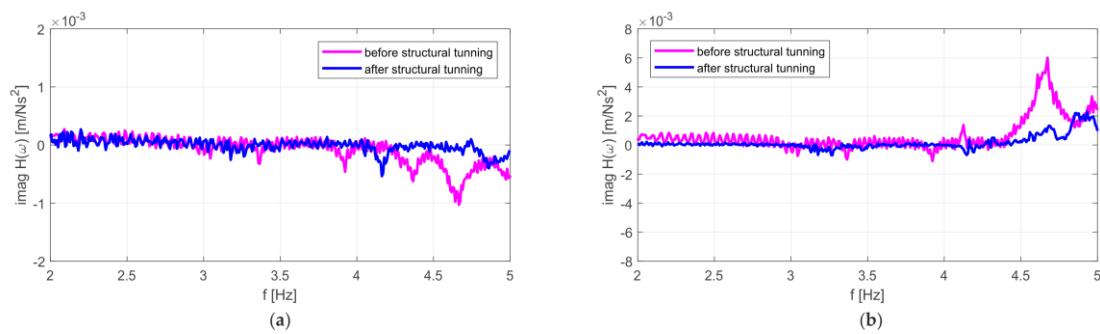
**Figure 28.** Experimental transition functions for the end of the concrete cantilever (a) before and (b) after stand structural tuning.

Repeated in situ tests were carried out in order to verify the correctness of the original concept of stadium stand tuning. The results of measurements made after structural tuning are shown in Figures 28 and 29. It can be seen that that frequencies identified during crowd-induced vibrations are similar to the measurements before tuning (see Figures 9 and 10), because the same nature of the jumping load. It is important, however, that the natural frequencies of the structure were shifted after structural tuning (see Figure 28), decreasing resonance significantly. The individual resonance zones moved towards the higher frequencies.
