# Non-Destructive Testing of the Longest Span Soil-Steel Bridge in Europe—Field Measurements and FEM Calculations

**Abstract:** The article describes interdisciplinary and comprehensive non-destructive diagnostic tests of final bridge inspection and acceptance proposed for a soil-steel bridge made of corrugated sheets, being the European span length record holder (25.74 m). As an effect of an original concept a detailed and precise information about the structure short-term response was collected. Periodic diagnostics of bridge deformations was done one year after it was built. Load test design was based on numerical simulations performed by means of finite element method (FEM). In situ measurements were done with the aid of: inductive sensors, optical total station, and terrestrial laser scanner. The results produced by terrestrial laser scanning were used to build a precise image of structure deformation in 3D space during the tests. The accuracy of laser mapping was significantly increased using the information coming from total station and inductive sensors. These have higher accuracy and therefore can be used as reference. Thus, new quality in measurements is introduced. Good

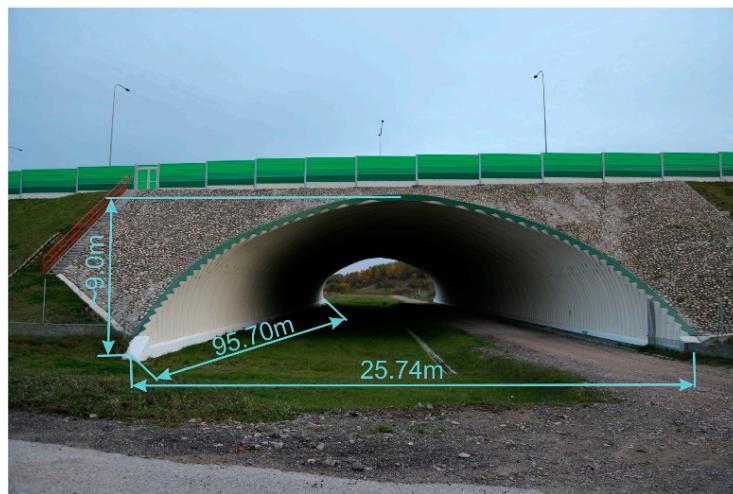
**Figure 1.** Soil-steel bridge side-view taken in October 2019.

The considered soil-steel bridge is a new one, built in 2017. It is a single-span arch structure, as shown in Figures 1 and 2. The steel shell is made from UltraCor, 9.5 mm thick, corrugated sheets, produced by ViaCon Polska Ltd. company ([36]) (Rydzyna near Leszno, Poland), which are shown in Figure 3. The corrugated sheets are connected to each other with bolts. S315MC steel was used to produce the shell. The bridge foundations are built of Franki piles. The UltraCor structure is covered by soil compacted in a way that its relative density is not less than 98% of the maximum density determined in the laboratory. In the close vicinity of steel sheets, the compaction is not less than 95%. The steel arc span length is 25.74 m, whereas the total length of the bridge equals 95.70 m. The arc sagitta equals 9.0 m. These basic dimension, characterizing the structure, are depicted in Figure 1.

The bridge carries the national road number 16 and crosses a path for animals and a road built for the purpose of road maintenance (refer to Figure 1).

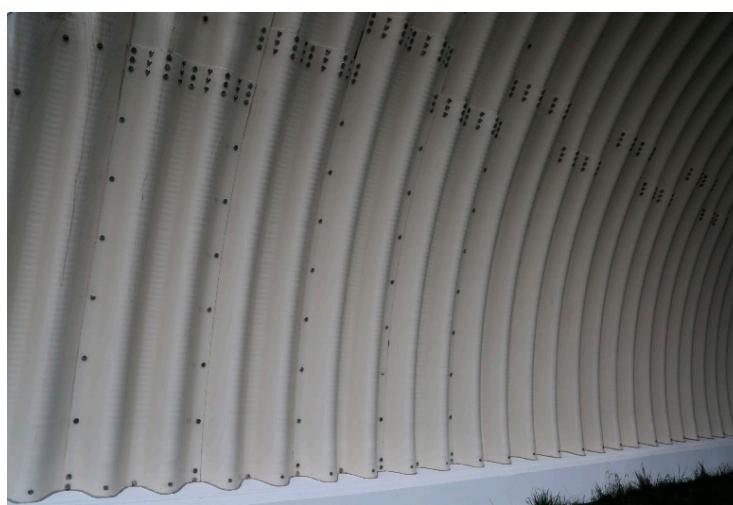
**Figure 3.** The corrugated steel sheets and their bolt connections.

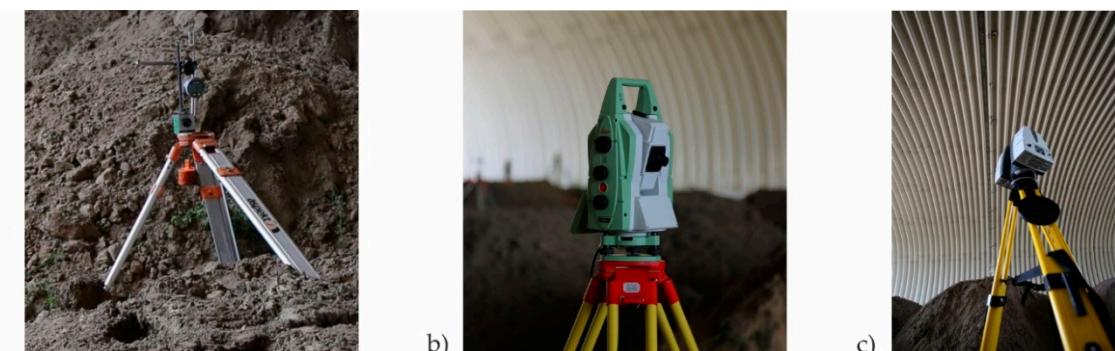
**Figure 4.** Devices and sensors used to measure basic bridge properties: (a) vertical translation inductive sensor, (b) total station, (c) laser scanner.

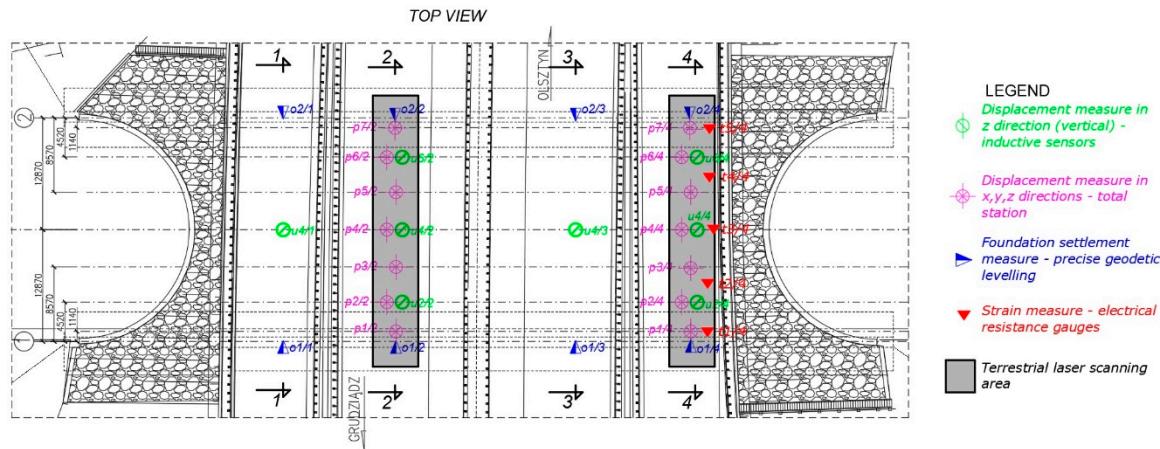
**Figure 5.** Location of the network of sensor used to collect the data during the static tests. Top view of the bridge.

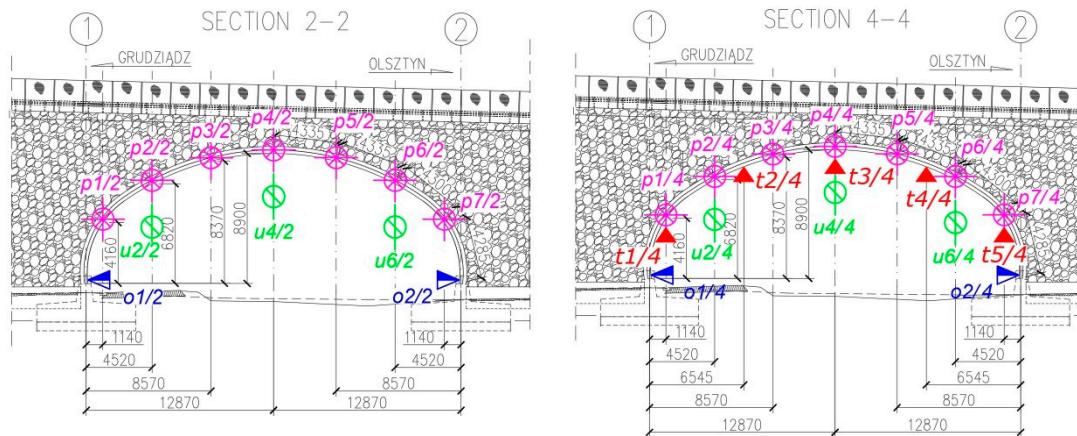
**Figure 6.** Location of the network of sensor used to collect the data during the static tests. Sections 2-2 and 4-4 (dimensions in (mm)).

At first, appropriate preparation of the test field was done. The laser scanner was positioned in the line of the axis of each measured bridge cross Sections 2-2 and 4-4 (as shown in Figure 5) and remained in the same place during each testing. Hence, the alignment of scan positions was not an issue. The total station was placed in a way that all the target prisms in the measurement points were visible. The positions of prisms (total station measure) and targets (laser scanning) were in accordance with the testing project. It has to be mentioned here, that during the tests a decision was made to do the total station survey in 9 instead of 7 points. Additional measures were done in o1 and o2 points. Thus, for each cross section under consideration, regarding the total station surveying, data were gathered from o1, o2, p1, p2, p3, p4, p5, p6, and p7. Moreover, two reference points, which are not marked in Figure 5, were established on the steel shell in the region where the deformations under the loads were very small, but still in the vicinity of the measured section. These were used to check the correctness of deformation registration. Additionally, the appropriateness of the total station surveying was checked using the data gathered by inductive displacement sensors. In Table 1 vertical displacements registered by total station ( $p_{2/4}$ ,  $p_{4/4}$ ,  $p_{6/4}$ ) and inductive sensors ( $u_{2/4}$ ,  $u_{4/4}$ ,  $u_{6/4}$ ), during S2 test, when maximum load was put on the road lane right above 4-4 section, are compared.

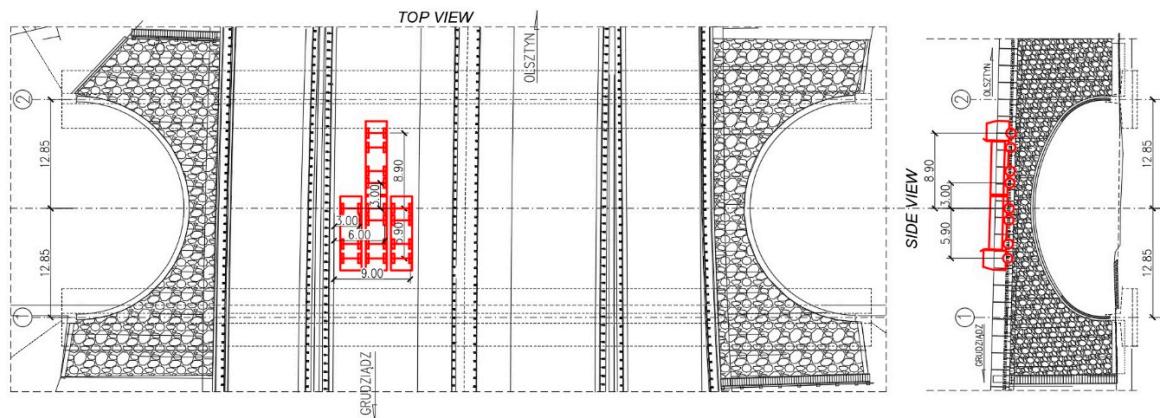
**Figure 7.** Schematic drawing of trucks locations during the S1 test configuration (dimensions in (m)).

To load the bridge and study its response during the tests 4-axle trucks were used. The total mass of each of the truck was 32 tons. The trucks were positioned in a way to maximize the loading effects in the measurement points. Two configurations of trucks positions were studied during the classical static tests. These were denoted as S1 and S2. The trucks were put on the bridge one by one, steadily in columns. Schematic drawing of trucks locations during the S1 test configuration is presented in Figure 7. Views from three different perspectives that document trucks positions during the S1 test configuration are shown in Figure 8.

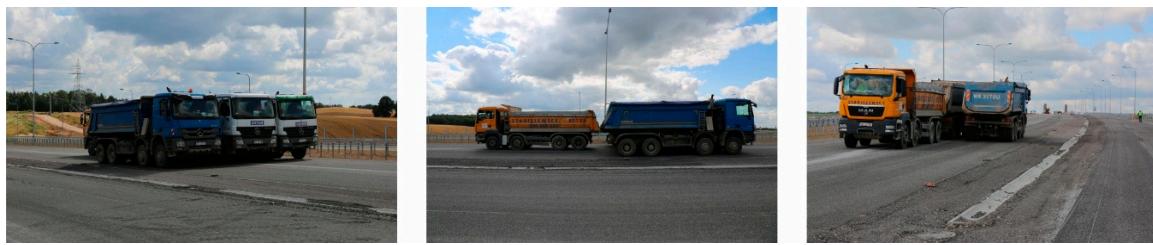
**Figure 8.** The trucks, positioned during the S1 test configuration. Views from three different perspectives.

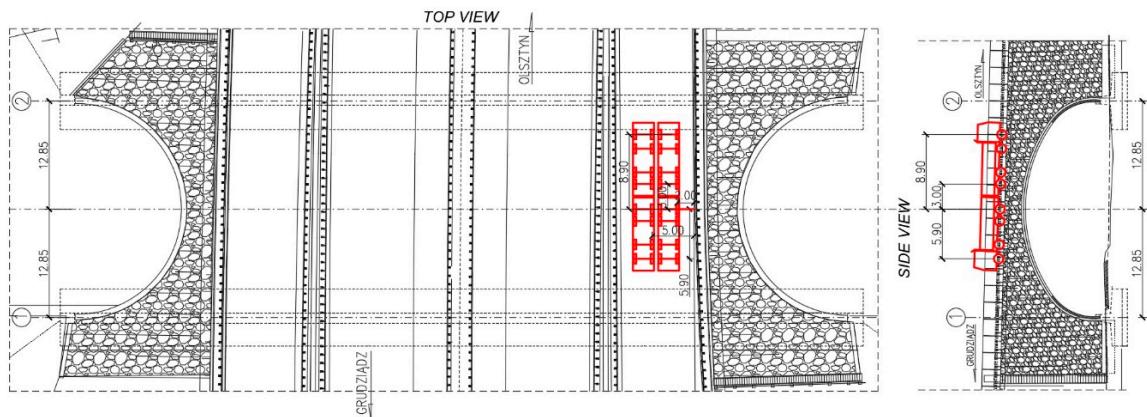
**Figure 9.** Schematic drawing of trucks locations during the S2 test configuration (dimensions in (m)).

Schematic drawing of trucks locations during the S2 test configuration is presented in Figure 9. Views from three different perspectives that present trucks positions during the S2 test are depicted in Figure 10.

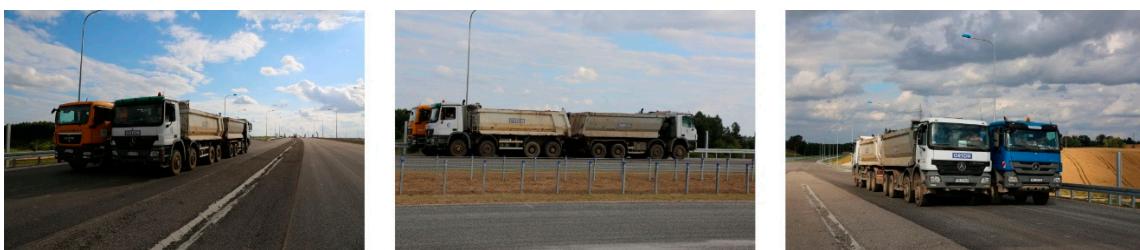
**Figure 10.** The trucks, positioned during the S2 test configuration. Views from three different perspectives.

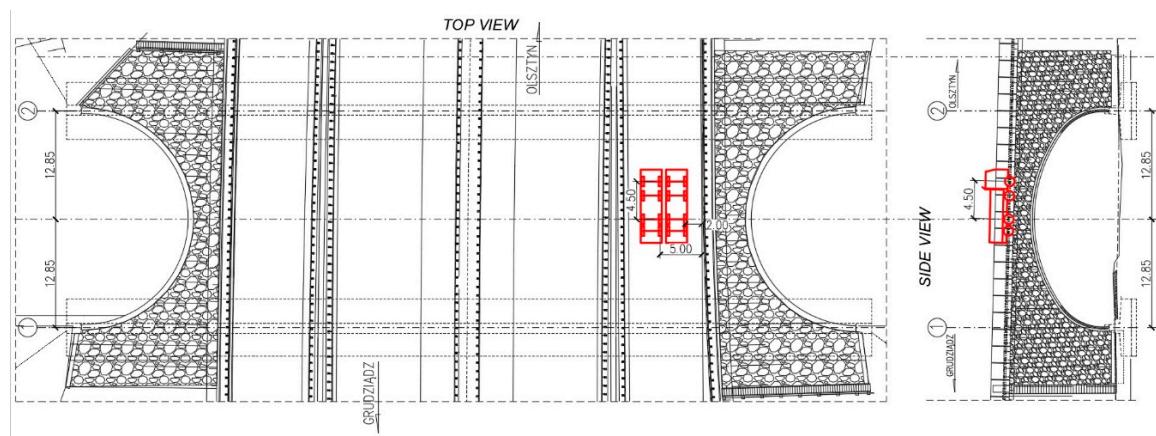
**Figure 11.** Schematic drawing of trucks locations at M24 stop (dimensions in (m)).

The bridge response was also checked under moving ballast of two trucks positioned side by side. These test configurations were denoted as M11 to M16 for the trucks standing on the road lane above 2-2 section and M21 to M26 for the trucks located above the 4-4 section. The trucks stopped in 6 equally spaced locations over the bridge. In Figure 11 schematic drawing of trucks locations at M24 stop is shown, whereas trucks moving between M23 and M24 testing positions are depicted in Figure 12.

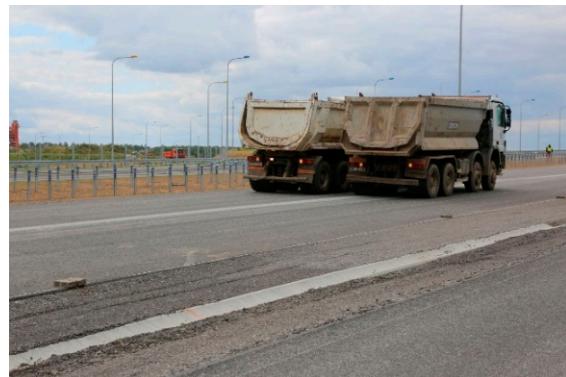
**Figure 12.** The trucks moving between M23 and M24 testing positions.

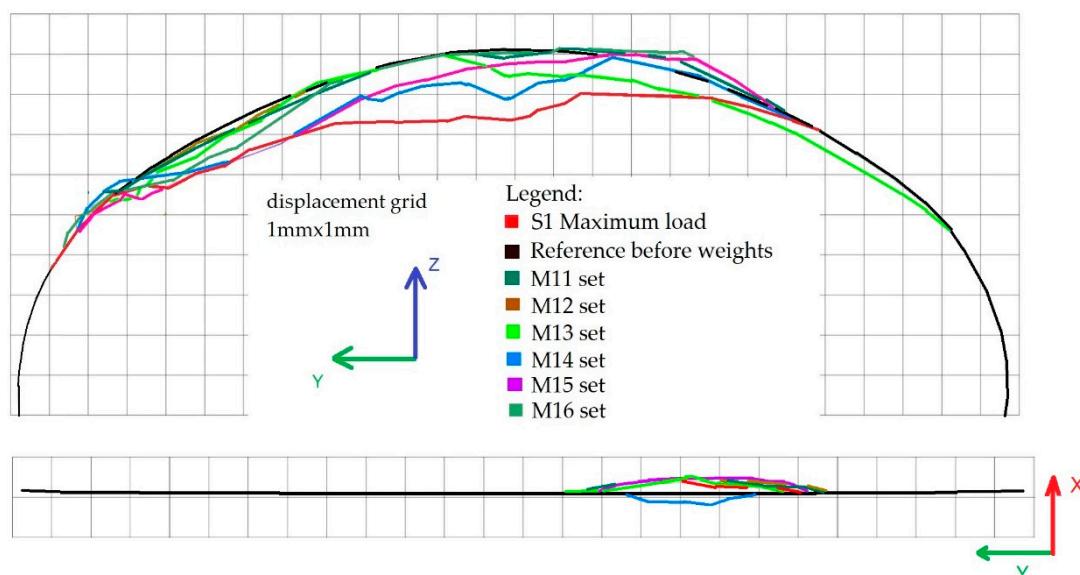
**Figure 13.** Deformations of the bridge cross Section 2-2 in the Y-Z (top) and X-Y (bottom) planes under loading schemes S1 and M11–M16.

At that point, data were collected, containing images of reference and deformed states of the structure. Therefore the displacements of the steel shell were easily calculated for all the cross sections under consideration. The resulting deformations of the bridge cross Section 2-2 in the Y-Z and X-Y planes under loading schemes S1 and M11–M16 are shown in Figure 13. Similarly in Figure 14, shell deformations are shown for the 4-4 cross section for the following loading conditions S2 and M21–M26.

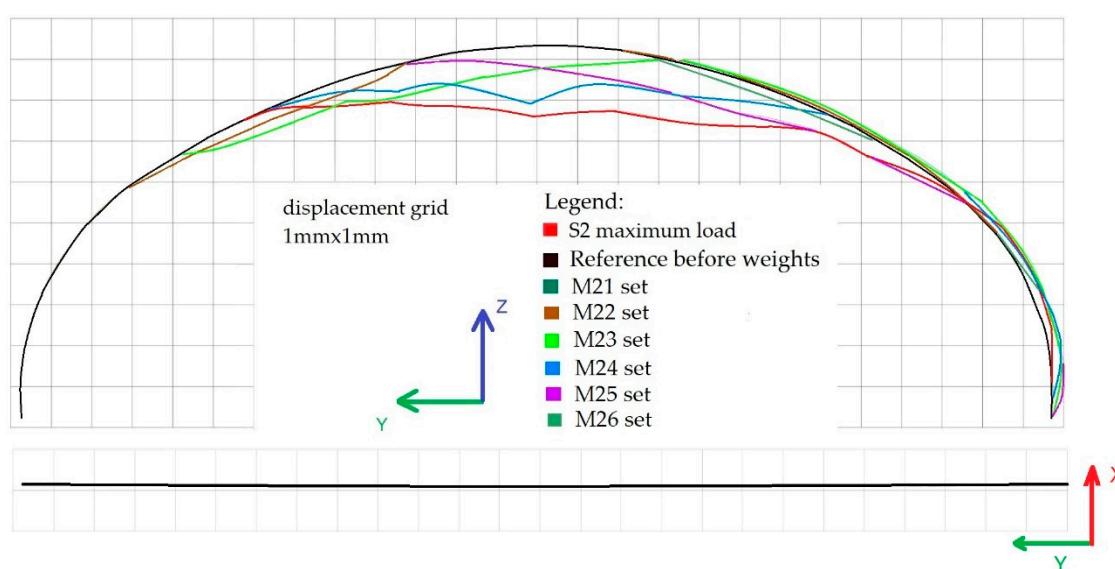
**Figure 14.** Deformations of the bridge cross Section 4-4 in the Y-Z (top) and X-Y (bottom) planes under loading schemes S2 and M21–M26.

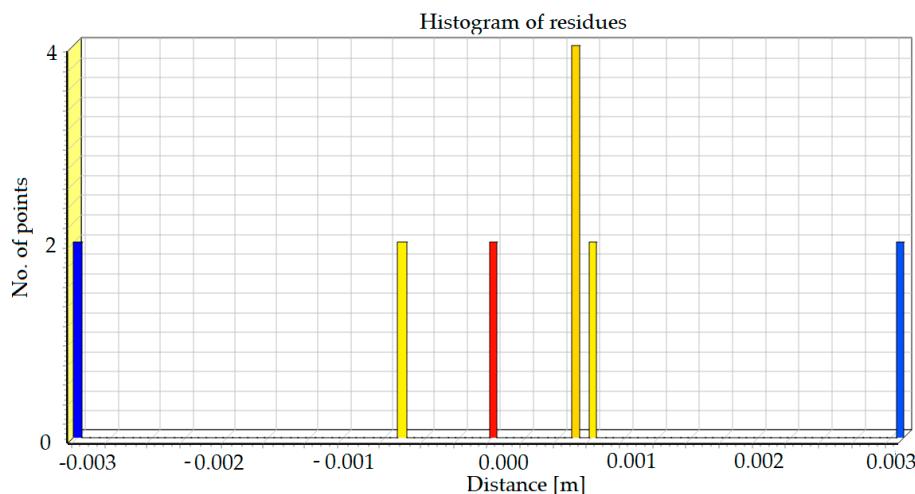
**Figure 15.** Histogram of residues which shows the precision of scan alignment.

As new scanning required new alignment of the device, the TLS accuracy could have been additionally checked. The Iterative Closest Points (ICP) algorithm was used to align scan positions correctly, besides of reference points that were stabilized outside of the structure. The positions of elements, which were used for the algorithm processing, were not changed during this time period and they have not been influenced by any external factors. The results of this alignment are presented in the form of histogram in Figure 15.

The standard deviation resulting from the alignment was  $\sigma = 1.6$  mm. Therefore, in order to reliably estimate the accuracy of the measurement, in accordance with the principles of normal distribution, we assumed that it is  $3 \times \sigma = \sim 5$  mm. In consequence, the accuracy of computed deformation differences (registered in the period between 2017–2018) should have not exceeded this value.

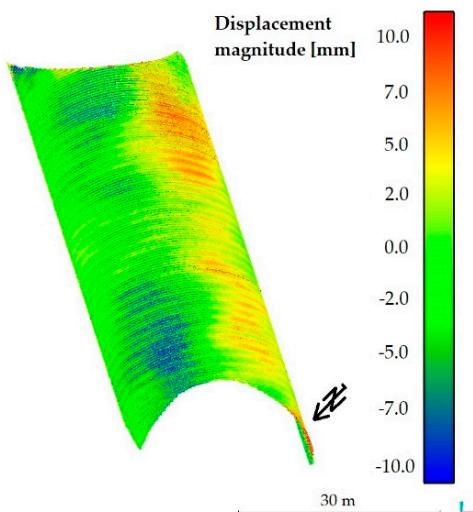
**Figure 16.** Periodic diagnostics of bridge deformations (displacement magnitude) measured one year after the final acceptance and inspection.

After the noise reduction had been done, it was possible to calculate the periodic diagnostics displacements of the steel shell that occurred between the years 2017 and 2018. The method described in paper [56] (available in CloudCompare software) was used for this purpose. This particular approach was chosen because most of the available comparative methods are based on the determination of the closest distance from a point or require 3D modelling of the compared surface. Thereby, they eliminate the problem of roughness, which cannot be eliminated here, as the corrugation of the steel sheets is an important feature of the whole structure and cannot be omitted. To find the distances between two point clouds, two main steps were done. First, normal surface and its orientation in 3D was estimated on a scale consistent with local surface roughness. Then, the mean surface change was measured along the surface normal direction and the local confidence interval was determined. This, in our opinion, allowed to obtain reliable information about the structure, which has varying roughness, as evidenced by the observed noise in the cloud of points and terrain diversity. The roughness is also reflected by the average change along the surface normal direction, as it was done in the second major calculation step of this procedure. In effect the distances between two point clouds were obtained and the deformations contours (magnitudes of displacements) are shown in Figure 16.

The results of the calculations presented in Figure 16 reveal that the upper part of the bridge has moved to the south up to 7 mm, while the shell in the vicinity of foundation remained undeformed. To check the accuracy of the obtained deformations a series of statistical tests, based on the Gaussian normal distribution, were run. Figure 17 presents the statistics of the Gauss function corresponding to the calculated distance uncertainties. On this basis it can be stated that the results were correctly determined in relation to the reference shown in Figure 15.

Owing to the above, the uncertainty of the measured deformations (Figure 16) equals approximately 2 mm (within the computed  $\sigma$  from alignment). This means that the laser scanning enabled to register all of the points characterizing the largest geometric changes. Nevertheless, this uncertainty suggests that some discrepancies of the measurements occurred during the scanning. These resulted possibly from the standard issues connected with stabilization of points, their indication, and establishment. However, because of the fact that the measurements were repeated one year after the final acceptance tests and during this period of time the construction works were still ongoing, such an accuracy of measurements is to a large extent satisfactory. For example in paper [51] laser scans of an external system were done using other techniques and the resulting precision and accuracy was not as good as here.

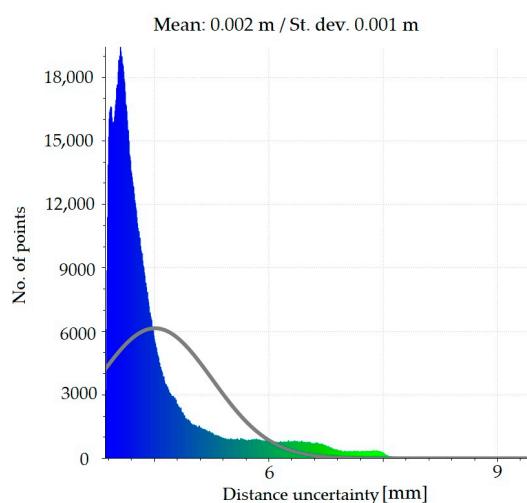
**Figure 17.** Distance uncertainty statistic.

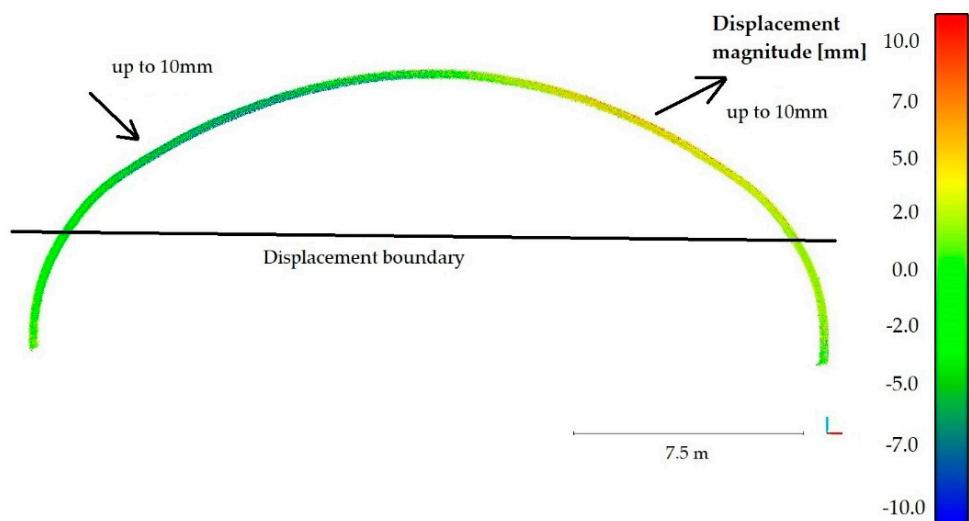
**Figure 18.** Displacements of the unloaded steel shell 2-2 section one year after the final acceptance and inspection tests.

Periodic diagnostic deformation images were created also in Sections 2-2 and 4-4, that were previously tested during static tests in 2017. This enabled to additionally cross-check calculations of deformations of the whole bridge, presented in Figure 16. To create them it was required to perform a number of computational operations, enabling interpretation of deformation changes of the bridge. The results obtained from scanning during short-term tests, were quite helpful in achieving this goal. Displacements of the unloaded steel shell one year after the final acceptance and inspection tests is shown in Figure 18 for the 2-2 section and in Figure 19 for the 4-4 section. The directions of the extreme values of displacements are also shown in Figures 18 and 19.

The aforesaid results reveal, that during one-year period of time, the bridge did not exhibit deformations below the black border line, marked in the figures and named as “displacement boundary”. In view of that, we noticed a certain negative feature of the computed periodic diagnostics deformations (see Figures 16, 18 and 19). Despite attaining satisfactory result of calculations, the displacements were not obtained in the lower parts of the steel shell. However, because of the measurement accuracy, their exact values are not so certain and may rather indicate the displacement tendency. Similarly, this could have resulted from the properties of the algorithm used. On the other hand, what also is interesting, the “displacement boundary” intersects the shell approximately at the same height at which bolt connections were done (refer to Figure 3). As one year passed since the date of final acceptance tests, slippage of this connections could have occurred and some rotations of the shell have become possible in this areas. This may explain why displacements of the upper part of the shell are only observed. Hence, a research gap has been identified here. These aspects will be analyzed and addressed in further studies.

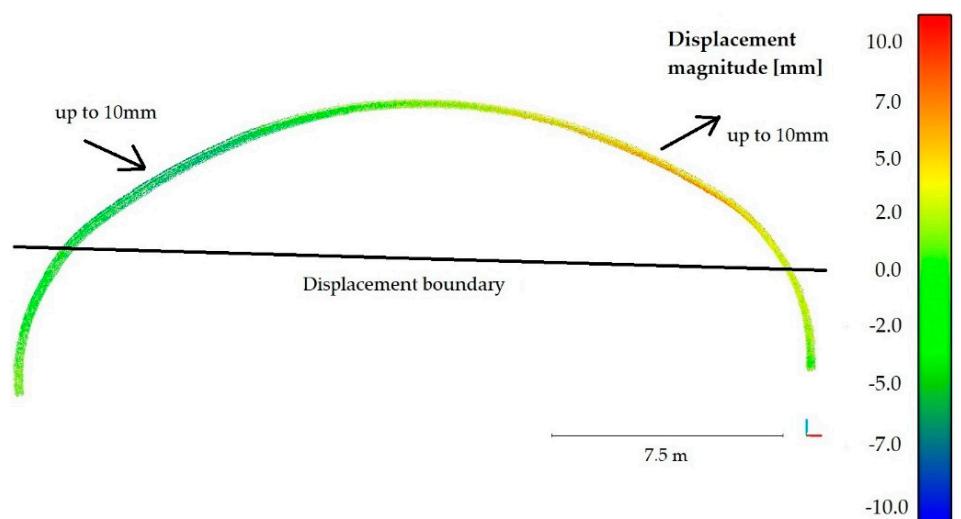
**Figure 19.** Displacements of the unloaded steel shell 4-4 section one year after the final acceptance and inspection tests.

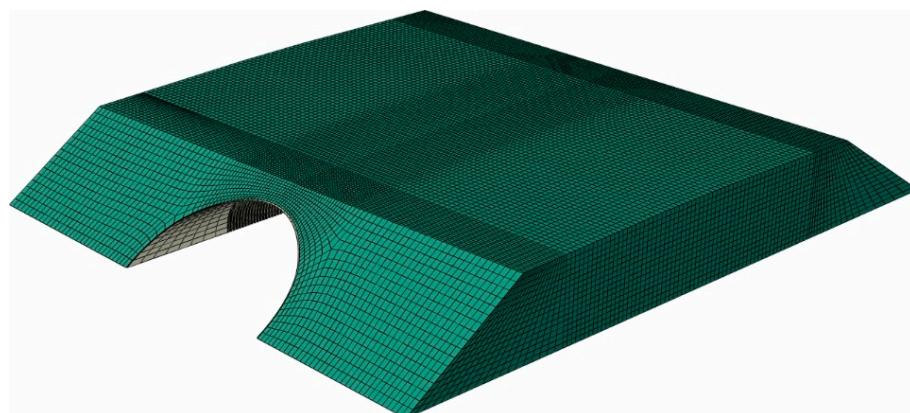
**Figure 20.** Finite element method (FEM) computational domain of the bridge.

Its size (distance from the bridge to the outer boundaries of the domain) was selected in such a way that it did not affect the results in the area of the steel shell. A structured mesh of finite elements was created. First-order solid C3D8I elements (refer to [58]) were used to model the soil continuum. These elements are enhanced by incompatible modes. This formulation enables very strong reduction of the locking effect, as stiffening in bending, being a consequence of the parasitic shear stresses or Poisson's effect, is almost eliminated. The steel parts were represented by shell S4 elements (see for example papers [34,59–61] for other applications of shell elements) with linear shape functions and full  $2 \times 2$  in-plane Gauss-Legendre integration scheme and some additional procedures preventing the locking effect. In the central part of the structure, namely in the region where the in situ measurements were taken, the corrugated sheets were modelled in detail having regard to the real geometry. A simplification was made close to the structure ends, where the steel sheets were treated as a shell endowed with equivalent orthotropic properties and thickness. It is worth mentioning that, often, the whole steel shell is treated as the one having some equivalent properties and uniform thickness (see for example papers [42,62]). Nevertheless, such a simplification cannot be done here, because we are interested in accurate estimation of stresses in the shell-corrugated sheets. The whole computational domain of the soil-steel composite structure is shown in Figure 20 and the detail depicting modelling approach of steel shell in Figure 21.

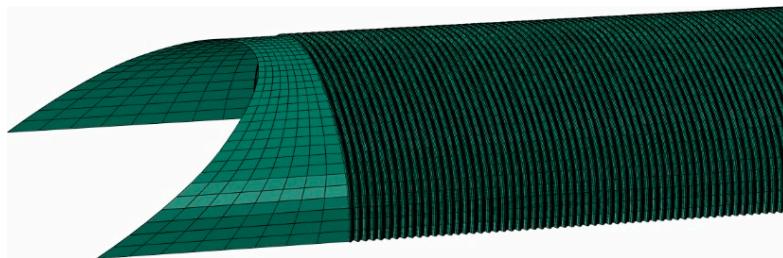
**Figure 21.** Steel shell in the numerical model: corrugated sheets in the center, equivalent shell close to the bridge ends.

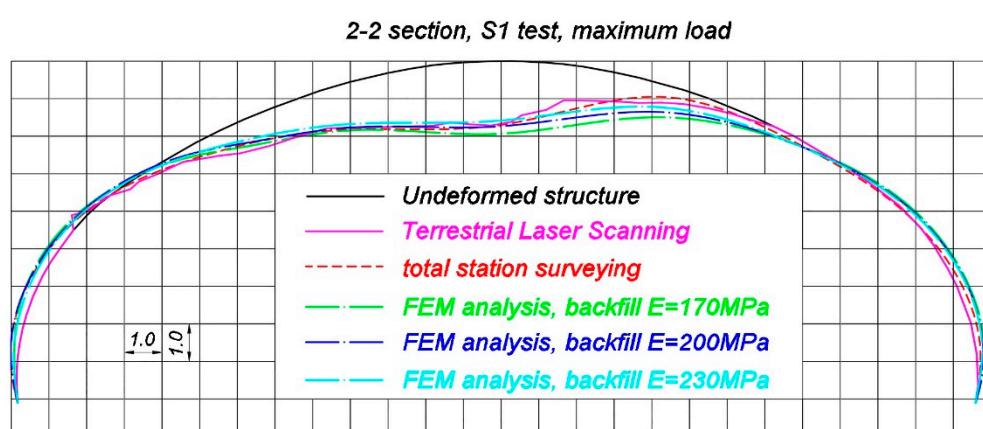
**Figure 22.** Comparison of the deformed shapes of the bridge in 2-2 section during the S1 test, when maximum load was applied, measured using terrestrial laser scanning, total station, and estimated by means of FEM (deformations in (mm) are 1000 times scaled).

It is seen in Figures 22–24 that the FEM estimations, even for different variants of the backfill elastic modulus, are generally in accordance with the measurements with regard to their quality and quantity. The backfill elastic modulus is an important parameter that affect the bridge response. It is a bit underestimated, when  $E = 170$  MPa. Better quality results are obtained for  $E = 200$  MPa and  $E = 230$  MPa. In order to investigate displacements of the steel shell in detail, now, the extreme vertical displacements, that were obtained in the p4/2 point for the test S1, p4/4 for the test S2 and the corresponding FEM values (for different backfill material properties) are analyzed in Table 3. In Table 3 both total ( $U_{\text{in-situ,tot}}$ ) and elastic ( $U_{\text{in-situ,el}}$ ) in situ measured displacements are presented to highlight the issue of the shell shape change when the bridge was unloaded.

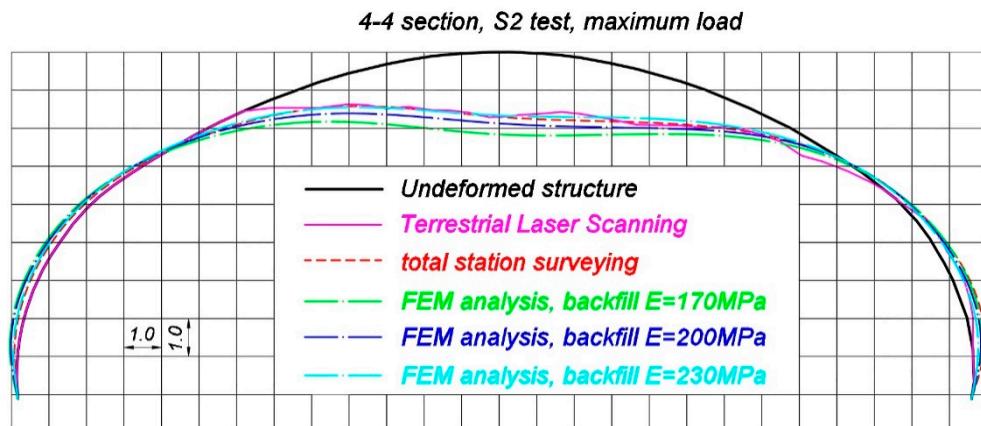
**Figure 23.** Comparison of the deformed shapes of the bridge in 4-4 section during the S2 test, when maximum load was applied, measured using terrestrial laser scanning, total station, and estimated by means of FEM (deformations in (mm) are 1000 times scaled).

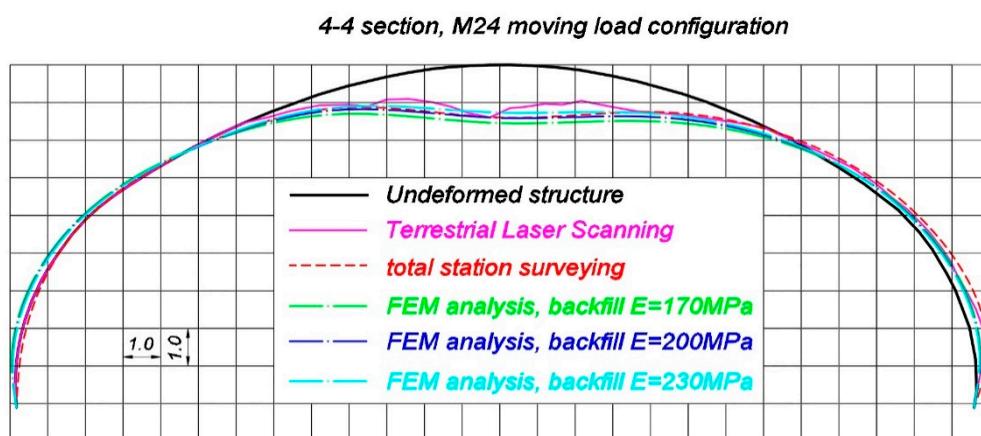
**Figure 24.** Comparison of the deformed shapes of the bridge in 4-4 section during the moving load M24 configuration, measured using terrestrial laser scanning, total station, and estimated by means of FEM (deformations in (mm) are 1000 times scaled).
