# Nondestructive Testing of the Miter Gates Using Various Measurement Methods

The aim of this paper is to indicate the causes of the poor operation of the water gates at the river barrage on the Vistula river in Włocławek (the city located in the center of Poland). The problem had been identified by lock operators during normal operations of the chamber filling and emptying. It was related to a “sudden movement” that caused vibrations and shocks of the lock lower gates. The vibrations were transformed to other structural elements and were also noticeable in the control room building. The administrator of the facility failed to identify the main cause of the excessive vibration. Long-time and intensive vibrations can cause structural damage to a river barrage. Control structures related to the damaged strategic facilities pose a serious hazard and can cause enormous human and material losses. Due to these concerns, the facility owner commissioned an engineering evaluation regarding the cause of the vibrations and a proposed method of repair. Given the high importance of facilities in the form of locks on waterways, the detection of possible failures and appropriate monitoring of th

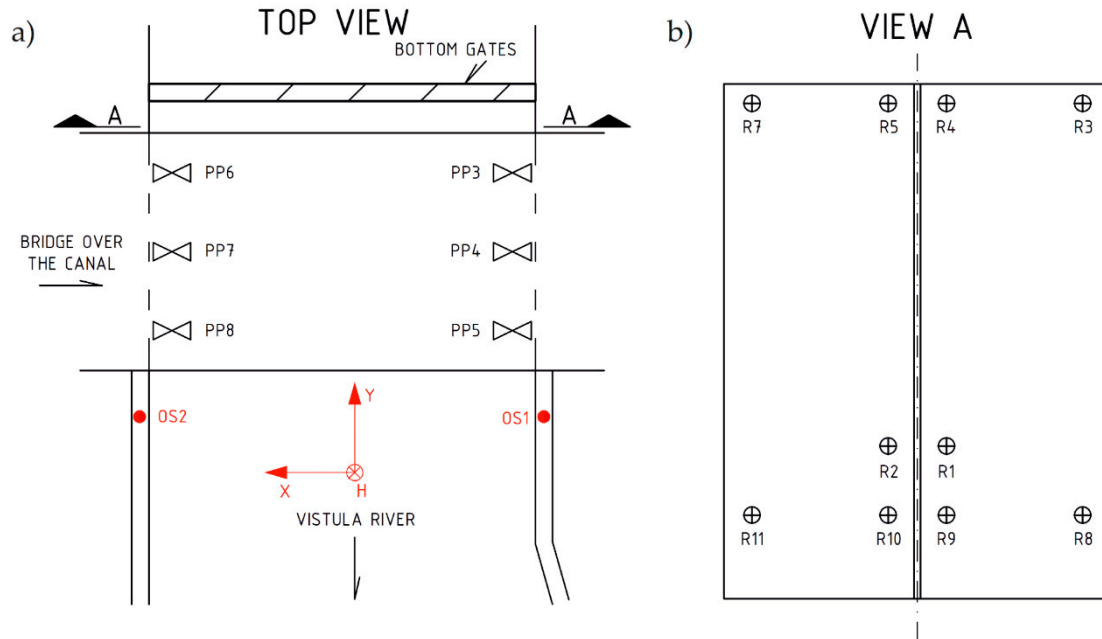
Surveying measurements were based on measurements performed with Leica TS30 (Leica Geosystems AG, Heerbrugg, Switzerland) (with a precise mode about 0.6 mm + 1 ppm / typ. 7 s) at data recording precision of 0.1 mm. Figure 6 specifies the locations of control points (from PP3 to PP8), measurement positions (OS1 and OS2), and measuring points (from R1 to R10).

**Figure 6.** Sketch regarding a location of gates displacement measuring points. (a) Sketch regarding the location of control points and measurement positions, top view; (b) View from bottom water.

For comprehensive survey and assessment regarding the entire gate deformation, measurements were performed with laser scanning. All measurements were performed using the Faro branded device, Focus 3D X130 (FARO Swiss Holding GmbH, Beringen, Switzerland) (with an accuracy of about 2 mm and a measurement speed up to 1 million points per second). Survey results allowed assessment regarding gates' element deformation during lock filling. Before measurement, stabilization followed 6 flat marks (Figure 6a) to ensure proper coordination of the system, and 6 positioning balls (Figure 7) providing data records at the required accuracy. Due to the gates' dimensions (12.50 × 16.00 m) and difficulty in accessing the gates, there was a need to take measurements from two different positions (from the left side "OS1" and the right side "OS2", Figure 6) when performing the scanning.

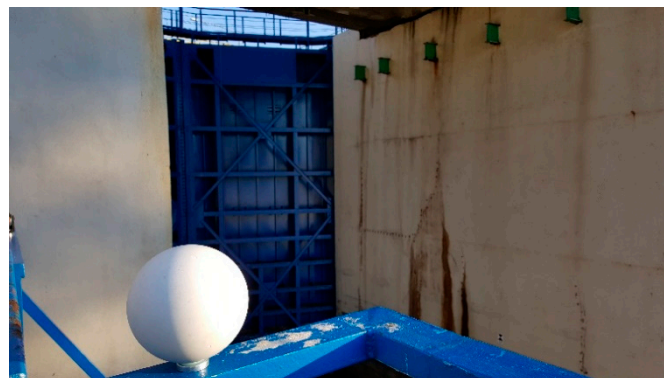
**Figure 7.** Representation of the surveying point during the tests.

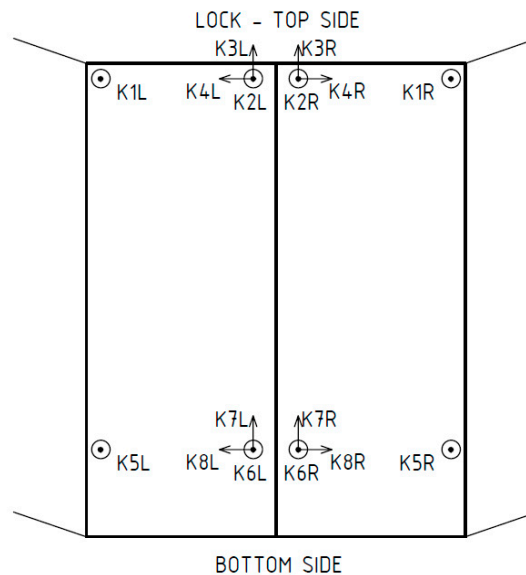
In each of the 6 positions, the gates' leaf was excited three times to natural vibrations, and then was left until vibrations damped. The measurements were carried out separately for the left leaf and separately for the right, as shown in Figure 4. Figure 10 specifies the location of the accelerometers placed on the gates' steel structure. The same sensors were used for both leaves. Therefore, the letter "L" (left leaf) or "R" (right leaf) was added, as shown in Figure 10, for channel markings. The gates were excited to vibrations by shaking the bridge railing, by one of the researchers standing on the top of the gates' leaf. The direction of the shakes was perpendicular to the gates' surface. The starting frequency of shaking was approximately 4 Hz, and during excitation, it was adopted to the natural frequency. After obtaining acceleration amplitudes close to  $1 \text{ m/s}^2$ , the shaking stopped. For analysis, when the shaking stopped and vibrations were damped to about  $0.5 \text{ m/s}^2$  was used as a signal.

**Figure 10.** Location of the control points on the gates and the direction of the acceleration measurements.

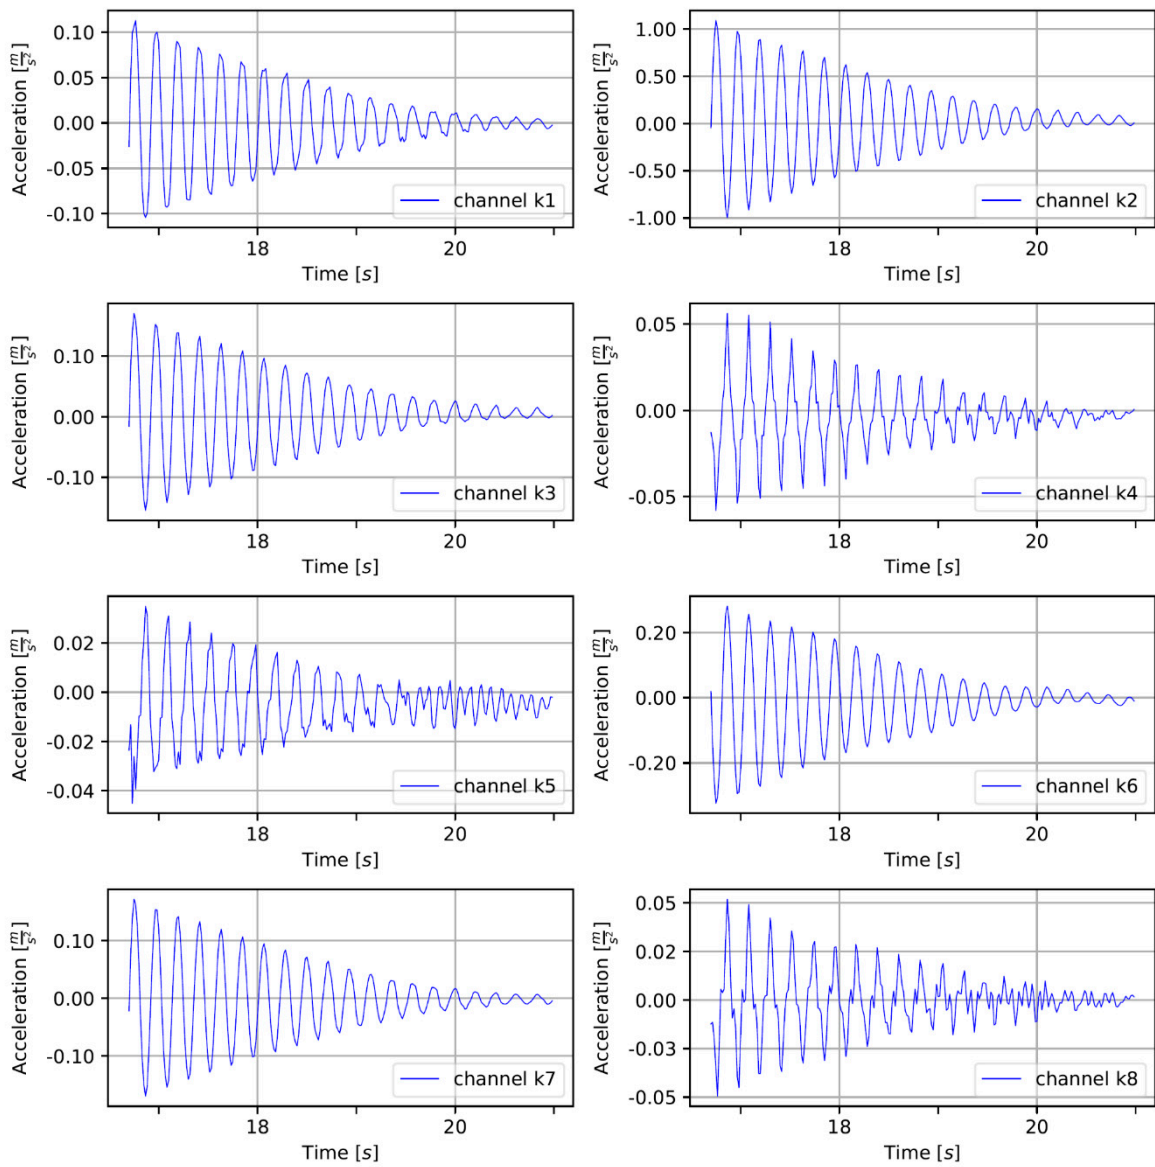
Before static analysis, the model underwent verification provided by comparing model eigenforms and eigenfrequencies with those identified in the field tests. Figure 11 shows an example of the measured accelerations in the gates' left leaf in the middle position after shaking stopped. Each signal underwent basic, preparing processing, the constant component was removed, and the appropriate natural vibrations were cut from the whole series. To ensure better results in the ERA, in the range of lower frequency (0–15 Hz), the signal was downsampled to 60 Hz. To build the Hankel matrix, the following parameters of shape were used:  $\alpha = 12$  and  $\beta = 200$ . To identify stable modes, stabilization diagrams were used. Figure 12a presents an example of the classic version of the diagram, where all calculated poles are presented. On the chart, marked with red crosses, on the one hand, are poles which were evaluated as real as compared with results from previous iterations. On the other hand, the poles evaluated as numerical and artificial are marked with blue dots. Figure 12b shows a filtered version of the diagram. Here, only stable modes are shown. Additionally, on the background of the diagrams, a spectral density of signals is presented to demonstrate compatibility identified in the ERA modes and FFT results.

**Figure 11.** Acceleration measurements at points K1L to K8L during natural vibrations of the left gates' leaf.

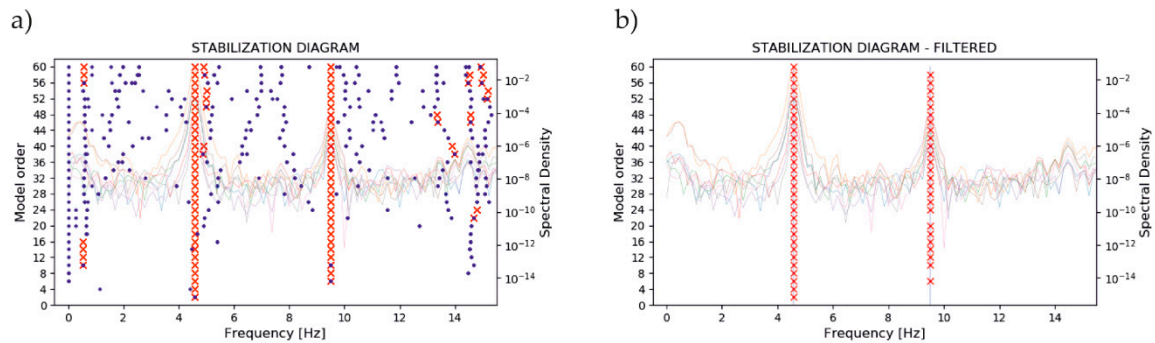
Among all measuring series, for both gates' leaves, in the range to 10 Hz, two eigenmodes always occurred. Sometimes, in the results, one more stable mod appeared and its frequency was below 1 Hz. Subsequent analysis confirmed that it was the first mod of opened gates. However, it did not show up in all measurements, and cannot be taken into account for comparisons and diagnostics. Table 1 summarizes the identified natural frequencies for the second and the third mod for each leaf separately.

**Figure 12.** Stabilization diagram created for the gates' left leaf. (a) Classic version; (b) Filtered version.
