Article

Optimization of Stabilizing Systems in Protection of Cultural Heritage: The Case of the Historical Retaining Wall in the Wisłoujście Fortress

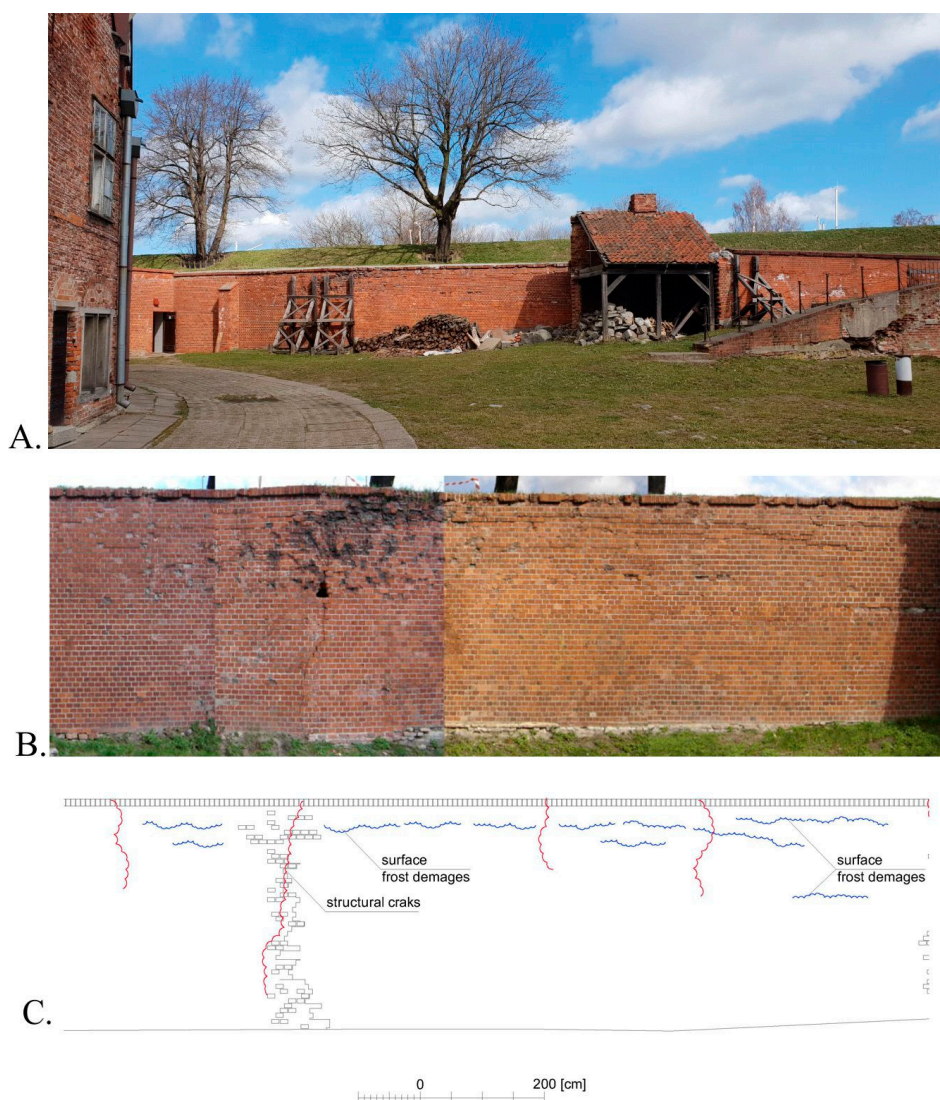
Figure 4. The retaining wall in the Wisłoujście Fortress: (A). Overall view; (B). Analyzed part of the retaining wall (photo taken in 2016); (C). Schematic pattern of cracks and damages.

Because the wall did, in fact, resist earth pressure for about 130 years, numerous vertical cracks have appeared on the surface of the wall, approximately within 0.5–2.3 m from each other (Figure 4). There is also surface freeze–thaw cycle damage visible on the wall, which could, to an untrained eye, look like cracks. Since the second half of the 19th century, two significant series of repairs have been carried out. The first was the addition of a 25 cm-thick brick siding layer and the second one was a buttress. The new facing (Figure 3A,B and Figure 5) was added without re-walling, which, paradoxically, led to deterioration of masonry over time: a crevice that developed between the new and old walls collected water (Figure 4). At low temperatures, the water froze, bursting the wall and

In conclusion, the primary reason for structural failure of the wall is associated with its structural characteristics (Figure 4). However, some cracks observed nowadays may have developed accidentally, due to pressure increase during the removal of greenery. Finally, the retaining wall had lost its stability in the past and had to be strengthened by the temporary wooden buttress (Figure 4A). Therefore, it is impossible to confirm whether the inclination has stopped or it is still increasing.
