Article

# Plasticity of Bead-on-Plate Welds Made with the Use of Stored Flux-Cored Wires for Offshore Applications

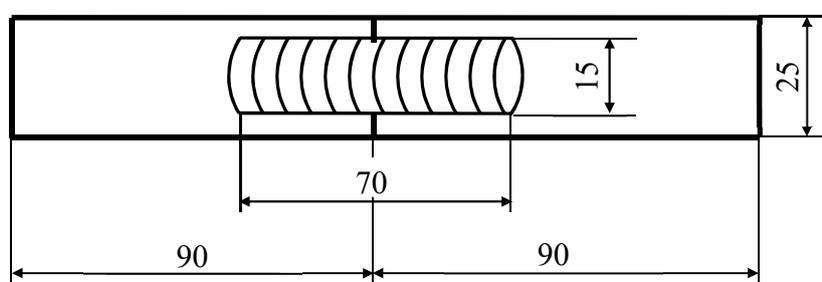
Figure 1. Scheme of test specimen and dimensions in millimeters.

Bead-on-plate welds were made on S355J2 steel specimens with thicknesses of 10 mm. Dimensions of specimens are given in Figure 1, chemical composition of base material and weld metal made with the use of wires is given in Table 1. Basic mechanical properties of weld metal made with the use of wires are given in Table 2.

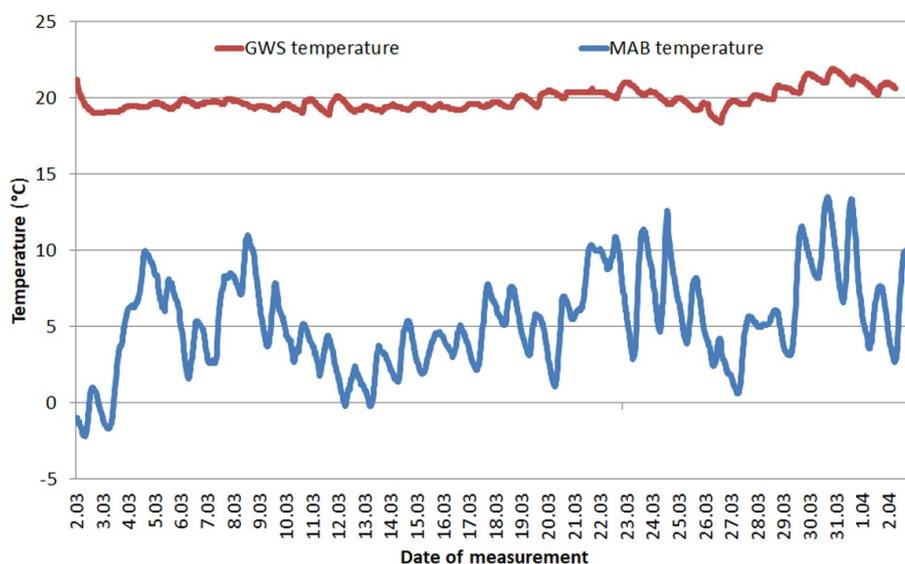
**Figure 2.** Ambient temperature changes during wires storage—Gdańsk welding site (GWS) and Mońki agricultural building (MAB)—1 month.

A comparison of temperature changes in GWS and in MAB is shown in the Figure 2. In addition, the Table 3 presents values of statistical measures and coefficients describing the temperature changes at each location in a given time period.

A clear difference is visible between the temperatures in MAB and GWS. For MAB, the temperature curve is always below the temperature curve measured in GWS. Storage conditions in GWS were stable in terms of temperature, temperature shocks are not visible.

The differences in recorded temperatures for studied areas result from both geographical and anthropogenic factors. The north-eastern part of Poland is an area where the continental climate with a higher temperature gradient begins to dominate. It results in clearly lower temperatures compared to Gdańsk, which is a port city, with a predominance of maritime climate. The second factor results from the degree of urbanization of both locations—Mońki is a small city and Gdańsk is a main city of a metropolitan area in northern Poland. The more specifically analyzed conditions in which the wires were stored may lead to the reason for differences in recorded relative humidity. The welding side is usually a drier place, there are not many sources of moisture. In contrast, unheated MAB may be exposed to increased air flow and water vapor supply from the environment. This analysis of the storage conditions is visible in Figures 2 and 3.

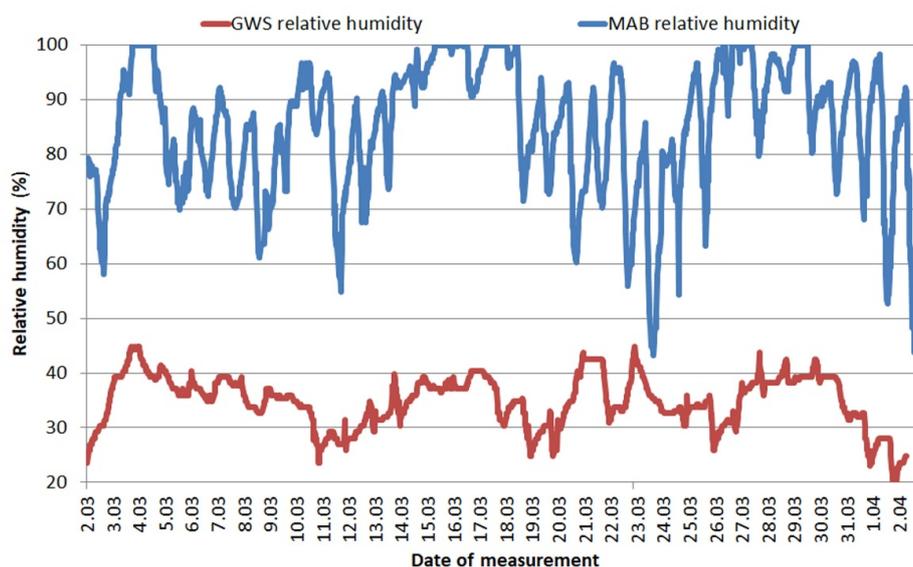
**Figure 3.** Ambient humidity changes during wires storage—Gdańsk welding site (GWS) and Mońki agricultural building (MAB)—1 month.

The Figure 3 shows a comparison of changes in relative humidity at the same time and for the same places. Coefficient values describing the change in this property are also given in Table 3.

For MAB, the registered humidity is very high, reaching up to 100%, which means that in the place where the wires were stored, the air was saturated with water vapor. The humidity was clearly lower in GWS. It did not exceed 50% at any time. Differences in the waveforms of temperature and relative humidity result, among others, from the fact that the GWS was heated.

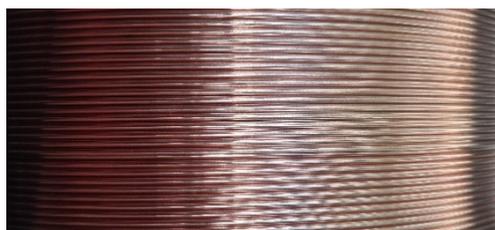
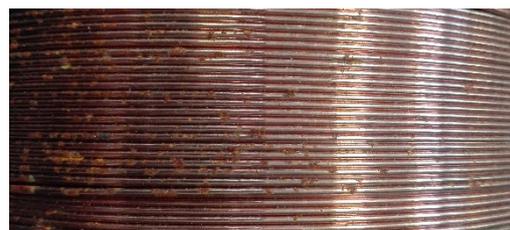
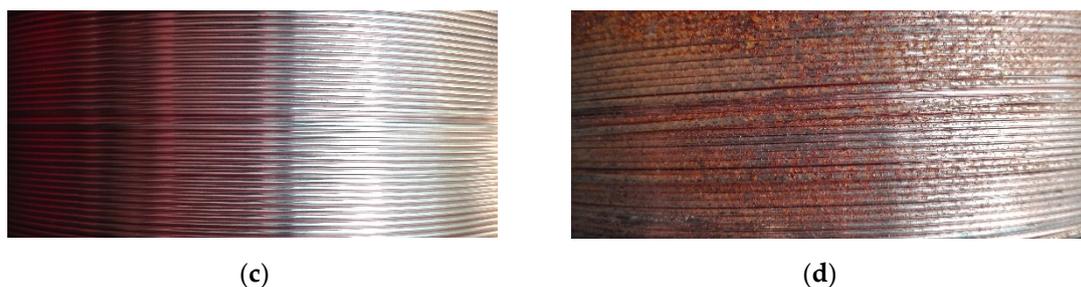
**Figure 4.** The surface layer of wire after storage: (a) A wire stored in Gdańsk welding site (GWS); (b) A wire stored in Mońki agricultural building (MAB); (c) B wire stored in Gdańsk welding site (GWS); (d) B wire stored in Mońki agricultural building (MAB).

Wires in delivery condition and wires stored for 1 month have been subjected to visual examinations. Photographs of the surface layer of those wires in delivery condition were already presented in the previous publication [20]. Pictures of the surface of the stored wires are shown in Figure 4. It can be clearly seen that the surface of wires stored in MAB has greater degradation than the surface of wires stored in GWS.

Differences can also be seen between the degradation that occurred in A wire and B wire. Both wires stored in the GWS have a shiny, smooth surface with no corrosion areas and no visible signs of degradation or environmental impact. In the MAB environment, A wire began to undergo surface corrosion—numerous corrosion areas of a small range are visible. The boundaries between the individual coils are clear, the non-corroded areas are still shiny and smooth. The B wire stored in the same environment was significantly more degraded. The entire surface is covered with corrosion products, which in some places have a significant thickness. Areas without a thick layer of rust were covered with a thin layer of corrosion products and there were no shiny areas.

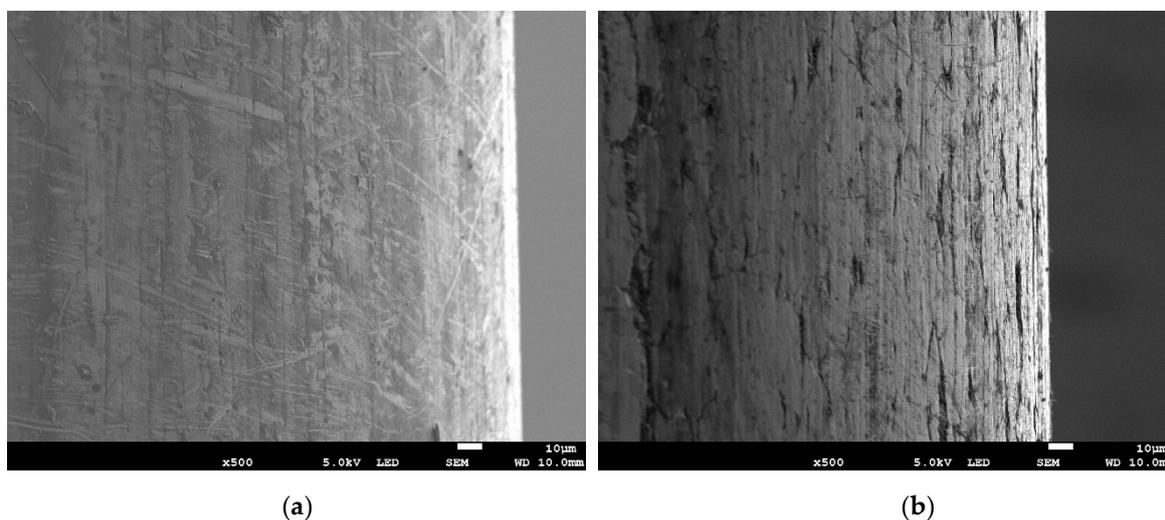
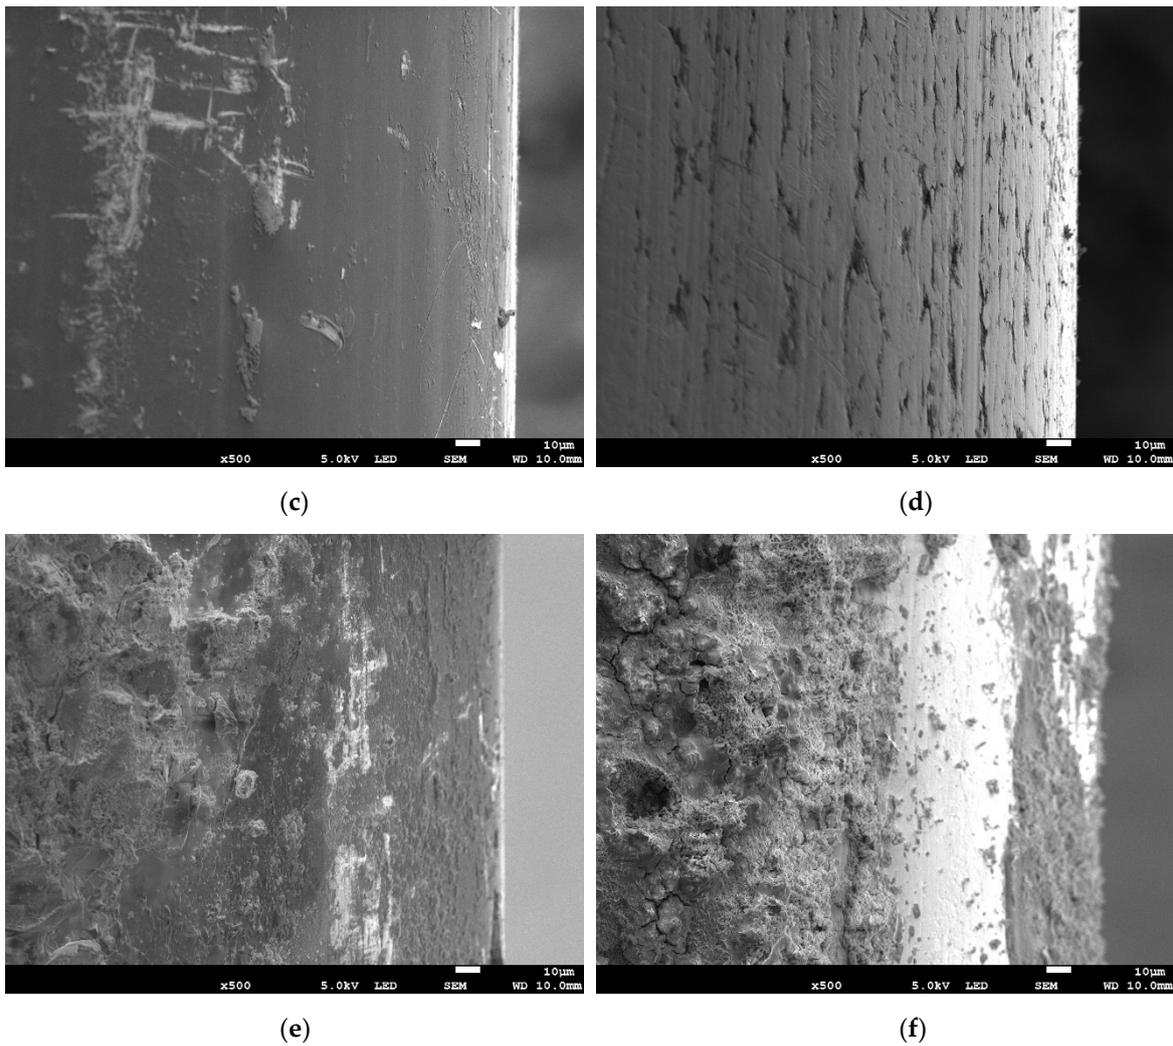
**Figure 5.** Surfaces of flux-cored wires: (a) A wire in delivery condition; (b) B wire in delivery condition; (c) A wire stored in GWS; (d) B wire stored in GWS; (e) A wire stored in MAB; (f) B wire stored in MAB.

SEM images show that the surfaces of both wires in delivery condition significantly differ (Figure 5a,b). The A wire is smooth, has a homogeneous surface without gaps in the continuity of the copper coating. On the contrary, B wire shows longitudinal grooves on the surface, located parallel to the axis of the wire and the direction of material forming. After storing the wires in GWS, A wire still has a smooth surface; only small precipitations can be observed on it (Figure 5c). The EDS analysis (Figure 6a) shows that these products mainly contain copper. B wire behaved similarly—in the grooves visible in Figure 5d, copper compounds accumulated (Figure 6c). Both wires from the MAB location are characterized by a high degree of degradation (Figure 5e,f). On their surface, precipitations of iron oxides were found, which was confirmed by the EDS analysis (Figure 6b,d). The differences between these wires can be seen in the SEM photos at higher magnification—A wire is only locally covered with a thicker layer of corrosion products, but a thin, brittle layer of iron oxides has formed on its surface (Figure 6b). A much thicker layer of corrosion products has accumulated on B wire. Figure 5e,f show the most degraded parts of the wires. Figure 5c–f also show the edge of the wires, which in each case shows no signs of corrosion other than atmospheric corrosion.

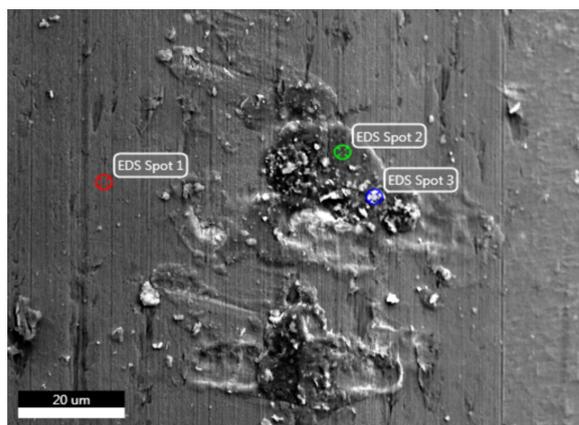
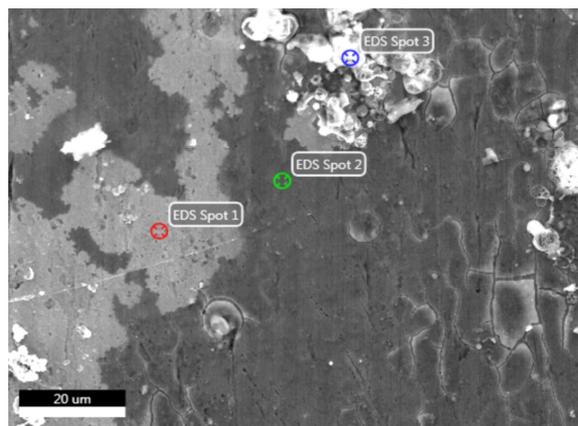
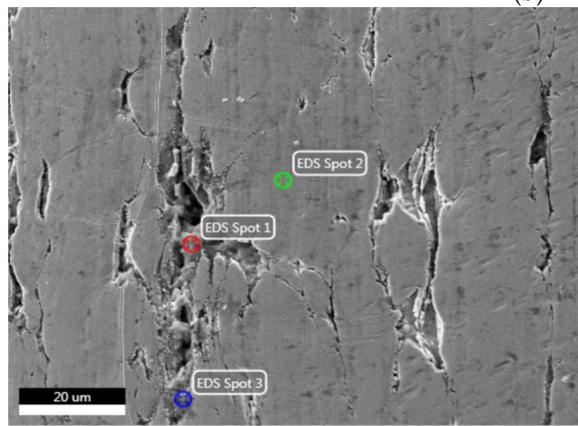
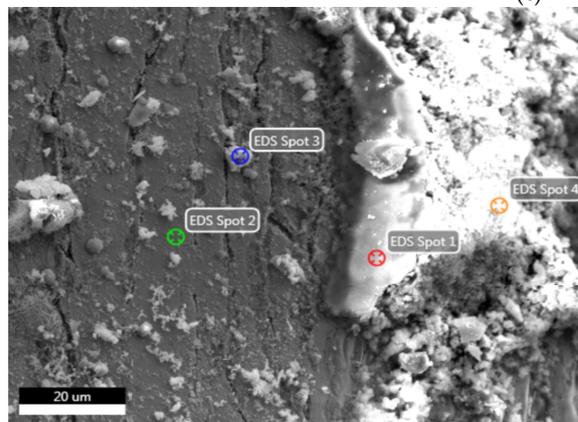
Zone	Fe	Cu	O	S
EDS Spot 1	5.01	91.44	3.55	-
EDS Spot 2	4.64	86.83	7.46	1.07
EDS Spot 3	4.19	90.68	4.48	0.65

Zone	Fe	Cu	O	S
EDS Spot 1	5.57	92.18	1.49	0.76
EDS Spot 2	43.53	53.44	2.45	0.58
EDS Spot 3	76.09	13.70	7.74	2.48

Zone	Fe	Cu	O	S
EDS Spot 1	22.38	65.55	9.43	2.68
EDS Spot 2	47.97	52.03	-	-
EDS Spot 3	22.37	58.85	19.48	4.30

Zone	Fe	Cu	O	S
EDS Spot 1	60.51	5.43	33.58	0.48
EDS Spot 2	66.30	33.70	-	-
EDS Spot 3	71.56	6.04	21.74	0.66
EDS Spot 4	60.68	6.26	32.61	0.45

**Figure 6.** SEM image and spot EDS analysis of flux-cored wires: (a) A wire stored in GWS; (b) A wire stored in MAB; (c) B wire stored in GWS; (d) B wire stored in MAB.

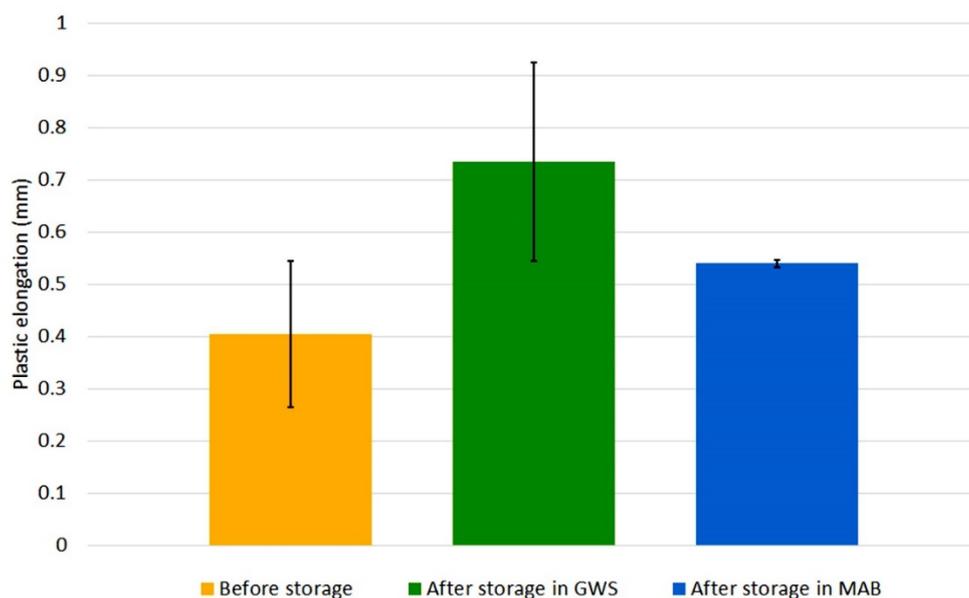
Figure 8. Change in plastic elongation of welds made with A wire, caused by storage for 1 month.

The obtained values of plastic elongation and standard deviation for all specimens confirm the statistical significance of the results. Although the wires have the same specification, their elongation values in the initial state differ. The A wire, regardless of its storage location, was characterized by an increase in plastic elongation. The increase was greater in the case of GWS—nearly twice. However, B wire showed a different trend. Each of the specimens, welded with both GWS and MAB wire, had a smaller plastic elongation compared to the specimen welded with the wire in delivery condition. A large drop was particularly visible in the wire from MAB—the plasticity of the weld metal dropped almost four times with a double drop for the wire stored in GWS.

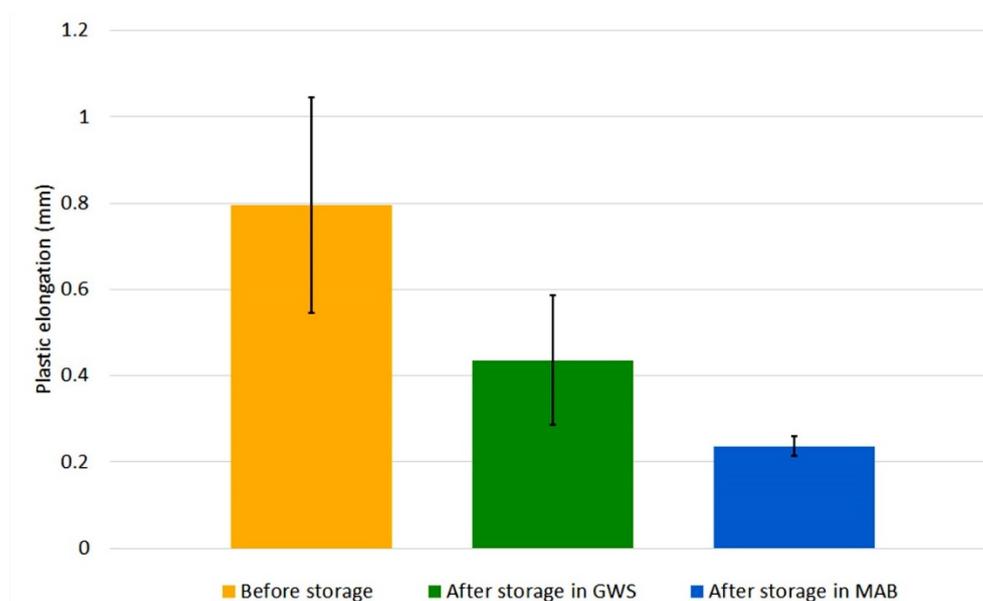
Figure 9. Change in plastic elongation of welds made with B wire, caused by storage for 1 month.

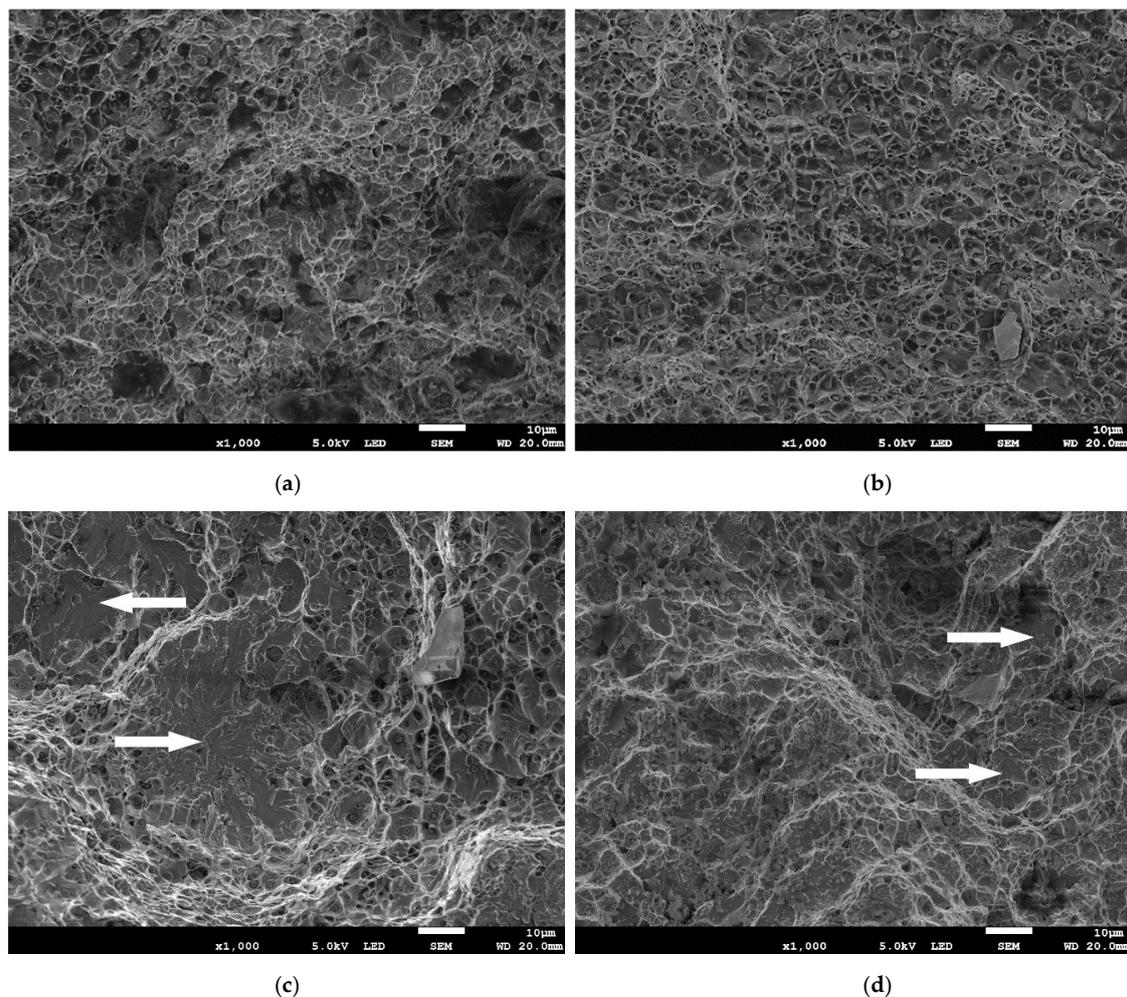
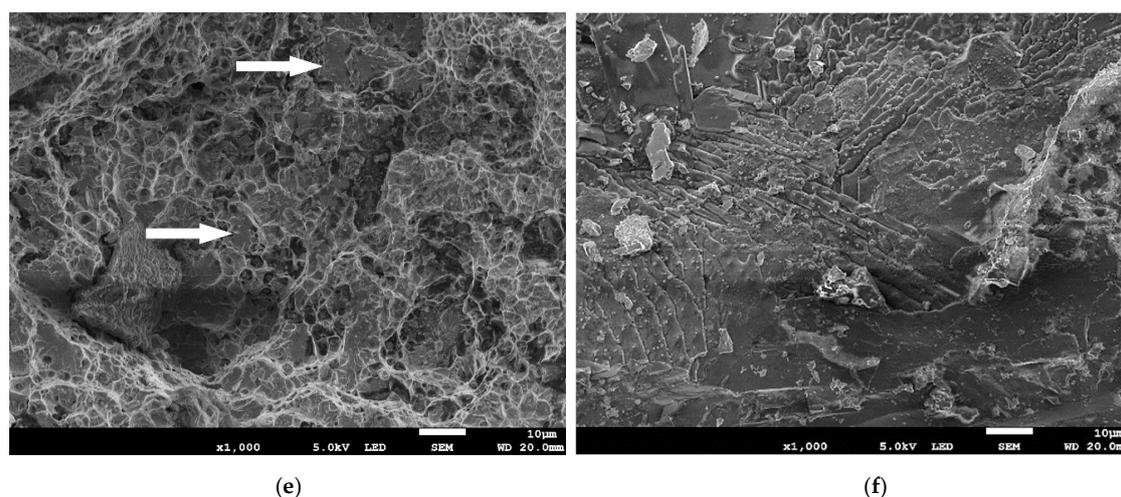
**Figure 10.** Fracture surfaces of specimens after tensile tests: (a) specimen made using A wire in delivery condition; (b) specimen made using B wire in delivery condition; (c) specimen made using A wire stored in GWS; (d) specimen made using B wire stored in GWS; (e) specimen made using A wire stored in MAB; (f) specimen made using B wire stored in MAB.

Figure 10 shows SEM images of fractures after tensile test. In Figure 10a,b, dimples, characteristic of the ductile microvoid coalescence fracture, are clearly visible. Such a fracture mode predominated in specimens made with wires in delivery condition. An increased share of the brittle fracture (marked with white arrows) was observed in specimens made of wire from the GWS and in the specimen made of A wire from MAB (Figure 10c–e). In this case, the quasi cleavage fracture was found. Three zones can be observed—at the face the fracture was more ductile, dimples appeared larger, in the middle zone between dimples flat cleavage areas appeared and at the root there were dimple clusters and larger areas of cleavage, with large steps. Figure 10f shows the fracture surface of a specimen made using B wire stored in MAB. In this specimen, cleavage fracture dominates. At 1000× magnification, only single dimples are visible, situated between large cleavage areas.

A change in plasticity can also be observed by comparing the mode of fracture of the tensile tested specimens (Figure 10). The most characteristic is the transition from the ductile microvoid coalescence fracture to the almost complete cleavage fracture for the specimen made using B wire stored in MAB. Such a great change is directly related to the results of plasticity indexes (Table 5), which also indicate a very intense degradation of bead-on-plate weld plasticity for this wire and location. In all fracture surfaces, at least some dimples were found and they were all equiaxed, which confirms that tensile loading was the main loading type responsible for breaking of specimens.
