# Properties of Old Concrete Built in the Former Leipziger Palace

**Abstract:** This research aims to determine the mechanical, chemical, and physical properties of old concrete used in the former Leipziger Palace in Wrocław, Poland. The cylindrical specimens were taken from the basement concrete walls using a concrete core borehole diamond drill machine. The determination of the durability and strength of old concrete was based on specified chosen properties of the old concrete obtained through the following set of tests: measurements of dry density, tests of water absorption, specification of concrete compressive strength and frost resistance, determination of the modulus of elasticity, measurement of the pH value, determination of water-soluble chloride salts and sulphate ions, and X-ray diffraction analyses. Large dispersions of the compressive strength (10.4 MPa to 34.2 MPa), density (2049 kg/m<sup>3</sup> to 2205 kg/m<sup>3</sup>), water absorption (4.72% to 6.55%), and stabilized secant modulus of elasticity (15.25 GPa to 19.96 GPa) were observed. The paper is intended to provide scientists, civil engineers, and designers with guidelines for examining and assessing the long

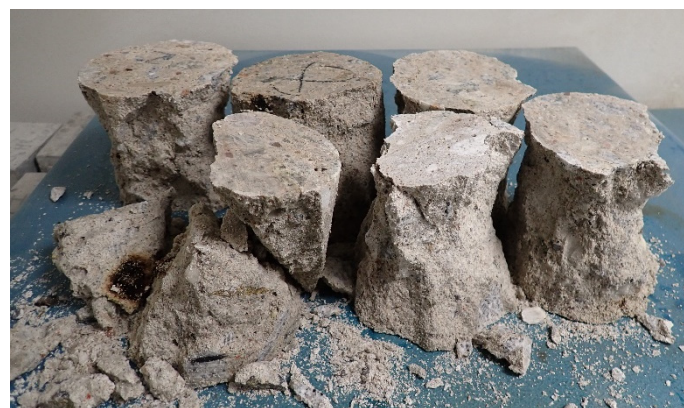
**Figure 6.** Parts of some concrete specimens after uniaxial compressive tests—views of the form of failure with visible organic inclusions and predominance of fine aggregates.

The uniaxial test results of the compressive strength for old concrete cores vs. the dry density are shown in Figure 5. Figure 5 exhibits the general characteristic, that an increase in the density of old concrete caused a higher compressive strength and lower water absorption of old concrete. The compressive strength of concrete cores varied from 10.4 MPa to 34.2 MPa. The difference in compressive strength results may result from the production technology, which was probably based on hand mixing with handmade proportions of the concrete components. Additionally, a lack of uniform compaction during the placement of old concrete causes differences in dry density and compressive strengths. The mean in-situ compressive strength value was  $19.7 \pm 2.8$  MPa, while the median was equal to 16.4 MPa. The strength results of the concrete cores were comparable to the cube strength (see EN 12504-1 standard [53]), so  $f_{c,cube} = f_{c,cycl 100} = 19.7 \pm 2.8$  MPa. Figure 6 shows that parts of some concrete specimens after uniaxial compressive tests—views of the form of failure with visible organic inclusions and predominance of fine aggregates.

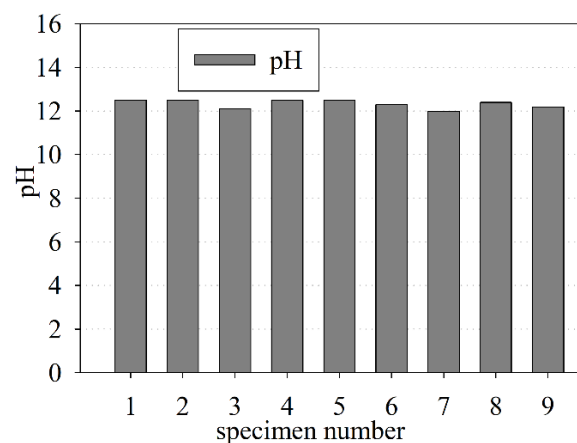
Figure 10. The pH value of the old concrete.

The pH value is an important factor that influences the corrosion rate of reinforcement [75,76]. Freshly made concrete has a pH value that varies from 12.5 to 13.5 [77], while the corrosion of reinforcement generally occurs when the pH value is less than 9 [78]. Under the laboratory tests for the old concrete samples, it was determined that the mean value of the pH was  $12.33 \pm 0.06$ , while the median was 12.40. The pH values for the old concrete ranged from 12.00 to 12.50 (see Figure 10). The pH of the old concrete was in the safety range. One of the concrete cores (which was not subjected to strength tests) included a flat bar-shaped reinforcement, which was in a very good condition, which confirms the results obtained for the safe pH value.

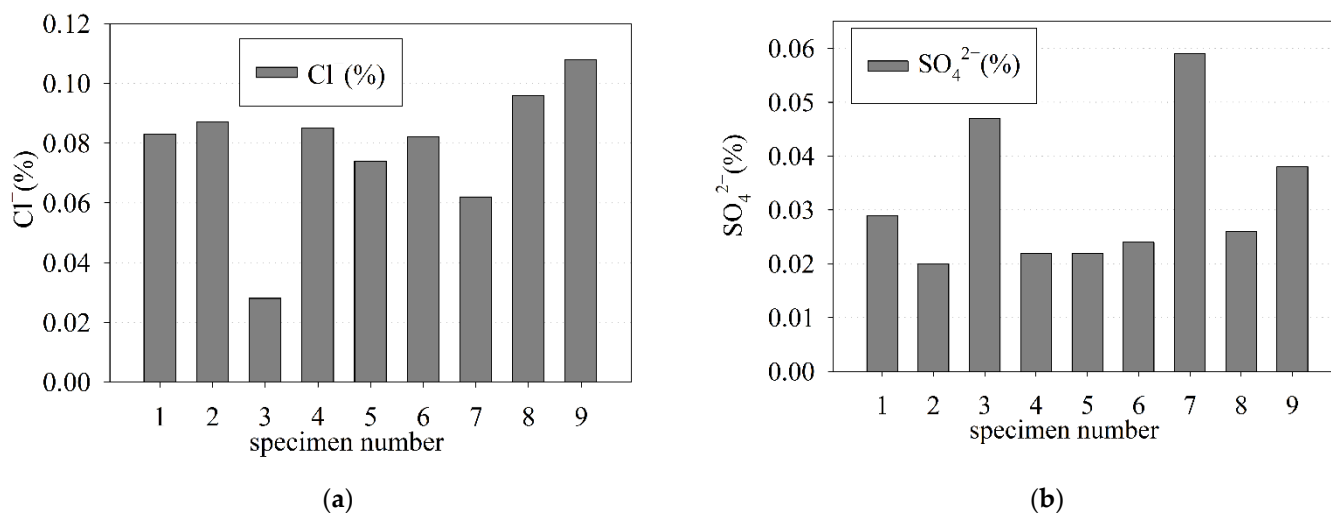
**Figure 11.** Content as the dry weight percentage of water-soluble (a) chloride ions ( $\text{Cl}^-$ ); (b) sulfate ions ( $\text{SO}_4^{2-}$ ).

The content of water-soluble chloride ions ( $\text{Cl}^-$ ) and sulfate ions ( $\text{SO}_4^{2-}$ ) was determined as the percentage of dry weight using the chemical tests. The water-soluble chloride ion values ranged from 0.028 % to 0.108 % (see Figure 11a), with the mean value equal to  $0.078 \pm 0.008\%$  and the median equal to 0.083 %. The sulfate ion values ranged from 0.020 to 0.059% dry weight (see Figure 11b), while the mean value was  $0.032 \pm 0.004\%$  and the median was 0.026% dry weight.

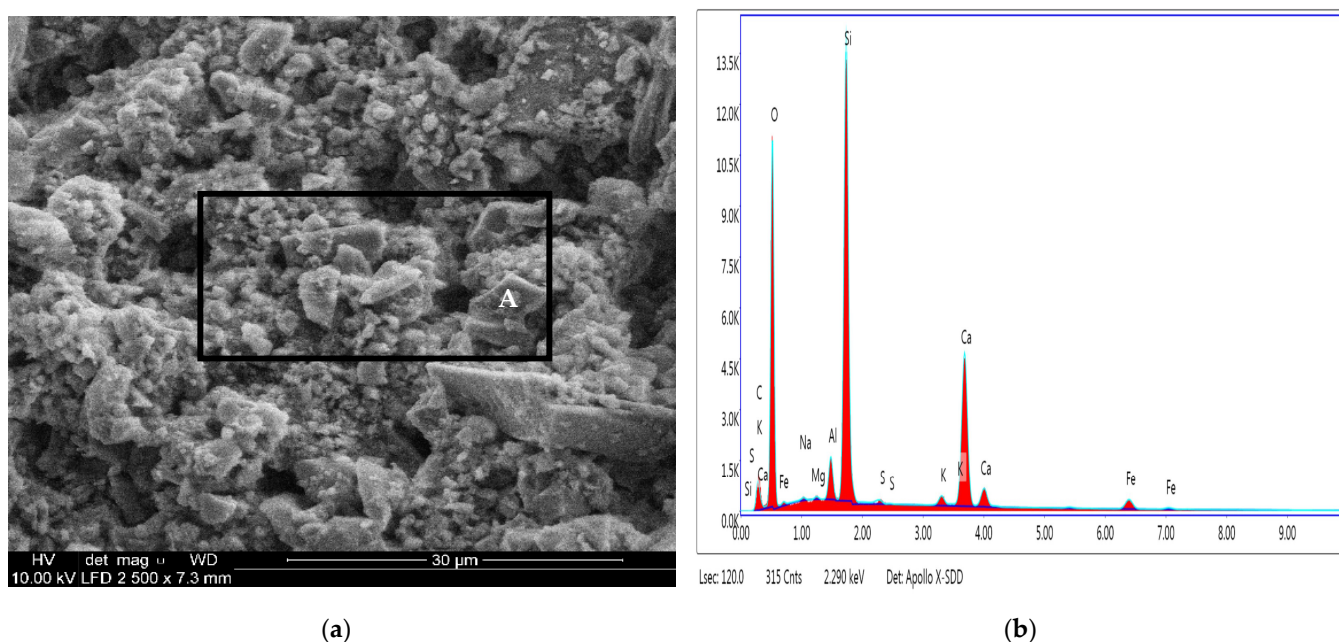
**Figure 12.** SEM/EDS analysis: (a) SEM microscopic images; (b) EDS of the sample on the selected area (A).

The scanning electron microscopy (SEM) image of the chosen sample taken from the old concrete structure is shown in Figure 12a. The results of the analysis of the chemical composition of the sample (in the selected area marked in Figure 12a) based on the presented spectrum (see Figure 12b) determined by the EDAX method are collected in Table 2.

The presented image SEM (see Figure 12a) of the chosen test sample shows that the old concrete element was a layer structure formed from the products of the cement hydration process. The shape and size of the crystalline phases are the result of the formation of chemical compounds in the structure of the tested concrete. According to the data presented in Table 2, the content of elements in the tested sample, taken from the structural old concrete element, is as follows: silica (43.9%), calcium (41.2%), iron (8.3%), aluminium (3.9%), and potassium (1.9%) by weight, respectively. The remaining amount of the identified elements in the structure of the tested sample was below 1% of the mass of the concrete sample.

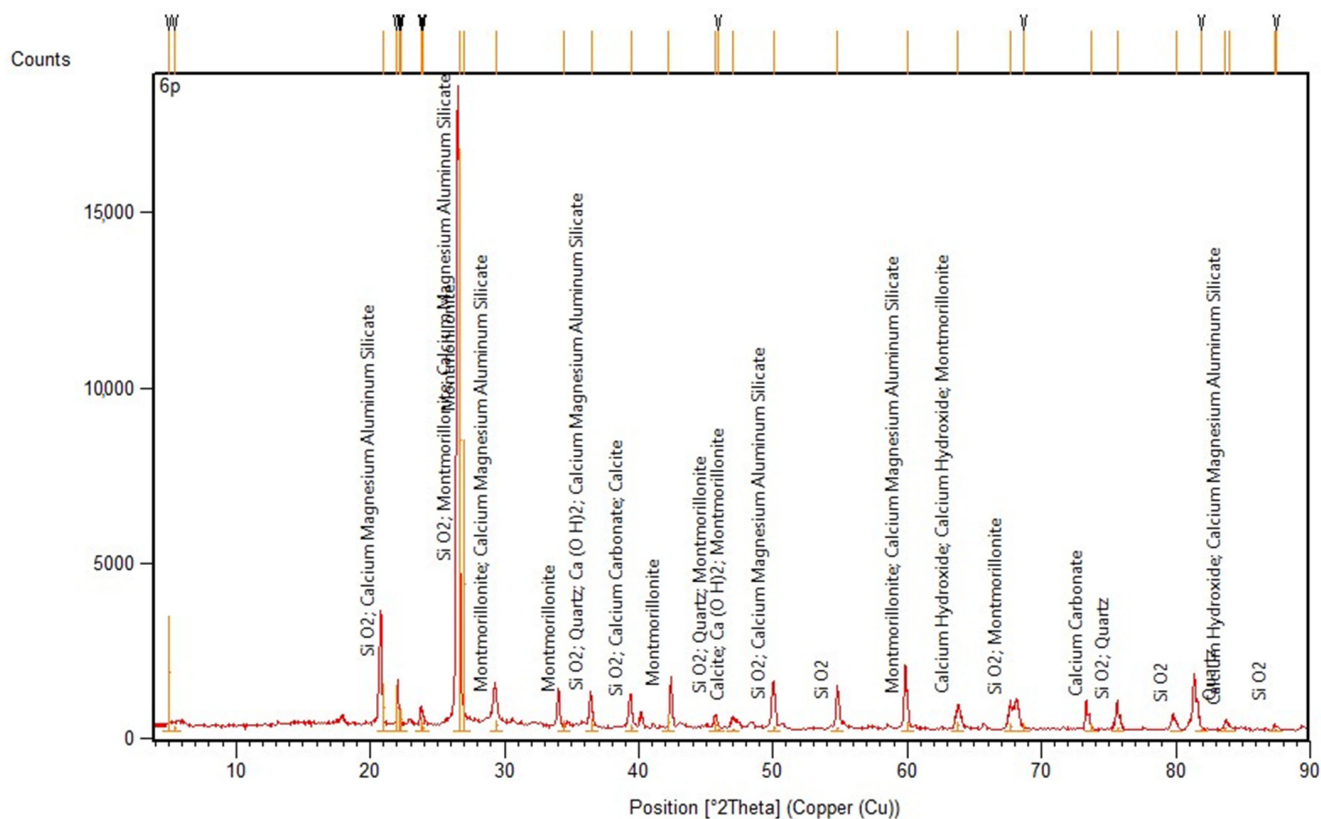
Figure 13. XRD pattern of the old concrete sample.

The XRD method was applied for the identification of the phase composition of the old concrete. The results of the mineralogical composition (in the form of a diffraction pattern) based on a chosen old concrete sample are presented in Figure 13.

The analysis of the evolution of concrete over the years, its phase composition, and its microstructure is critical to determine its durability. The obtained test results (see Figure 13) indicate that the following compounds were mainly dominant in the concrete structure after 120 to 140 years:  $(\text{Na,Ca})_{0,3}(\text{Al,Mg})_2(\text{Si}_4\text{O}_{10})(\text{OH})_2\text{xnH}_2\text{O}$ —montmorillonite, calcium–magnesium–aluminium–silicate hydrate (C–M–A–S–H),  $\text{CaCO}_3$  (calcite) as the carbonate phase,  $\text{Ca}(\text{OH})_2$ —portlandite, and  $\text{SiO}_2$ —quartz. The registered chemical compounds are products of the reacted clinker phases included in the cement used for concrete, including many years of exposure to atmospheric conditions and water.
